Neyagawa Boulevard, Oakville, Ontario

Phase One Environmental Site Assessment

GTR-23012833-A0

November 13, 2023

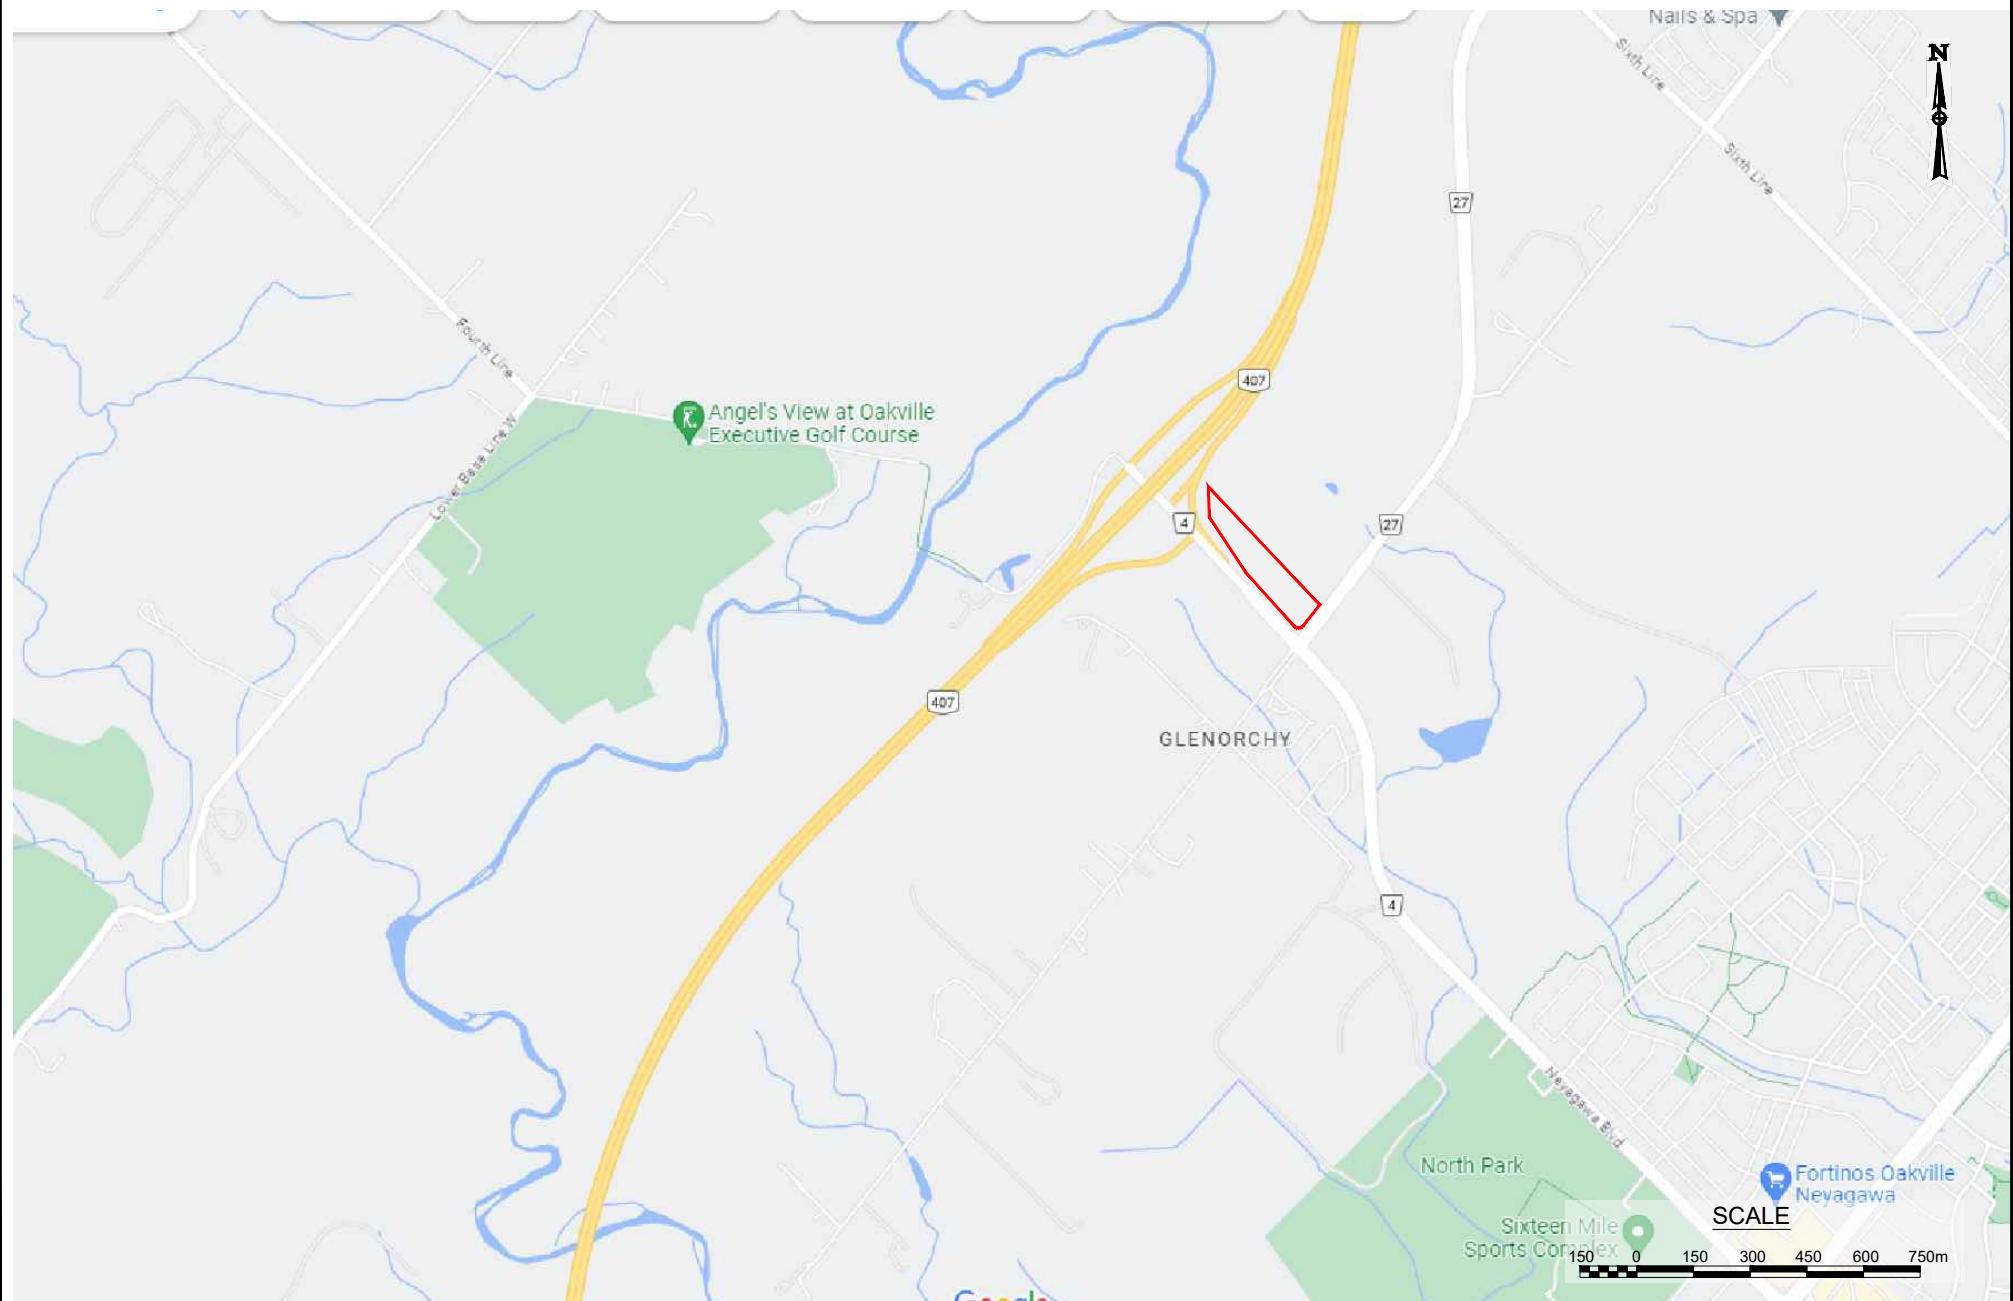
DATE: OCTOBER 2023 **FIG. NO.:** 1

The Site is situated at the northern corner of the intersection of Neyagawa Boulevard and Burnhamthorpe Road West, as shown on Figure 1. The Site measures approximately 2.4050 hectares (5.943 acres) in area.

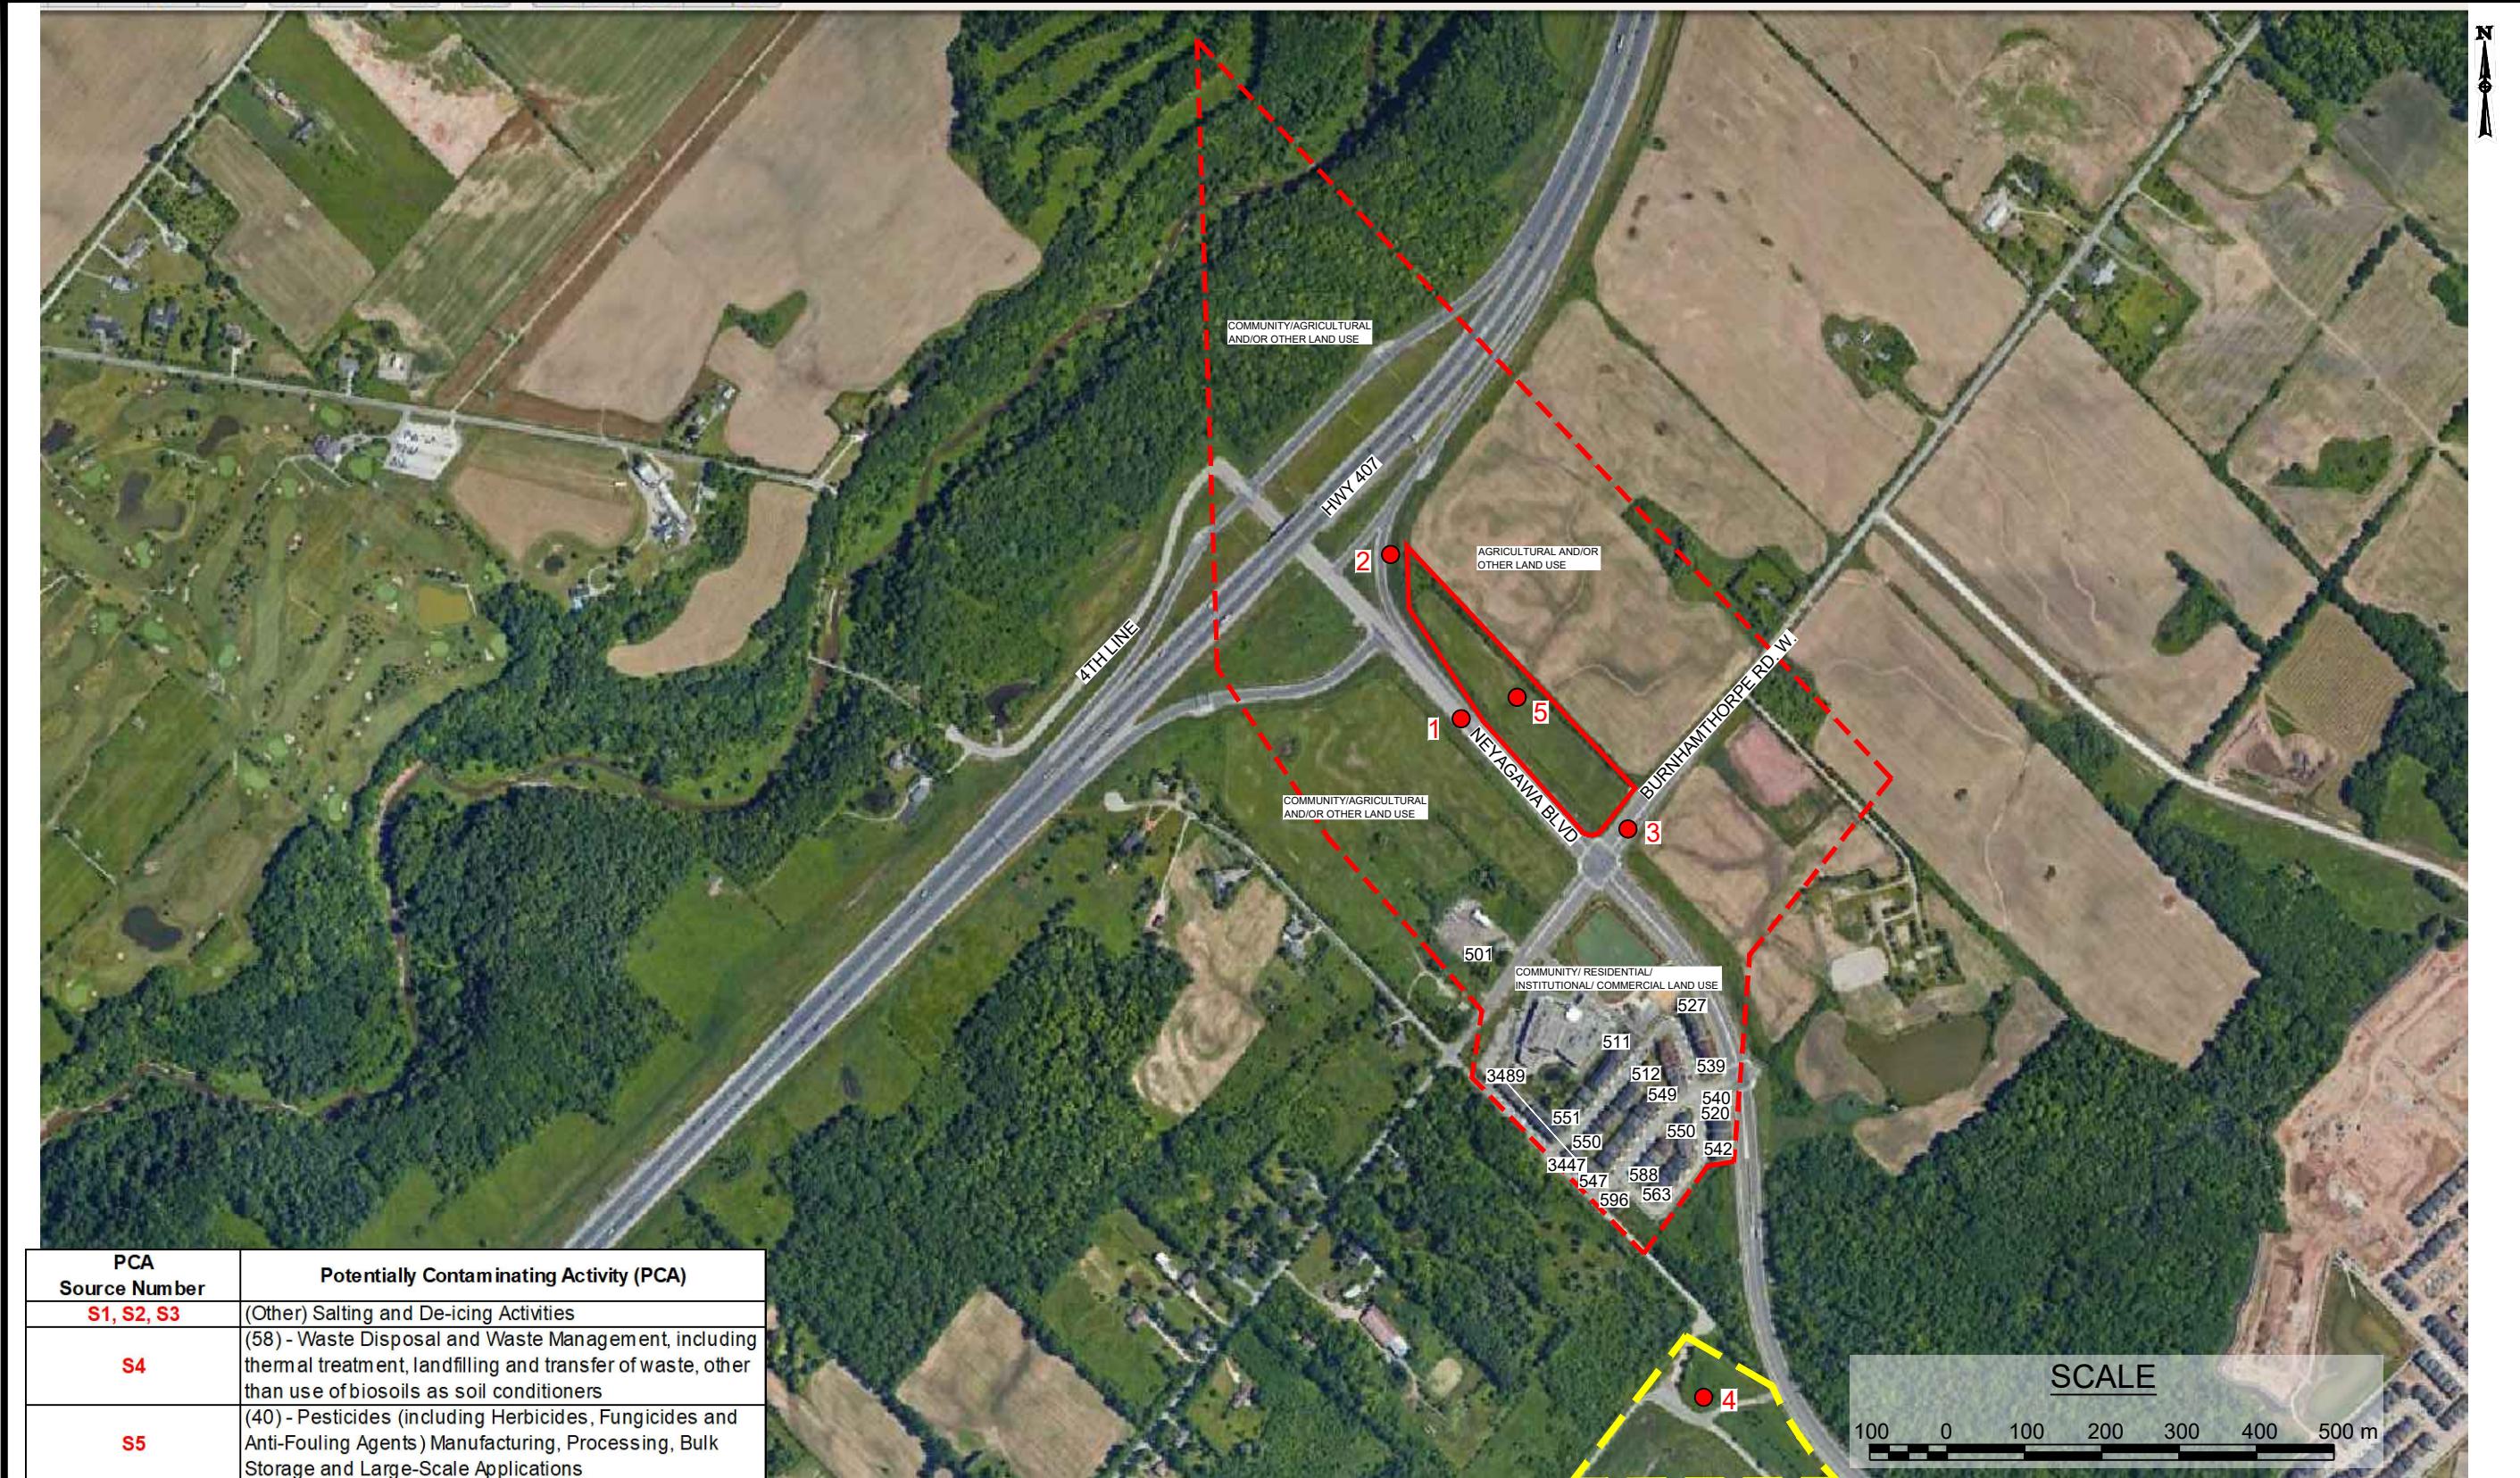
JOB NO.: GTR-22017294-B0 DRAWN BY: K.G.
SCALE: AS NOTED CHECKED BY: A.C.
DATE: OCTOBER 2023 FIG NO.: 2

PCA Source Number	Potentially Contaminating Activity (PCA)
S1, S2, S3	(Other) Salting and De-icing Activities
S4	(58) - Waste Disposal and Waste Management, including thermal treatment, landfilling and transfer of waste, other than use of biosolids as soil conditioners
S5	(40) - Pesticides (including Herbicides, Fungicides and Anti-Fouling Agents) Manufacturing, Processing, Bulk Storage and Large-Scale Applications

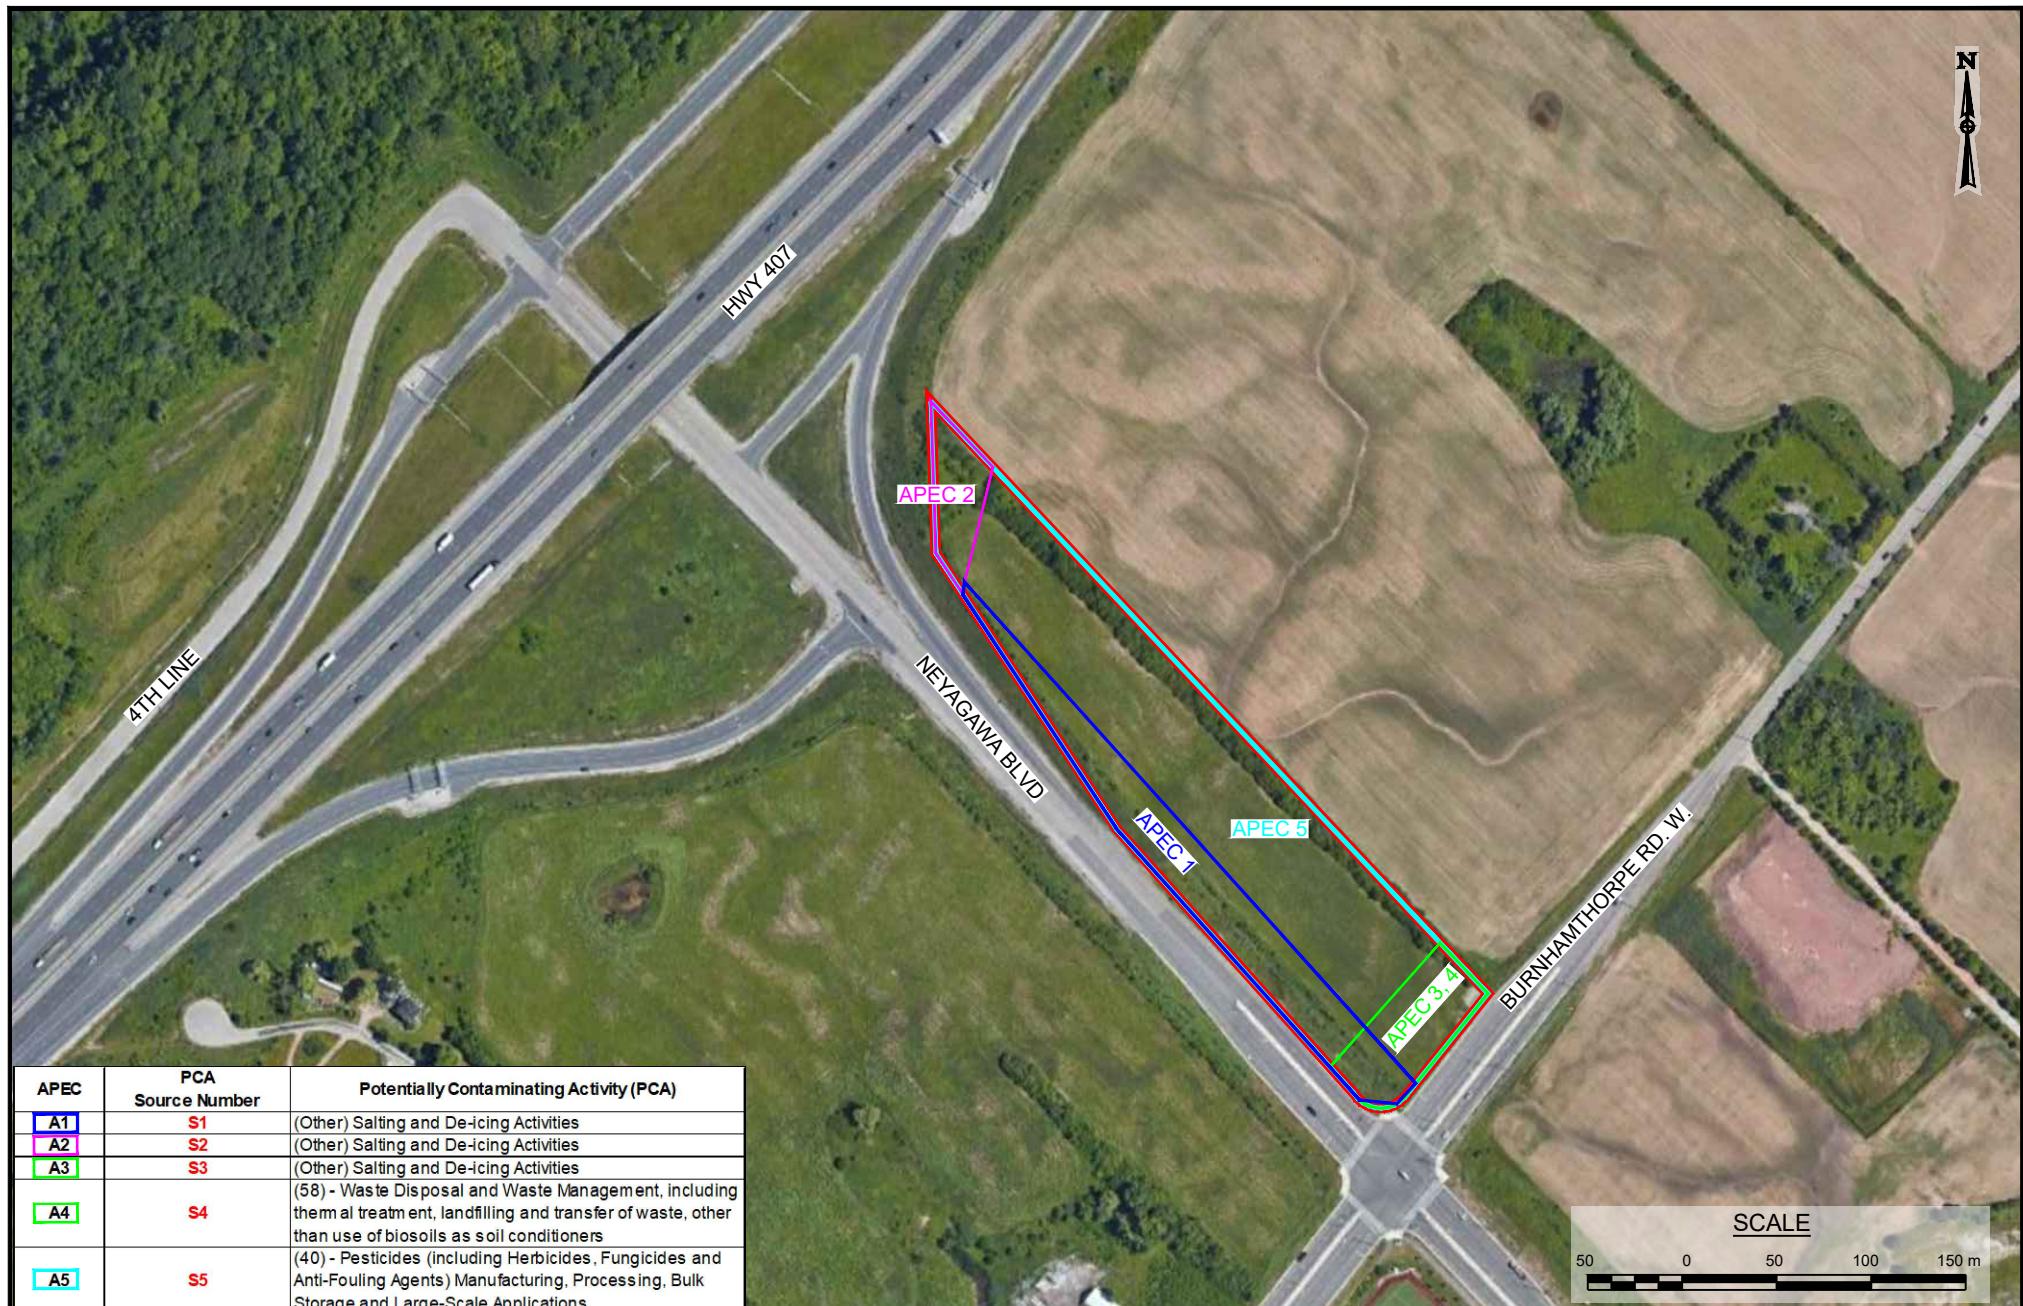
PROJECT NO.:	GTR-23012833-A0	DWN.:	K.G.
SCALE:	AS NOTED	CK:	A.C.
DATE:	OCTOBER 2023	FIG. NO.:	4

APEC	PCA Source Number	Potentially Contaminating Activity (PCA)
A1	S1	(Other) Salting and De-icing Activities
A2	S2	(Other) Salting and De-icing Activities
A3	S3	(Other) Salting and De-icing Activities
A4	S4	(58) - Waste Disposal and Waste Management, including thermal treatment, landfilling and transfer of waste, other than use of biosolids as soil conditioners
A5	S5	(40) - Pesticides (Including Herbicides, Fungicides and Anti-Fouling Agents) Manufacturing, Processing, Bulk Storage and Large-Scale Applications

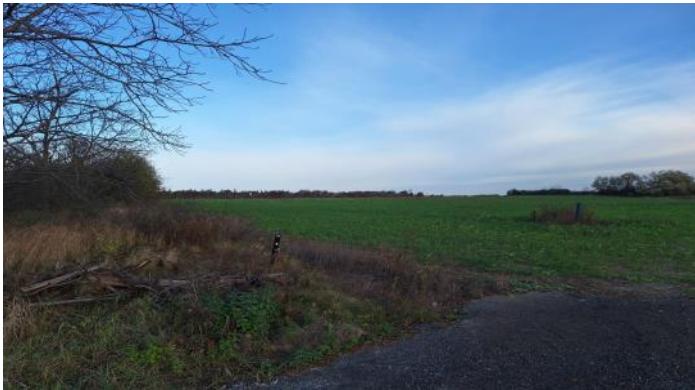
Photo 1: View of the adjacent property to the east and of existing monitoring wells (looking northeast).

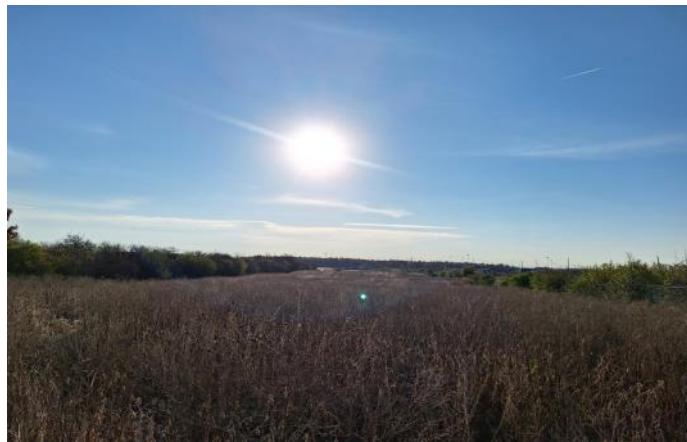
Photo 3: General view of the site from the north end (looking south).

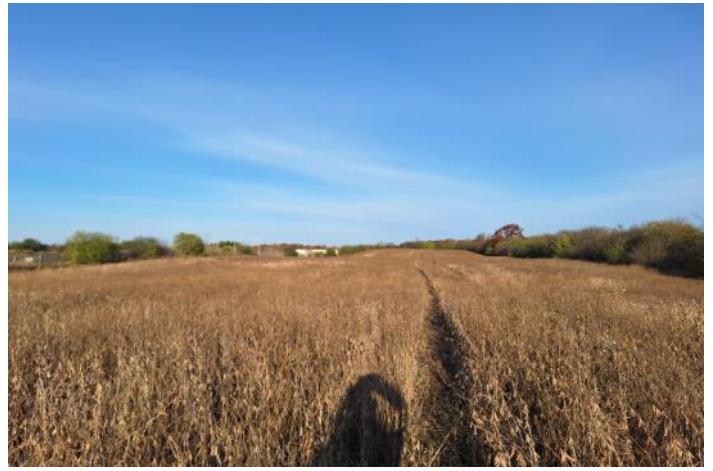
Photo 6: General view of the Site (looking north).

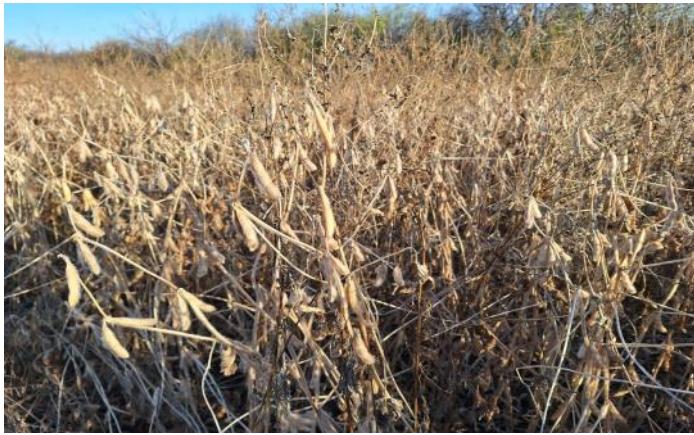
The Site is located at the north side of Neyagawa Boulevard, between Burnhamthorpe Road West and Highway 407, in Oakville Ontario. The Site is irregular in shape and is currently vacant with no structures. During the investigation soy bean crops were observed across the entirety of the Site. Given that it is unknown how long these crops have been present on-Site and whether pesticide has ever been applied to the crops, this was identified as a PCA [PCA 5 (PCA ID #40 - Pesticides (including Herbicides, Fungicides and Anti-Fouling Agents))].

Photo 7: View of the soybean crop grown across the Site.

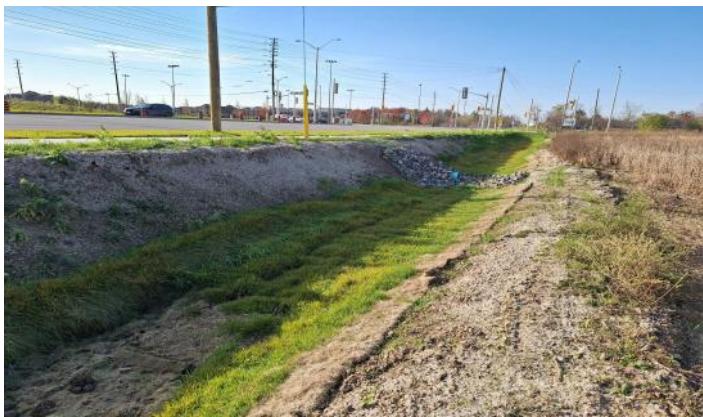
No certificates of approval for storm/sanitary sewer discharge were reported for the Site. At the time of the site reconnaissance, the catch basins and manholes for the storm and sanitary sewer were observed along Neyagawa Boulevard and Burnhamthorpe Road West.

Photo 11: View of the storm water management system along Burnhamthorpe Road West (looking southwest from Site entrance).
