DIGRAM DEVELOPMENTS OAKVILLE INC.

3380 SIXTH LINE, OAKVILLE, ONTARIO PHASE ONE ENVIRONMENTAL SITE ASSESSMENT

PROJECT NO.: 191-15687-00

DATE: JANUARY 22, 2020

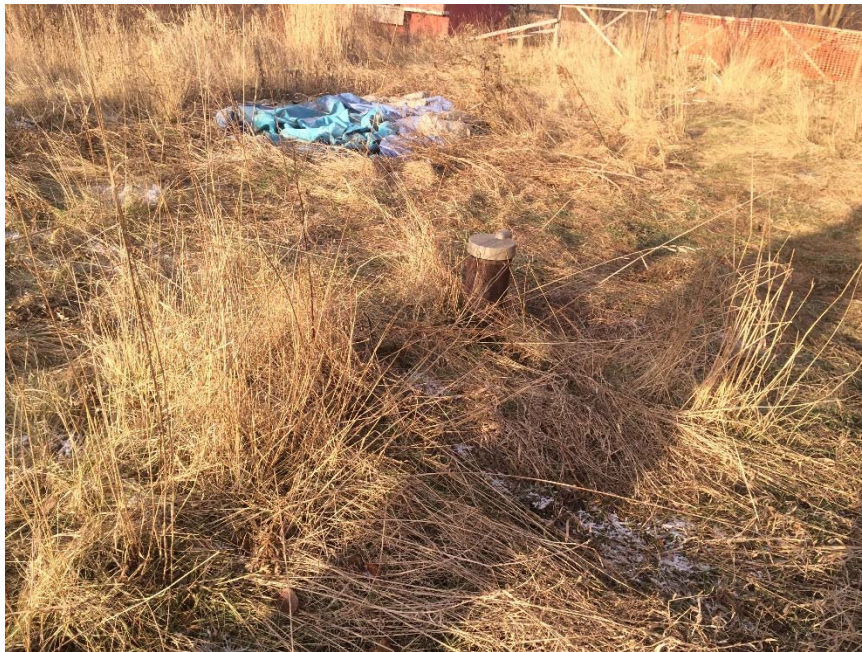
Photograph 2: View looking west at back yard of house. Grass ground cover and drinking supply well visible.

Based on the findings of this Phase One ESA, the potential for contamination at the Phase One Property is interpreted to be low. A Phase Two ESA is not recommended at this time. WSP recommends any existing monitoring wells on the Phase One Property which are damaged and / or no longer in use should be decommissioned as per Regulation (Reg.) 903: Wells under the *Ontario Water Resources Act* (R.R.O. 1990, amended January 2014).

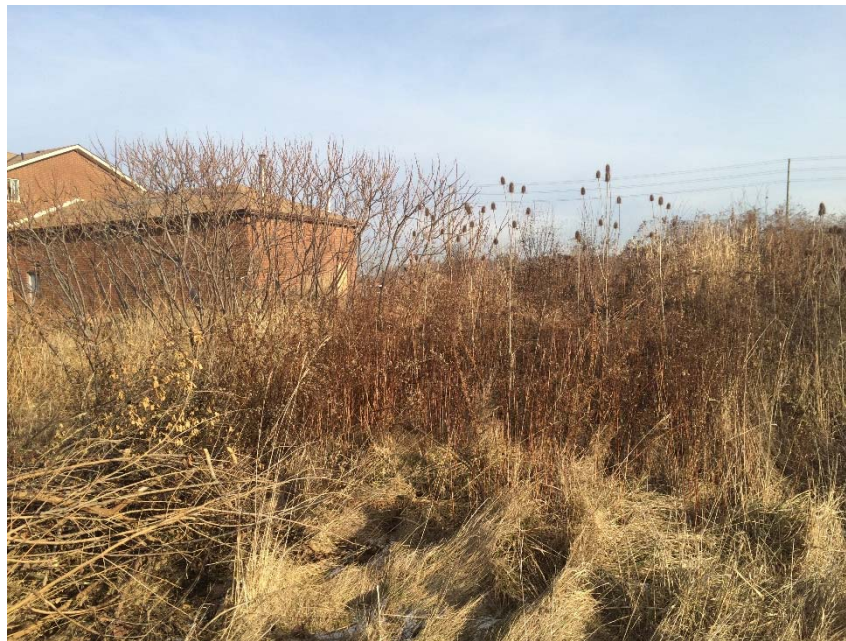
A raised mound was observed southeast of the house which is inferred to be the location of the septic system based on previous environmental reports (Photograph 8). A pile of household waste and refuse including tires, wood pallets, and scrap plastic and metal was observed along the north property boundary (Photograph 15).

Photograph 8: Below ground septic system, looking north.

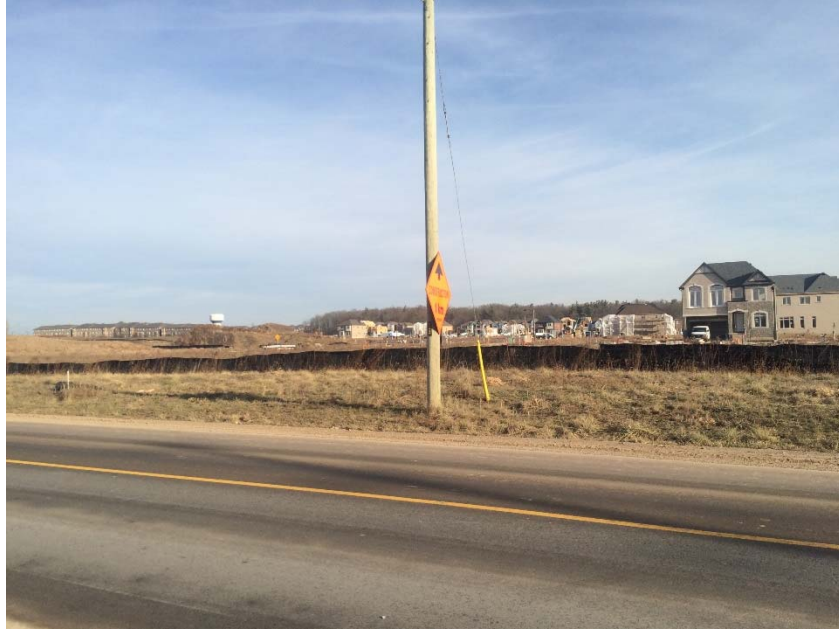
On the neighbouring properties to the north and northeast, across Sixth Line, piles of fill material were visible as residential housing development is under various stages of construction (Photograph 9). To the southeast, a monitoring well was observed on the agricultural property adjacent to the Phase One Property. The adjacent properties to the south and west are agricultural properties.

Photograph 9: Looking north, construction of new housing along Sixth Line.

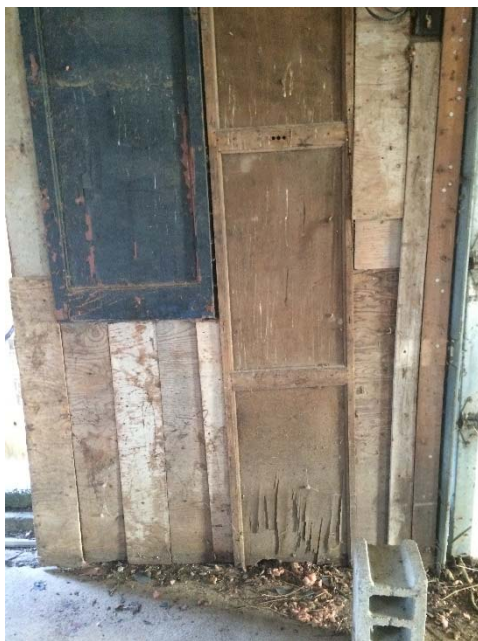
Although the barn was constructed in the 1990s, the interior wall materials in the north portion of the barn appeared to be finished with old doors which may be much older than the age of construction of the barn. Paint on the doors lining the walls was observed to be peeling and generally in poor condition (Photograph 10). These painted surfaces may be coated with lead-containing paint.

Photograph 10: Peeling paint on interior barn wall, looking west.

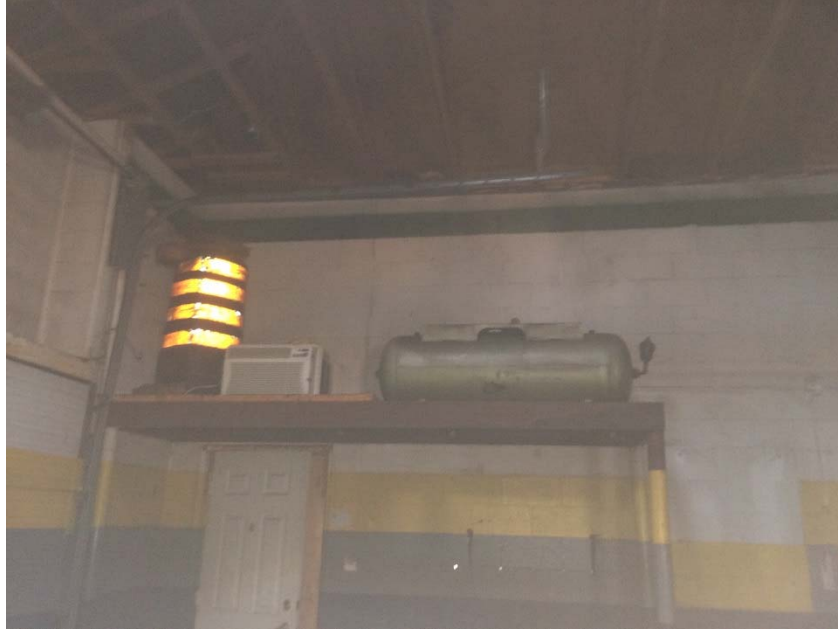
Photograph 11: Looking southeast, compressor inside garage attached to house.

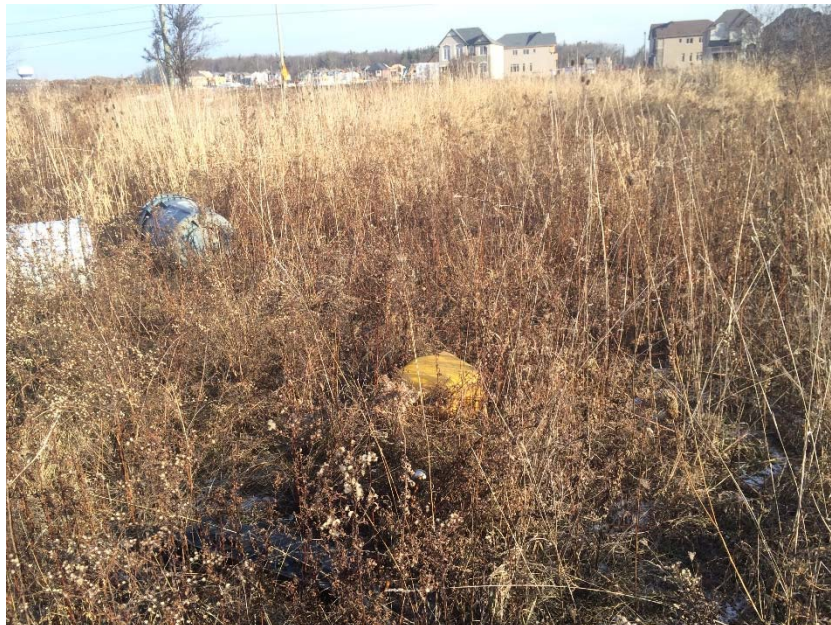
- Two approximately 20-litre jerry cans were observed east of the driveway parking area at the north end of the Phase One Property. As the cans were empty, no visual evidence of leaked or spilled fuel and no stressed vegetation was observed in the surrounding, the discarded cans are not considered as a PCA onsite.

Photograph 12: Looking east, discarded diesel potable container.

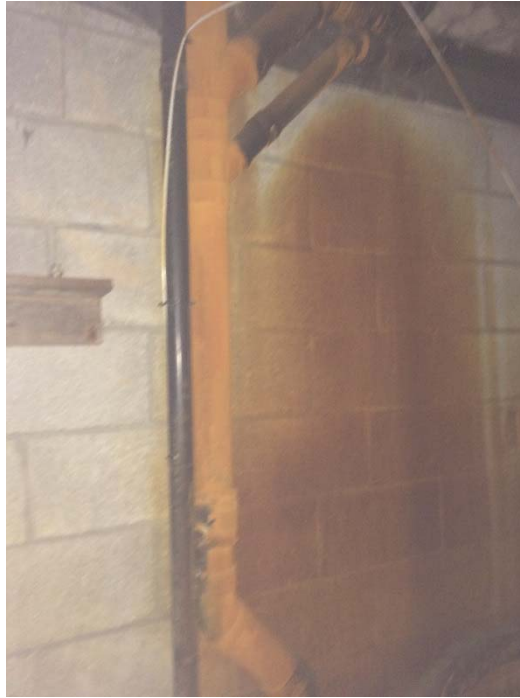
Photograph 13: Looking south, rust stains along southeast wall of house.

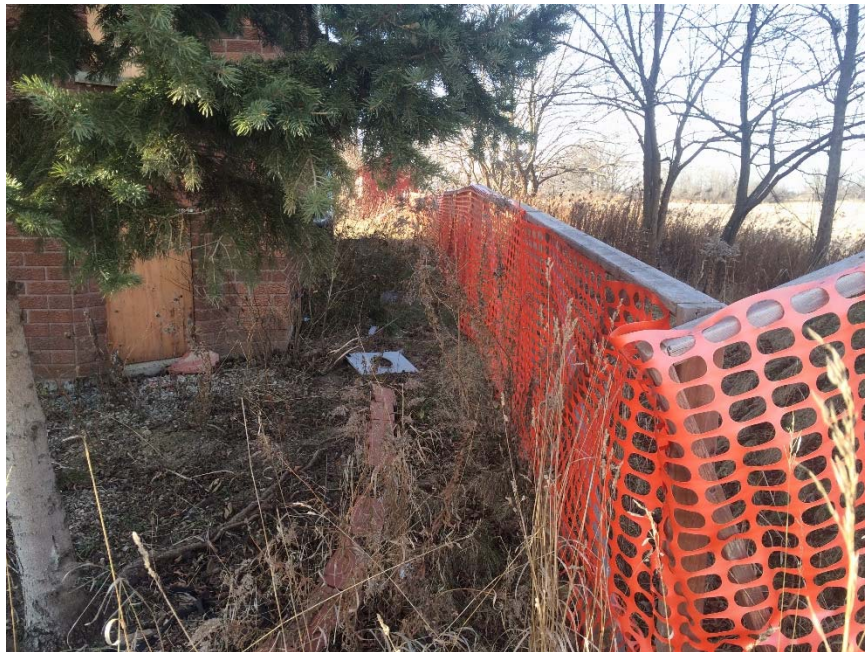
Photograph 14: Grass covered fill berm on northwest side of house, looking southwest.

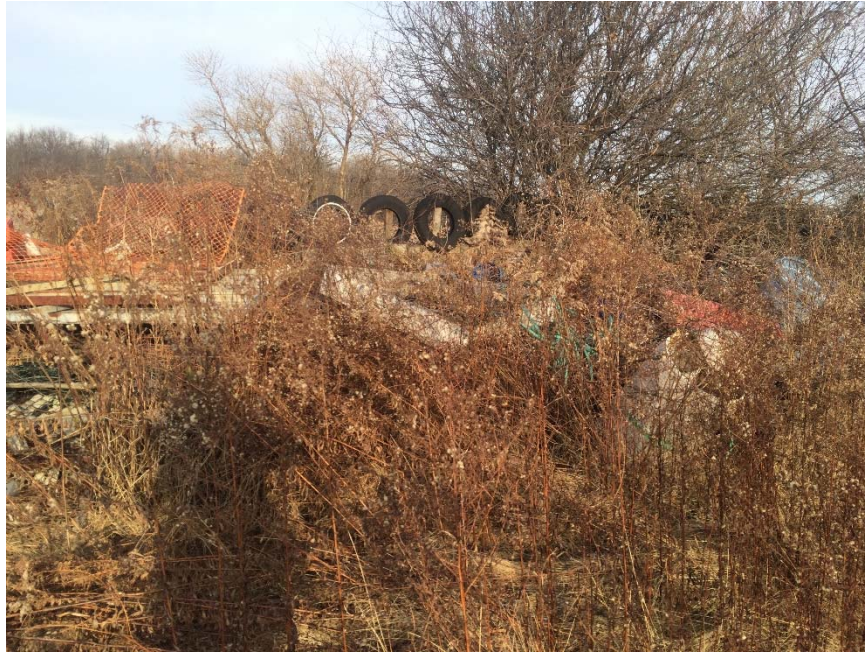
- Various discarded household items and tires were observed to be stored outside during WSP’s site reconnaissance. The waste items were contained in a makeshift storage area separated from the ground by plywood. No concern is identified related to the stored items.

Photograph 15: Household waste and tires southwest of the barn, looking west.

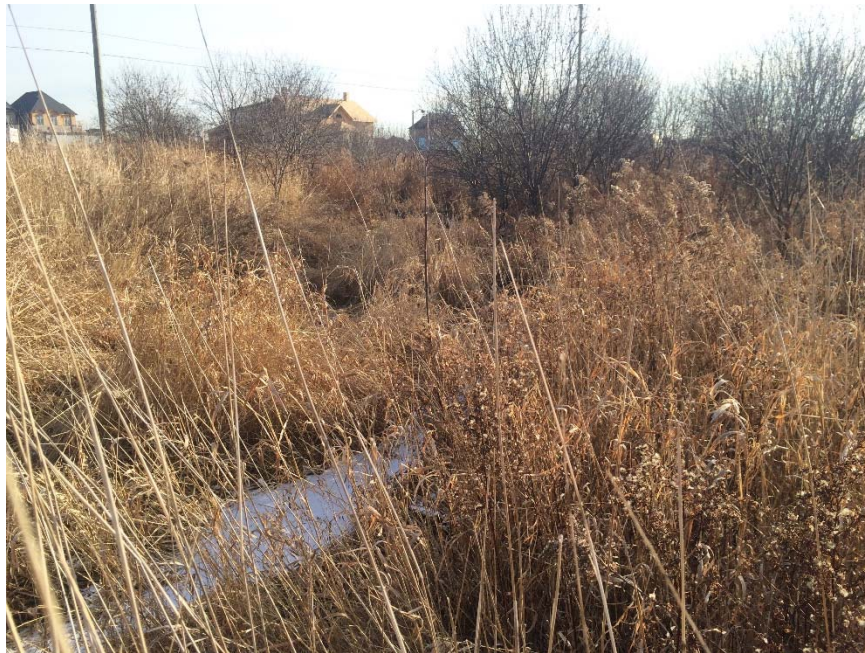
Morrison Creek was observed traversing between Sixth Line and the house onsite and was frozen at the time (Photograph 16).

Photograph 16: Frozen creek observed adjacent to driveway leading to the residence, looking southeast.
