**Midtown Oakville Transportation and Stormwater
Municipal Class EA Final Report June 2014**

**APPENDIX D
ENVIRONMENTAL CONDITIONS**

NATURAL HERITAGE REPORT

MIDTOWN OAKVILLE CLASS ENVIRONMENTAL ASSESSMENT

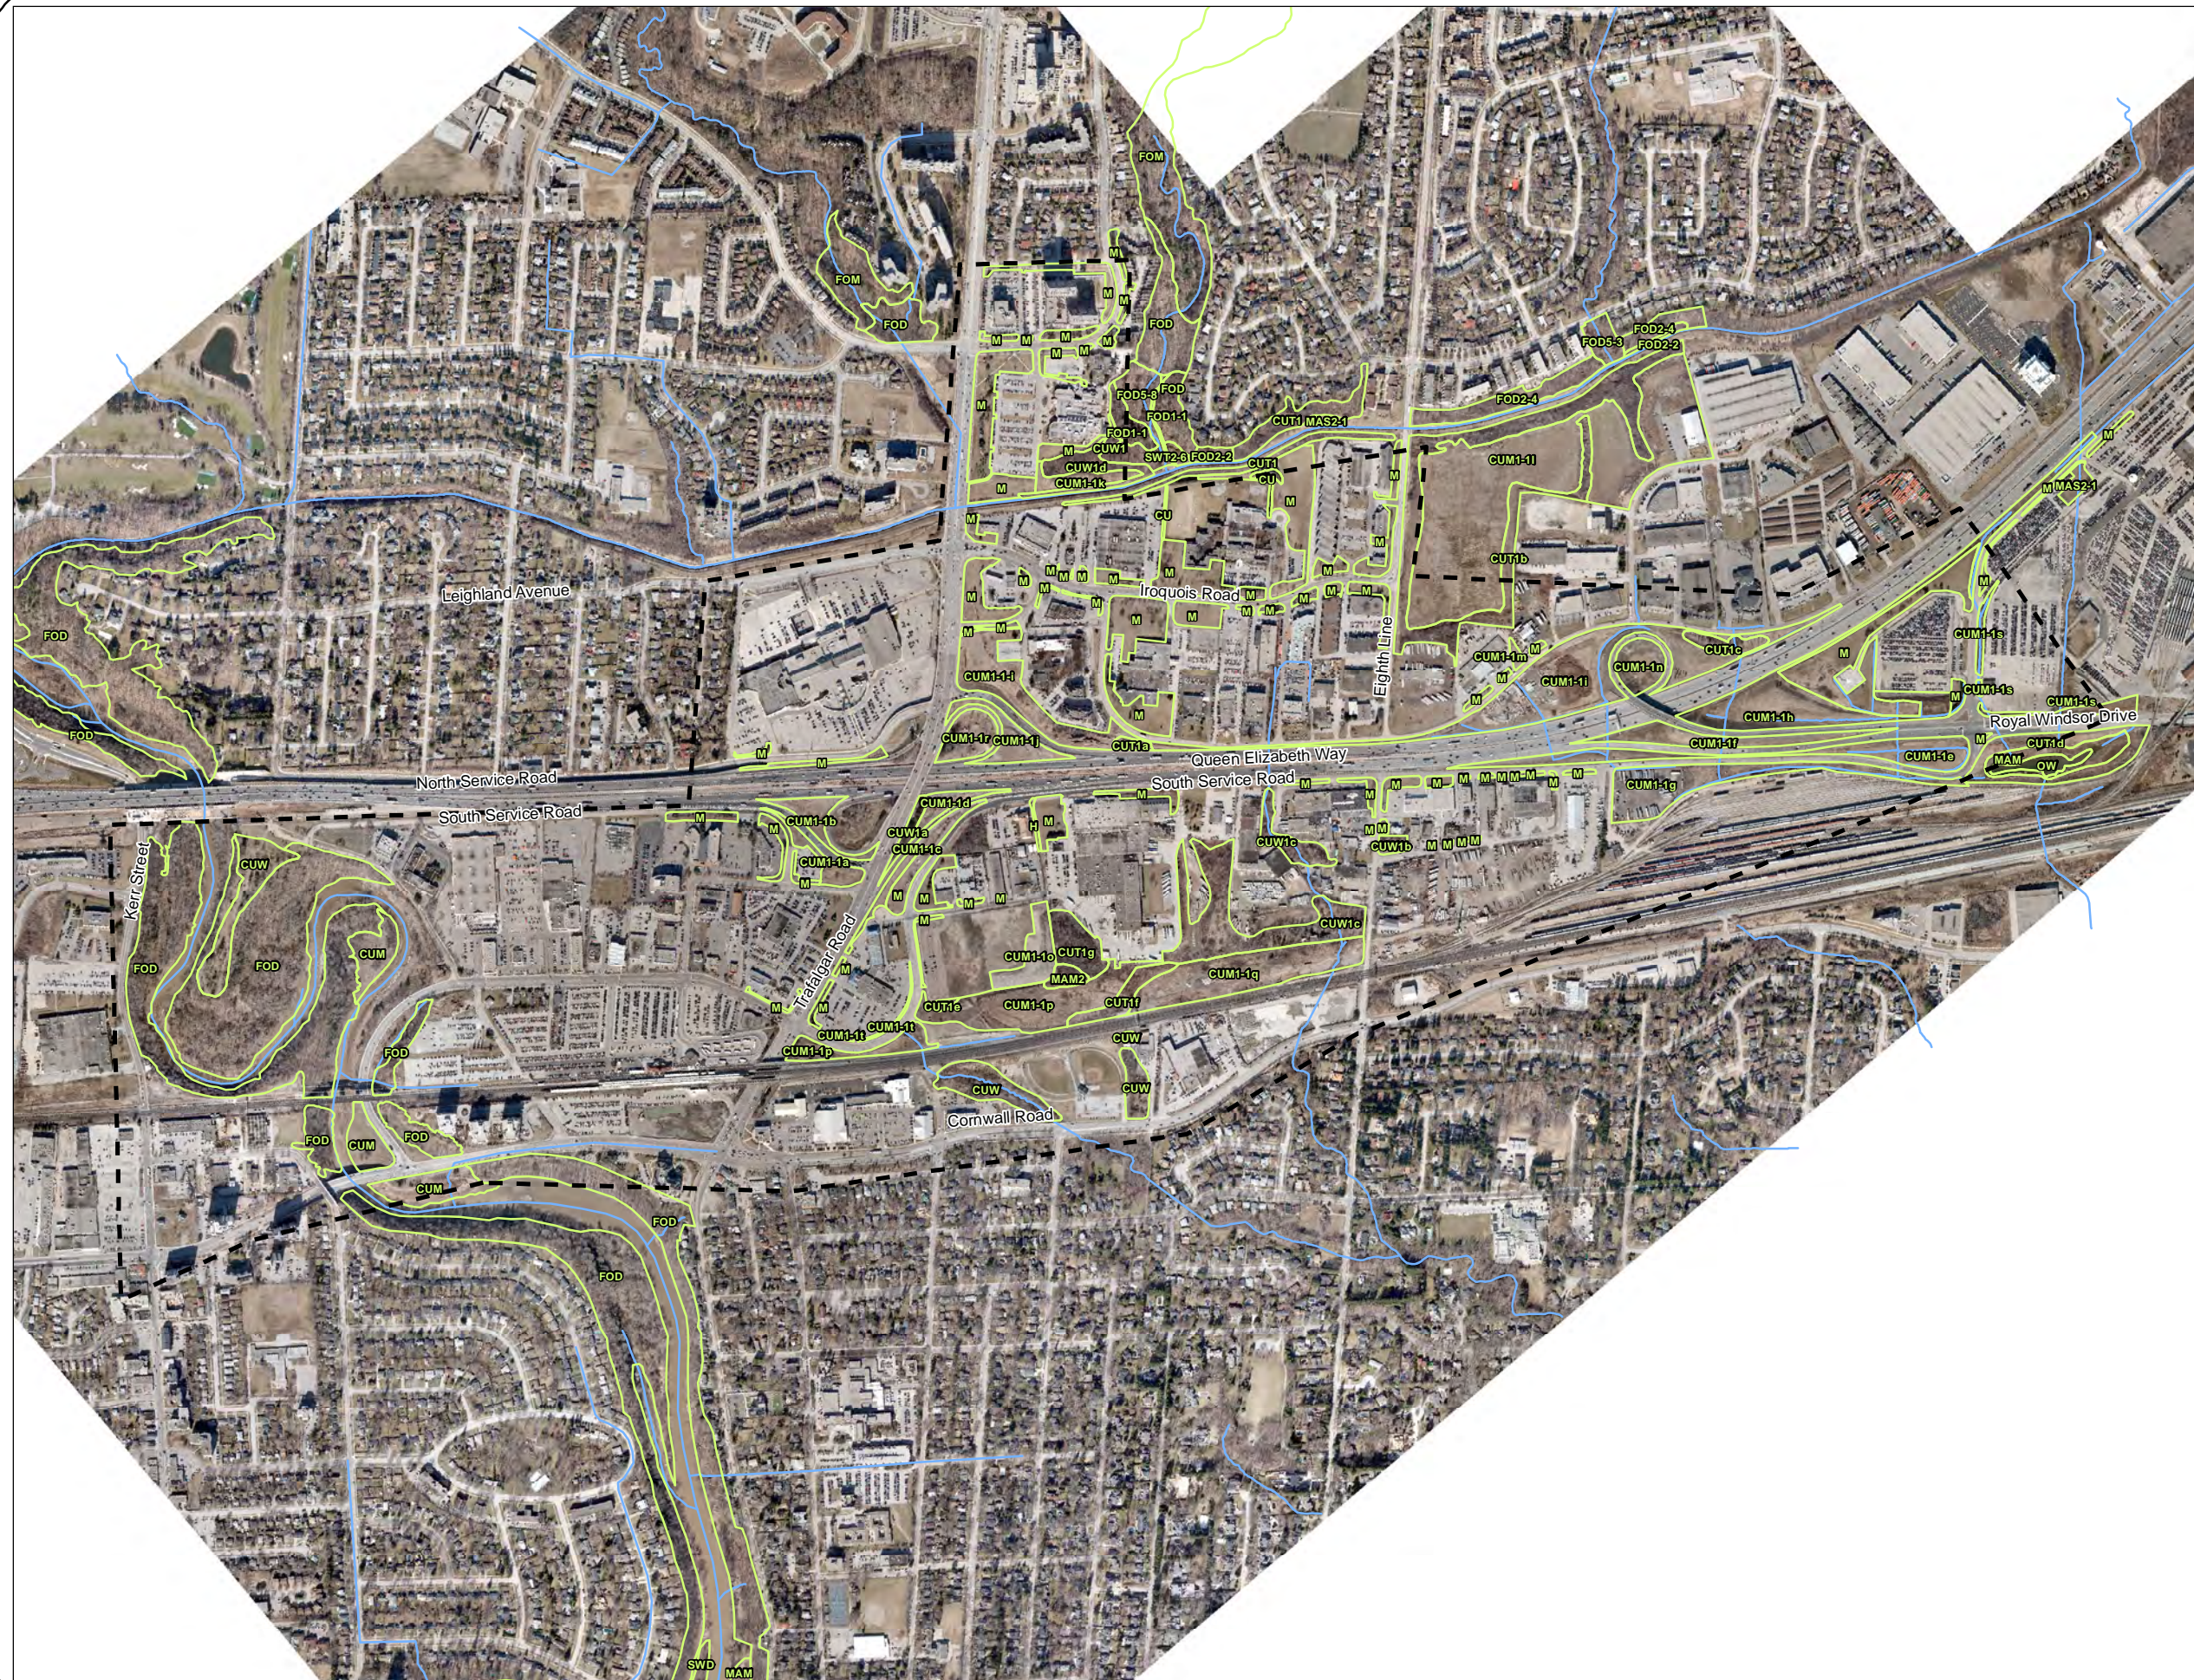
Five ELC vegetation community types were identified within the study limits during LGL's botanical survey including: Dry-Moist Old Field Meadow (CUM1-1a to t), Mineral Cultural Thicket (CUT1a to g), Mineral Cultural Woodland (CUW1a to d), Mineral Meadow Marsh (MAM2), and Cattail Mineral Shallow Marsh (MAS2-1). All of the vegetation communities identified within the study area are considered widespread and common in Ontario and are secure globally. These vegetation communities are delineated in **Figure 3** and are described in **Table 2**.

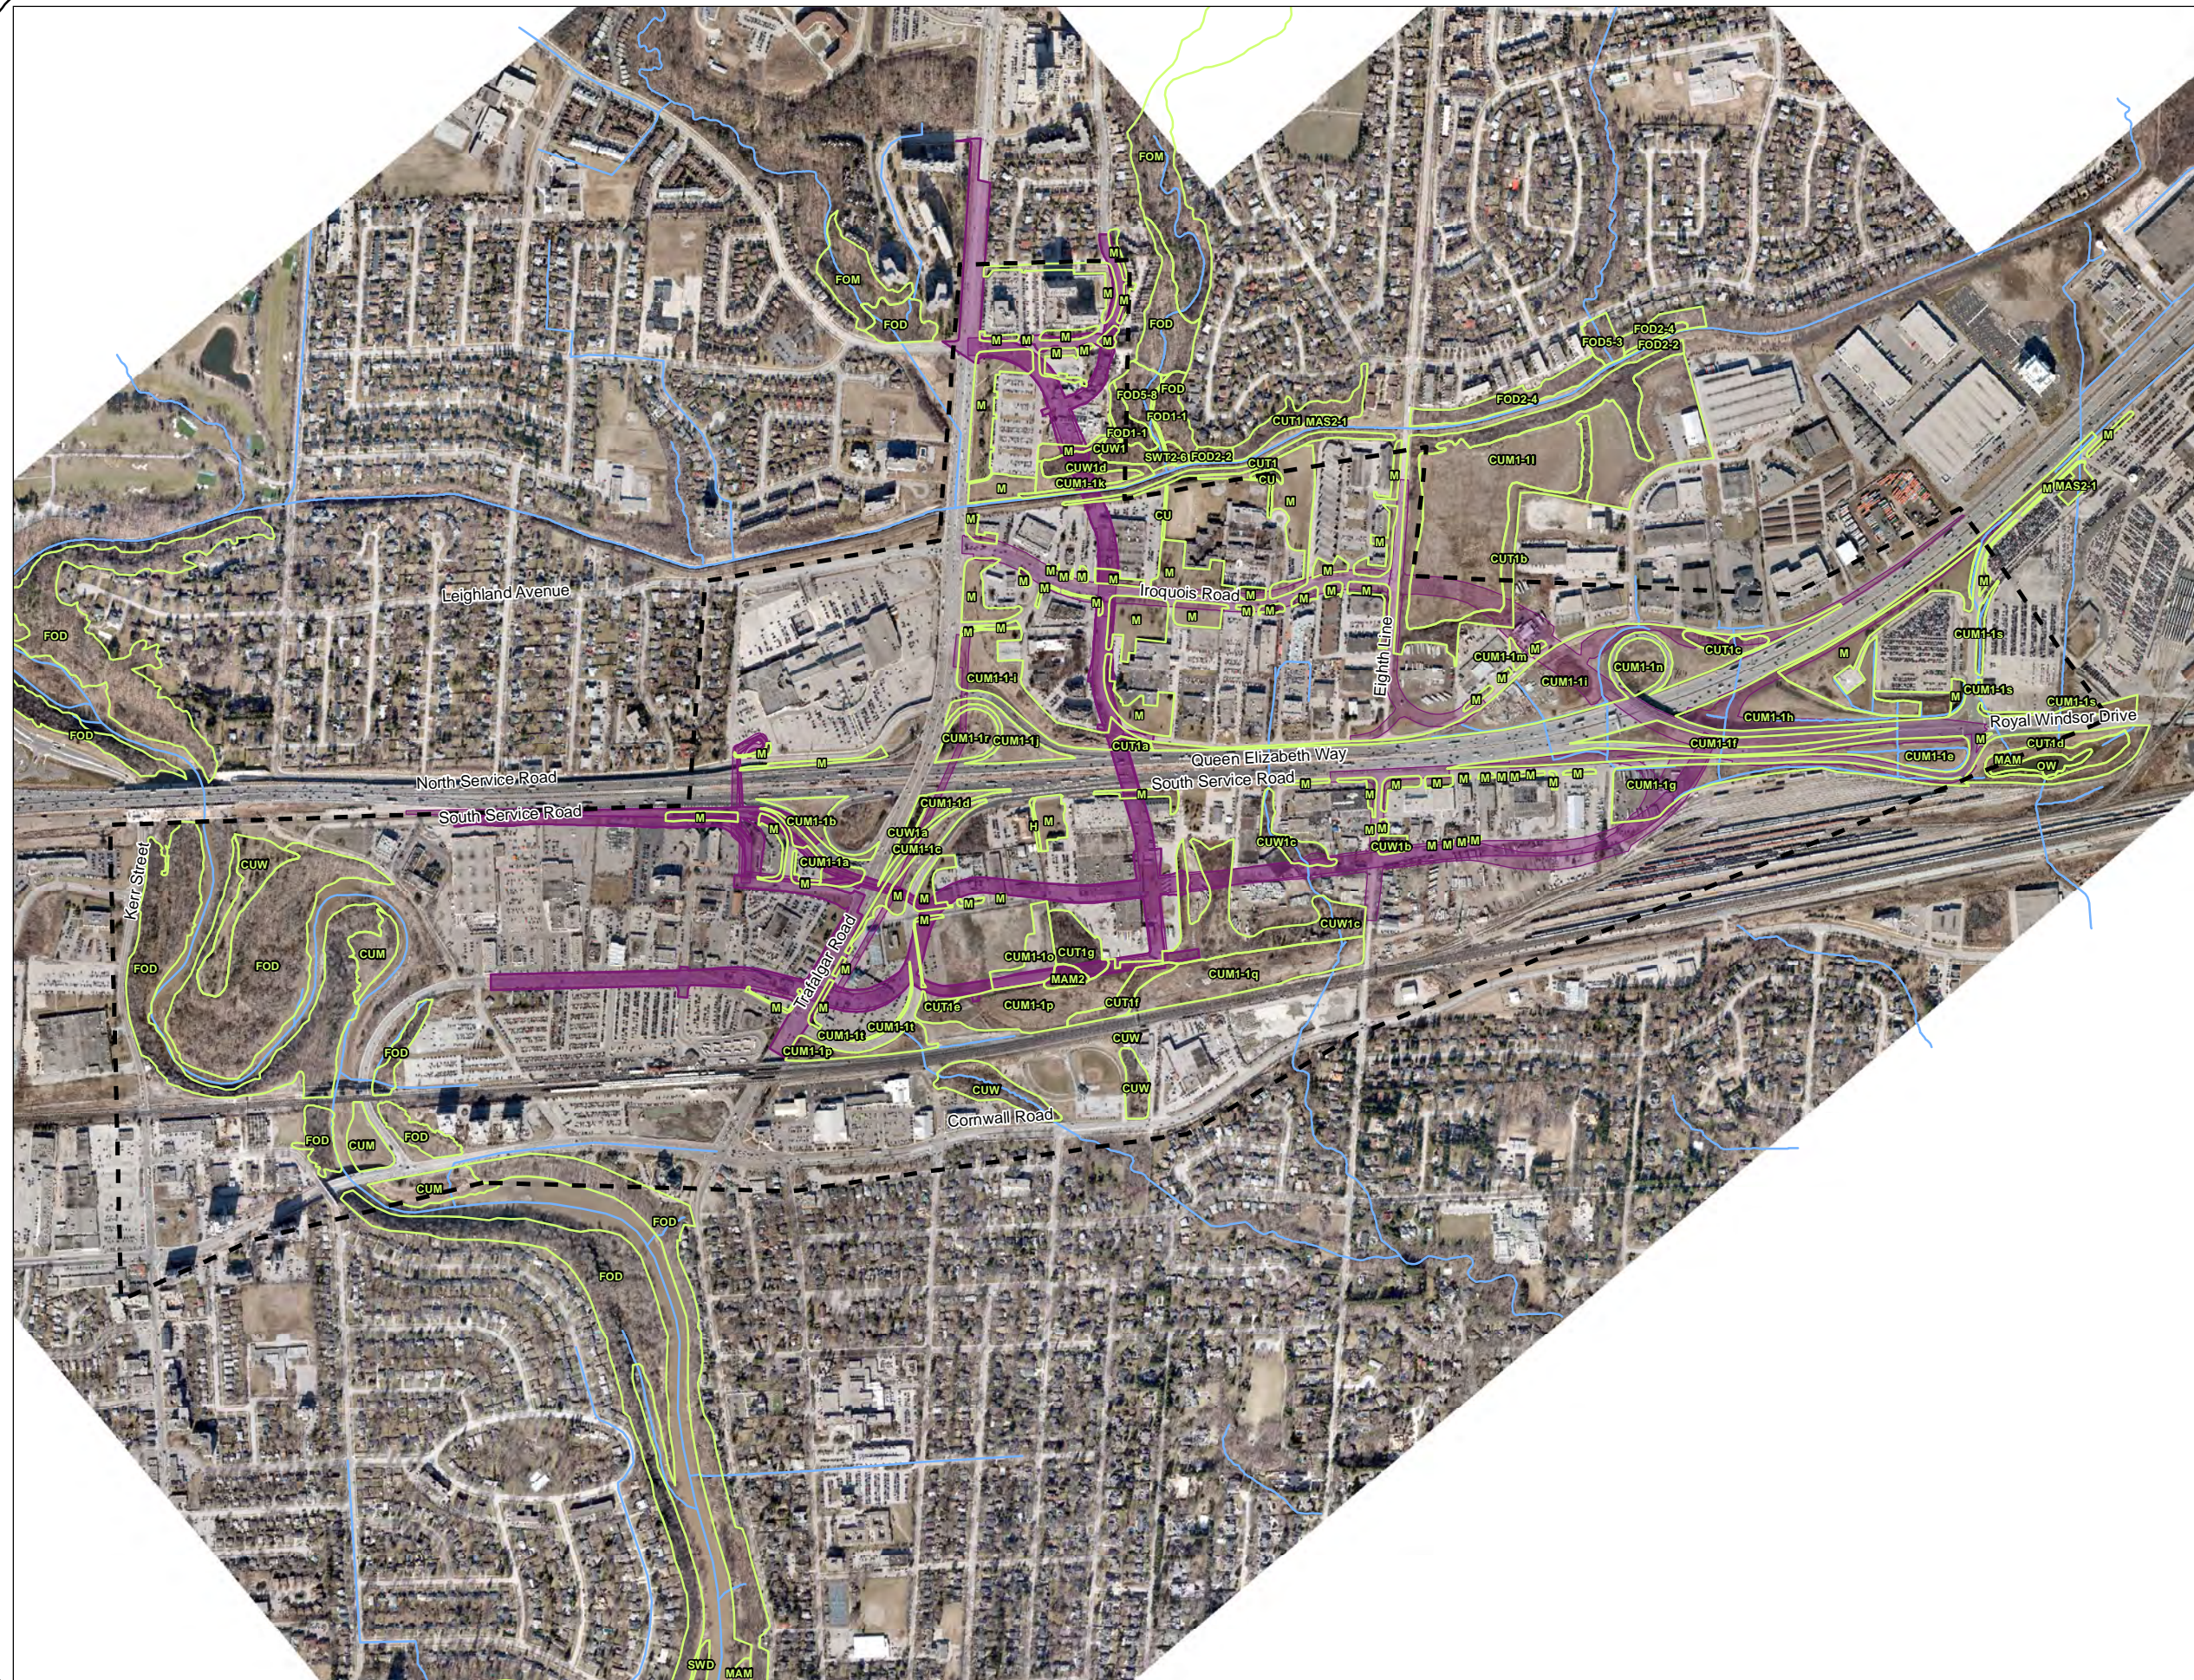
Project: TA8087	Figure: 6
Date: March, 2014	Prepared By: MWF
Scale: 1 : 12,000	Checked By: GNK

As noted in **Table 5** the largest impact will occur to the cultural communities with a removal of 8.85 ha. The impacts to the cultural communities will primarily involve the removal of narrow strips of cultural meadow adjacent to existing commercial buildings and in close proximity to QEW on-ramps/off-ramps. Larger sections of cultural vegetation will be removed near the rail yards at the southern extent of the study area and to the north of the QEW east of Eighth Line. Overall, impacts resulting in the loss of vegetation within these cultural communities are considered to be minor. Cultural communities typically persist in areas that are regularly disturbed, and as a result, generally contain a high proportion of invasive and non-native plant species that are tolerant of these conditions.

NATURAL HERITAGE IMPACT AREAS

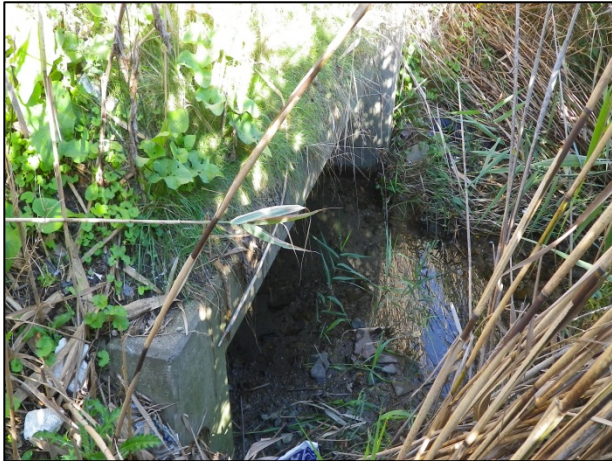
Tributary 1 of Lower Morrison Creek. Overlooking culvert outlet at South Service Road East (October 8, 2013).

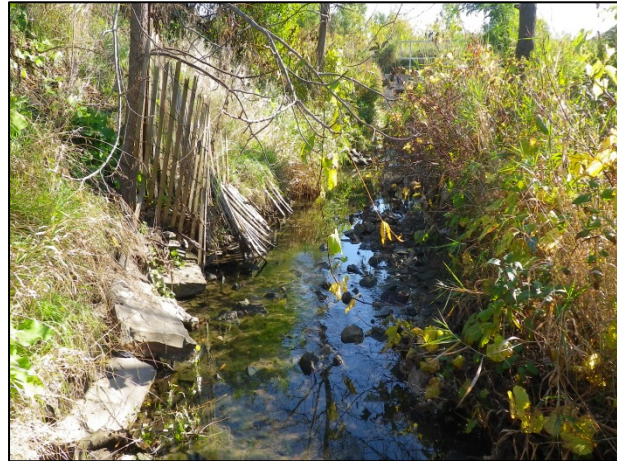
Tributary 1 of Lower Morrison Creek. Looking downstream (south) from downstream of South Service Road. (October 8, 2013).

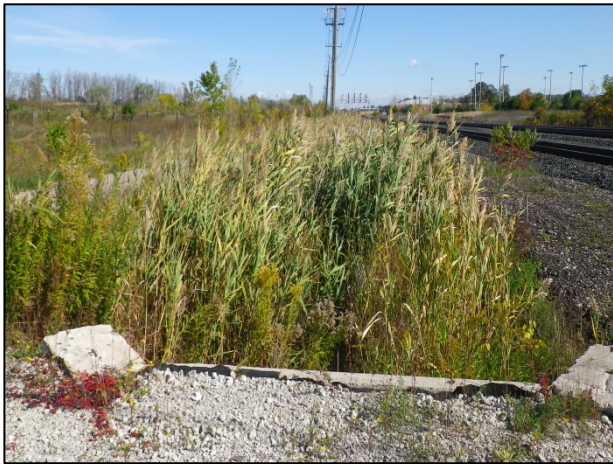
Ditch to the East of Tributary 1 of Lower Morrison Creek. Looking east (upstream) from East of the Tributary (October 8, 2013).

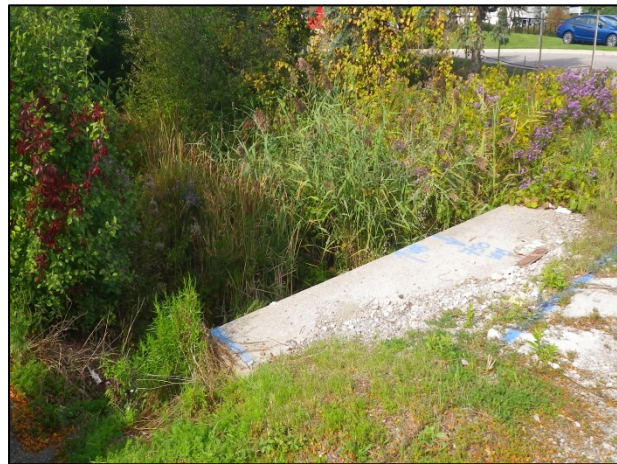
Tributary 2 of Lower Morrison Creek. Looking north (upstream) from north of North Service Road East (October 10, 2013).

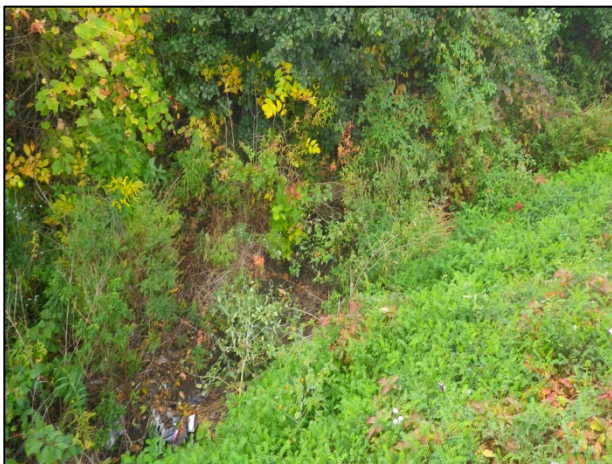
Tributary 2 of Lower Morrison Creek. Overlooking channel from north of North Service Road East (October 10, 2013).

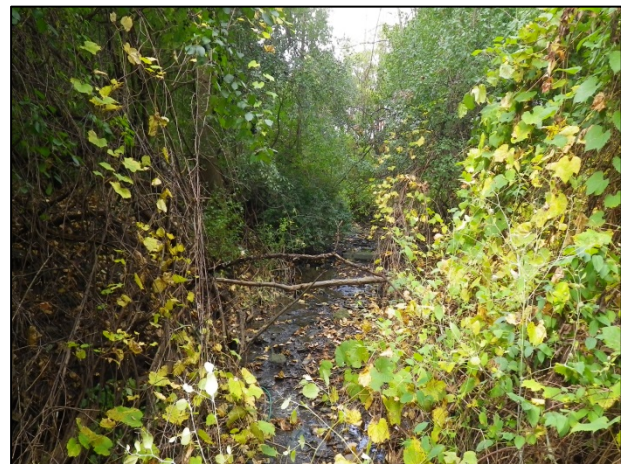
Tributary 2 of Lower Morrison Creek. Looking south (downstream) from approximately 100 m south of South Service Road East (October 8, 2013).

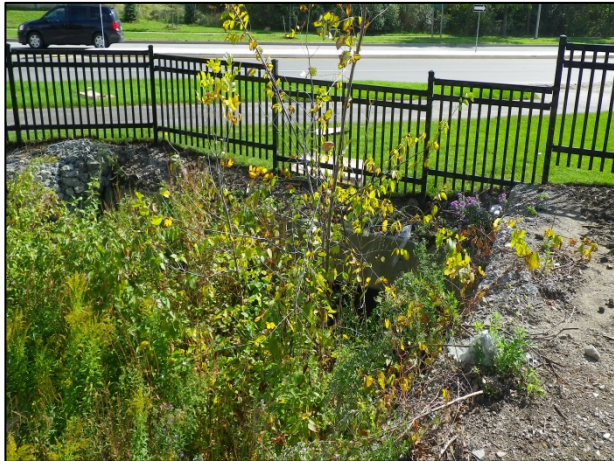
Tributary 2 of Lower Morrison Creek. Looking south (downstream) north of Cornwall Road (October 8, 2013).

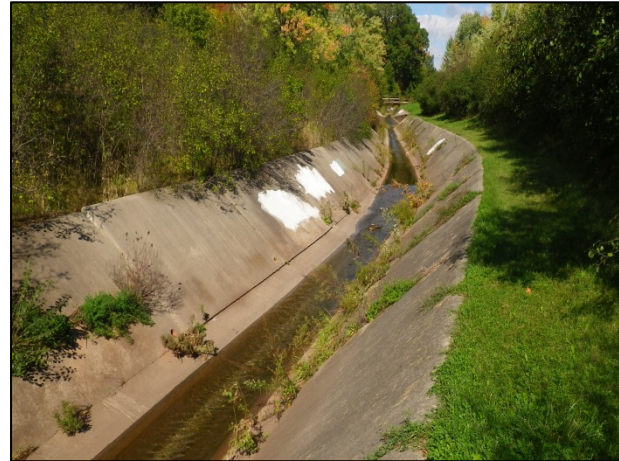
Morrison-Wedgewood Diversion Channel: Looking east (upstream) from approximately 250 m east of Trafalgar Road (October 8, 2013).

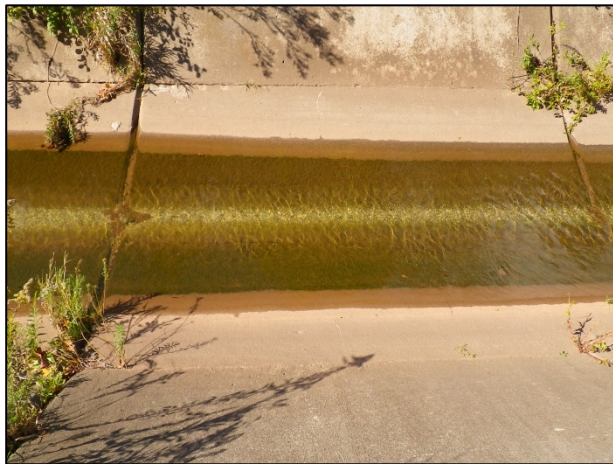
Morrison-Wedgewood Diversion Channel: Overlooking channel structure approximately 250 m east of Trafalgar Road (October 8, 2013).

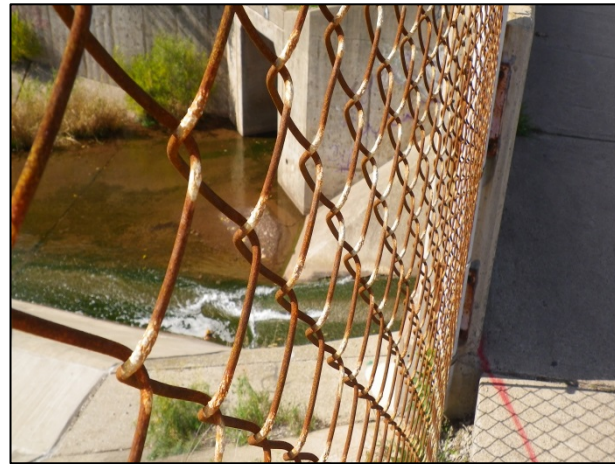
Morrison-Wedgewood Diversion Channel: Overlooking piped tributary that converges with main channel just west of Trafalgar Road (October 8, 2013).

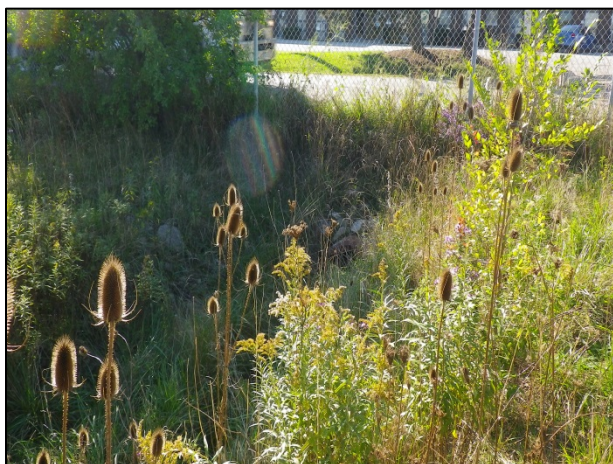
Ditch feature #1 of the QEW ditch system: Looking north (upstream) from south of North Service Road East (October 8, 2013).

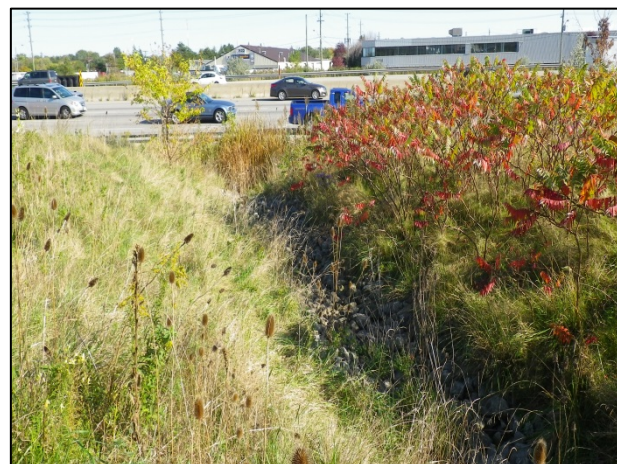
Ditch feature #1 of the QEW ditch system: Overlooking channel from north of the QEW (October 8, 2013).

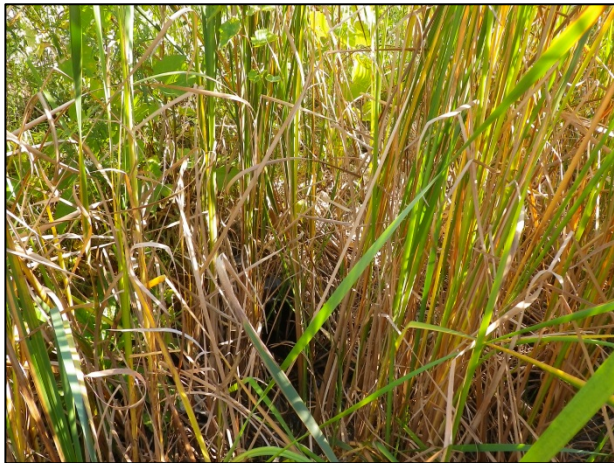
Ditch feature #1 of the QEW ditch system: Looking south (downstream) at the QEW crossing structure (October 8, 2013).

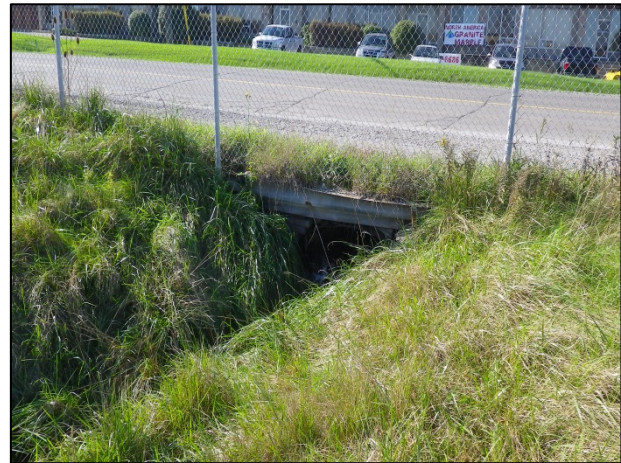
Ditch feature #2: Looking north (upstream) from downstream of North Service Road East (October 8, 2013).

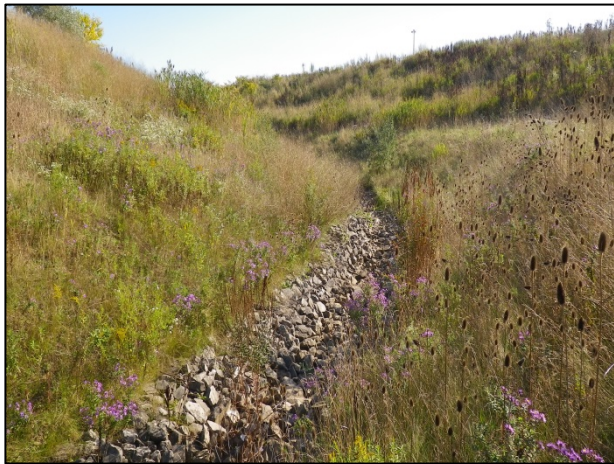
Ditch feature #2: Looking south (downstream) from downstream of North Service Road East (October 8, 2013).

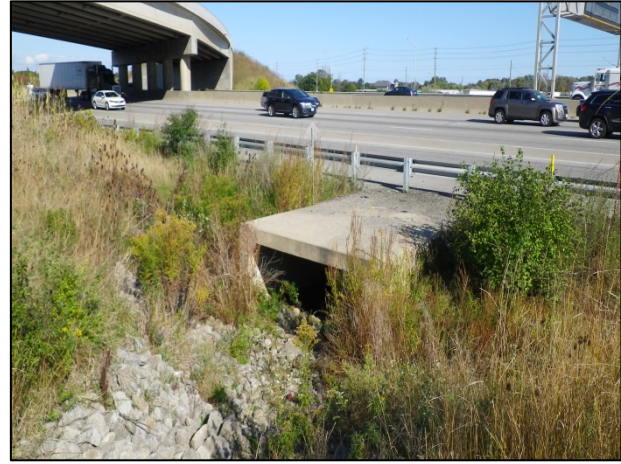
Ditch feature #2: Looking south (downstream) from upstream of the QEW (October 8, 2013).

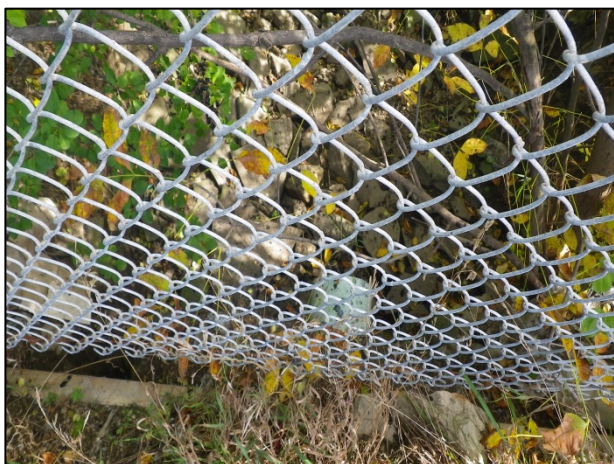
Ditch feature #3: Overlooking crossing structure and channel characteristics south of North Service Road East (October 8, 2013).

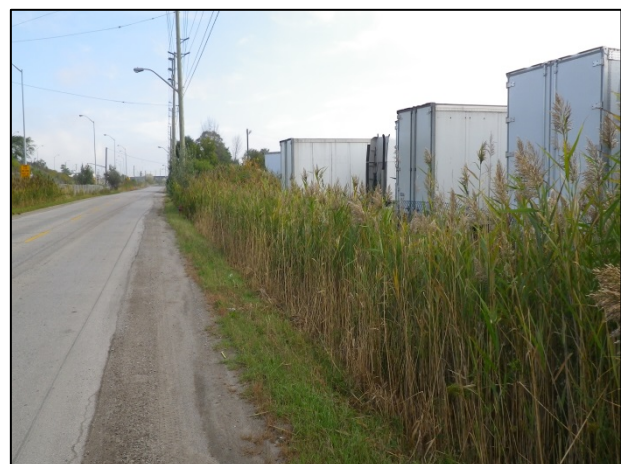
Tributary 1 of Lower Wedgewood Creek: Downstream of Ditch #1 and #2 convergence, south of South Service Road East (October 10, 2013).

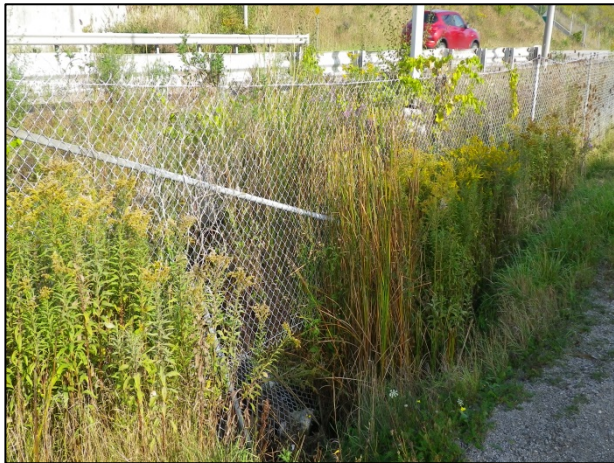
These two ditches converge and cross the south service road in a southeasterly direction. The channel is directed east at this point and then appears to end as a wetted depression approximately 50 m west of where ditch feature 3 crosses the south service road. A spring visit is highly recommended to determine if this tributary continues to end in a depression or provides indirect fish habitat to Tributary 1 of Lower Wedgewood Creek. This channel is directed along the south of the South Service Road, and the vegetation along this channel is dominated by phragmites, and terrestrial grasses/herbaceous species.

Ditch feature #3 : Looking north (upstream) from South Service Road East (October 10, 2013).

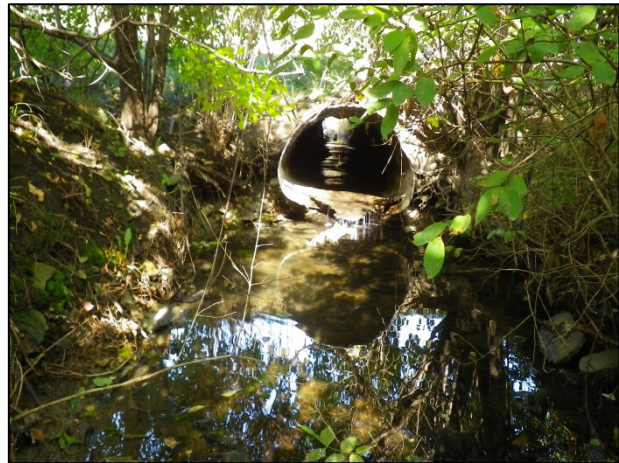
Tributary 1 of Lower Wedgewood Creek: Looking north (upstream) from south of South Service Road East where Ditch feature 3 outlets (October 10, 2013).

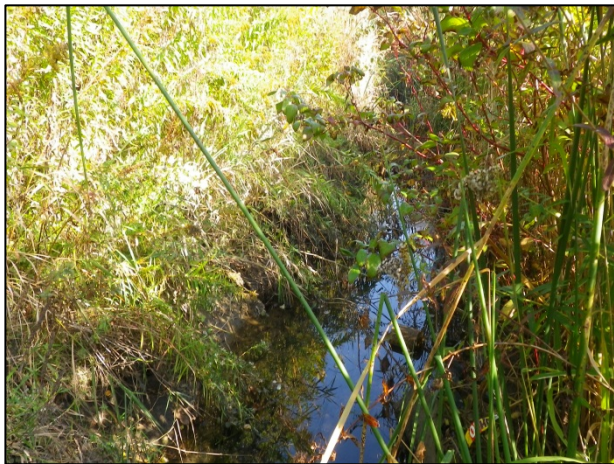
Tributary 1 of Lower Wedgewood Creek: Looking east (downstream) from south of South Service Road East (October 10, 2013).

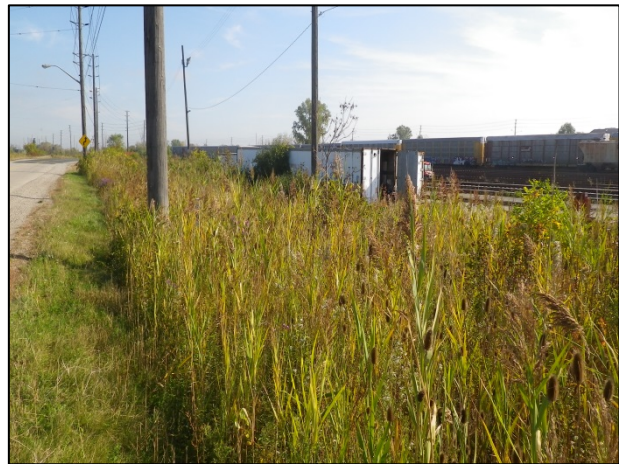
Tributary 1 of Lower Wedgewood Creek: Looking east (downstream) from south of South Service Road East (October 10, 2013).

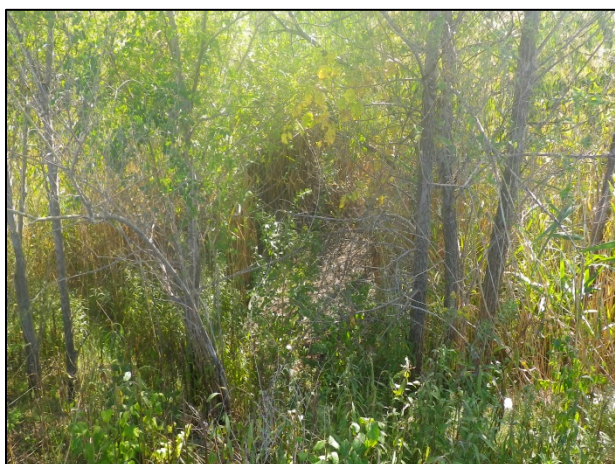
Tributary 2 of Lower Wedgewood Creek: Looking south (downstream) from south of Royal Windsor Drive.

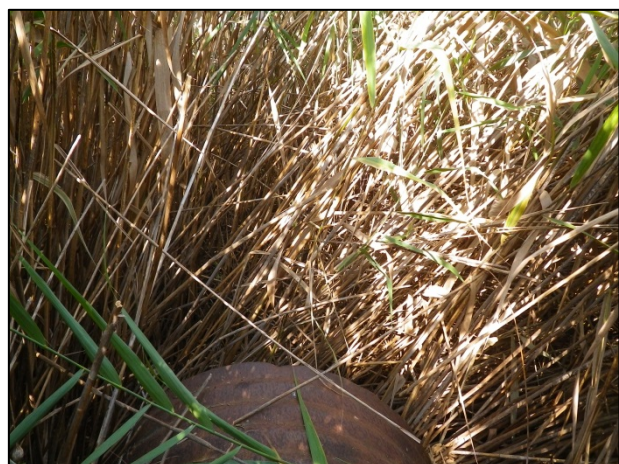
Tributary 2 of Lower Wedgewood Creek : Looking north (upstream) from north of South Service Road East.

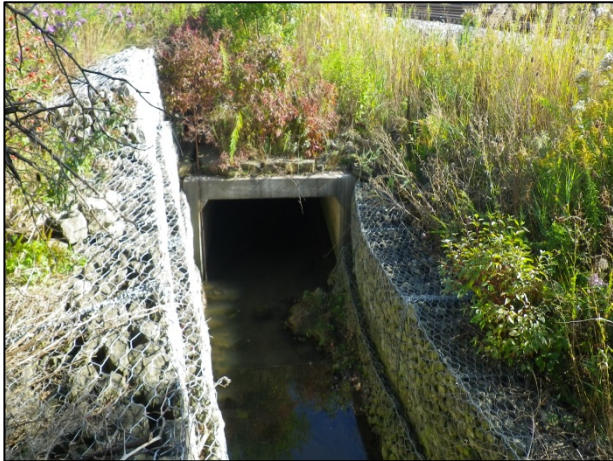
Tributary 1 of Lower Wedgewood Creek: Looking east (downstream), downstream of the convergence with tributary 2 (October 10, 2013).

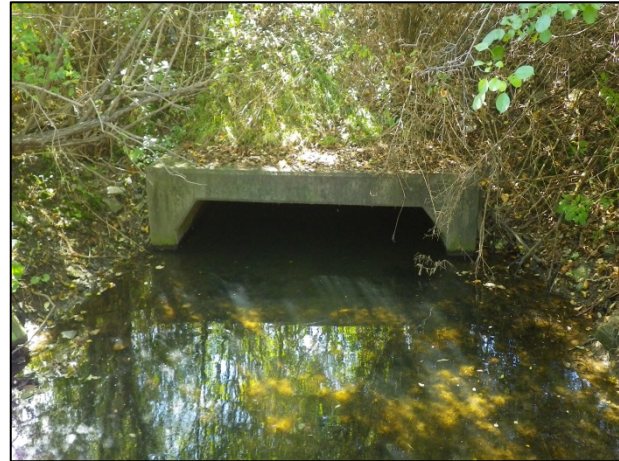
Tributary 1 of Lower Wedgewood Creek: Looking west (upstream) from east of South Service Road (October 10, 2013).

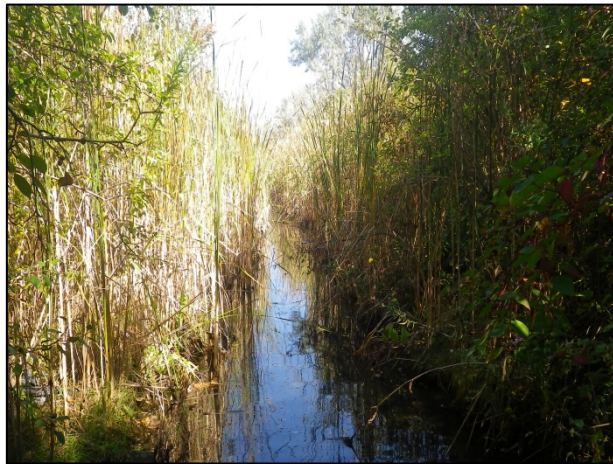
Tributary 1 of Lower Wedgewood Creek: Looking east (downstream) from east of South Service Road (October 10, 2013).

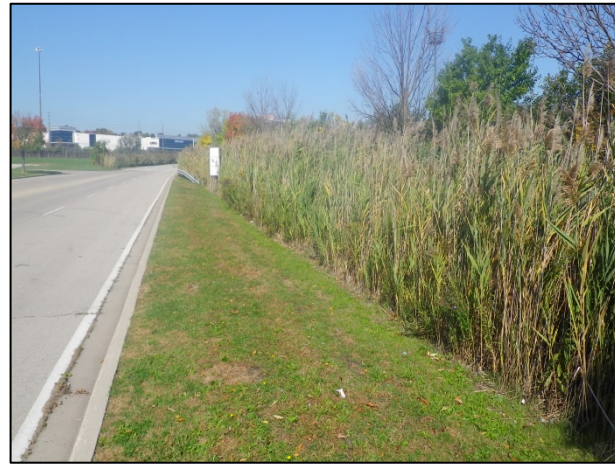
Tributary 3 of Lower Wedgewood Creek: Looking north (upstream) from North of the QEW on ramp (October 10, 2013).

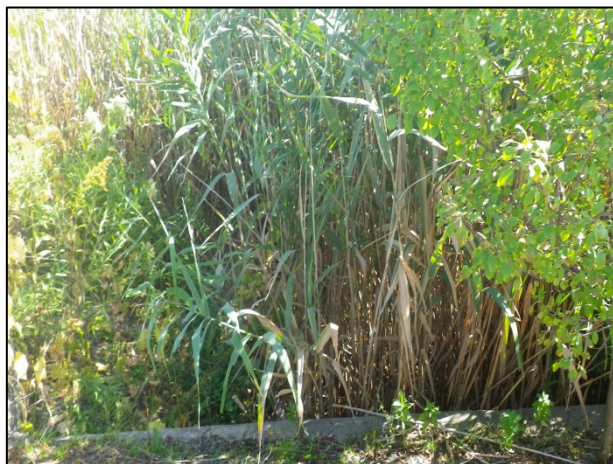
Tributary 3 of Lower Wedgewood Creek: Looking south (downstream) from south of Royal Windsor Drive (October 10, 2013).

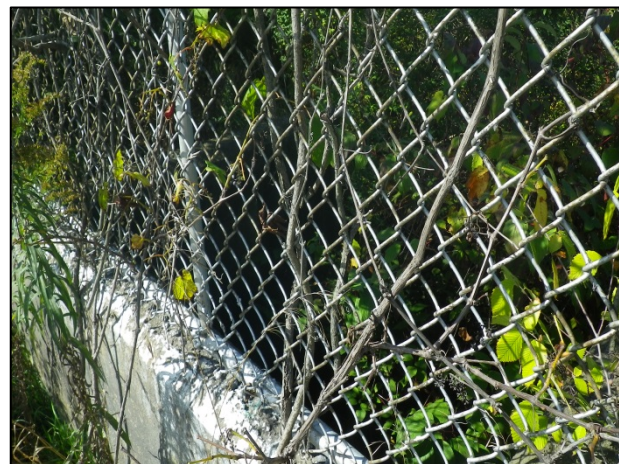
Tributary 4 of Lower Wedgewood Creek: Looking north (upstream) from north of Royal Windsor Drive (October 10, 2013).

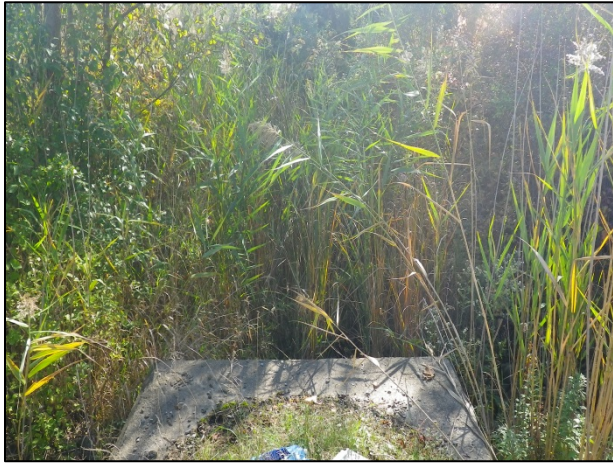
Tributary 4 of Lower Wedgewood Creek: Looking south (downstream) from south of Royal Windsor Drive (October 10, 2013).

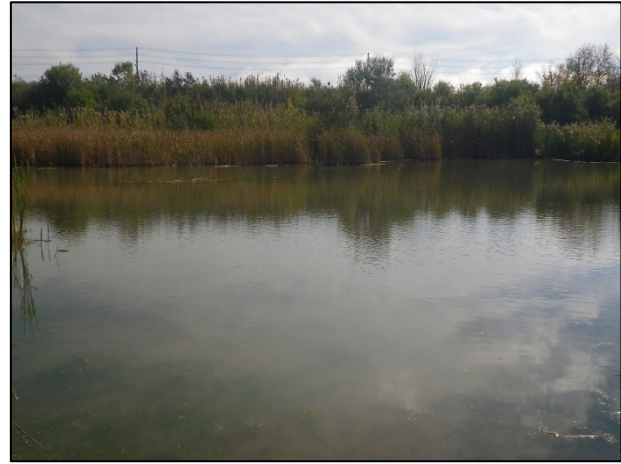
Tributary 4 of Lower Wedgewood Creek: Looking south (downstream) from south of Royal Windsor Drive toward online pond (October 10, 2013).

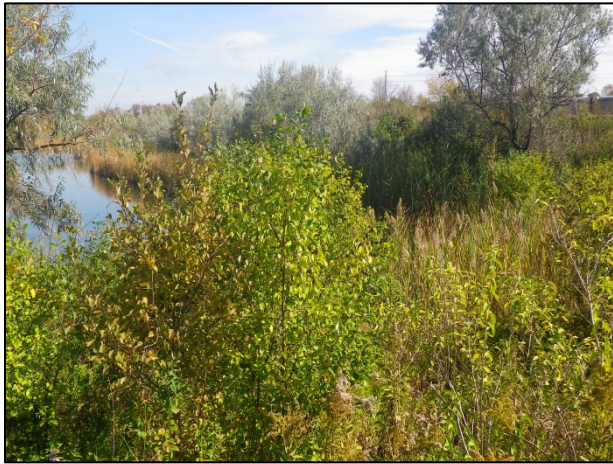
Tributary 1 of Lower Wedgewood Creek:
Overlooking online pond where the Tributaries
converge east of South Service Road (October 10,
2013).
