PHASE I ENVIRONMENTAL SITE ASSESSMENT

304 AND 318 SPRUCE STREET

OAKVILLE, ONTARIO

Project No. FE-P 22-12511

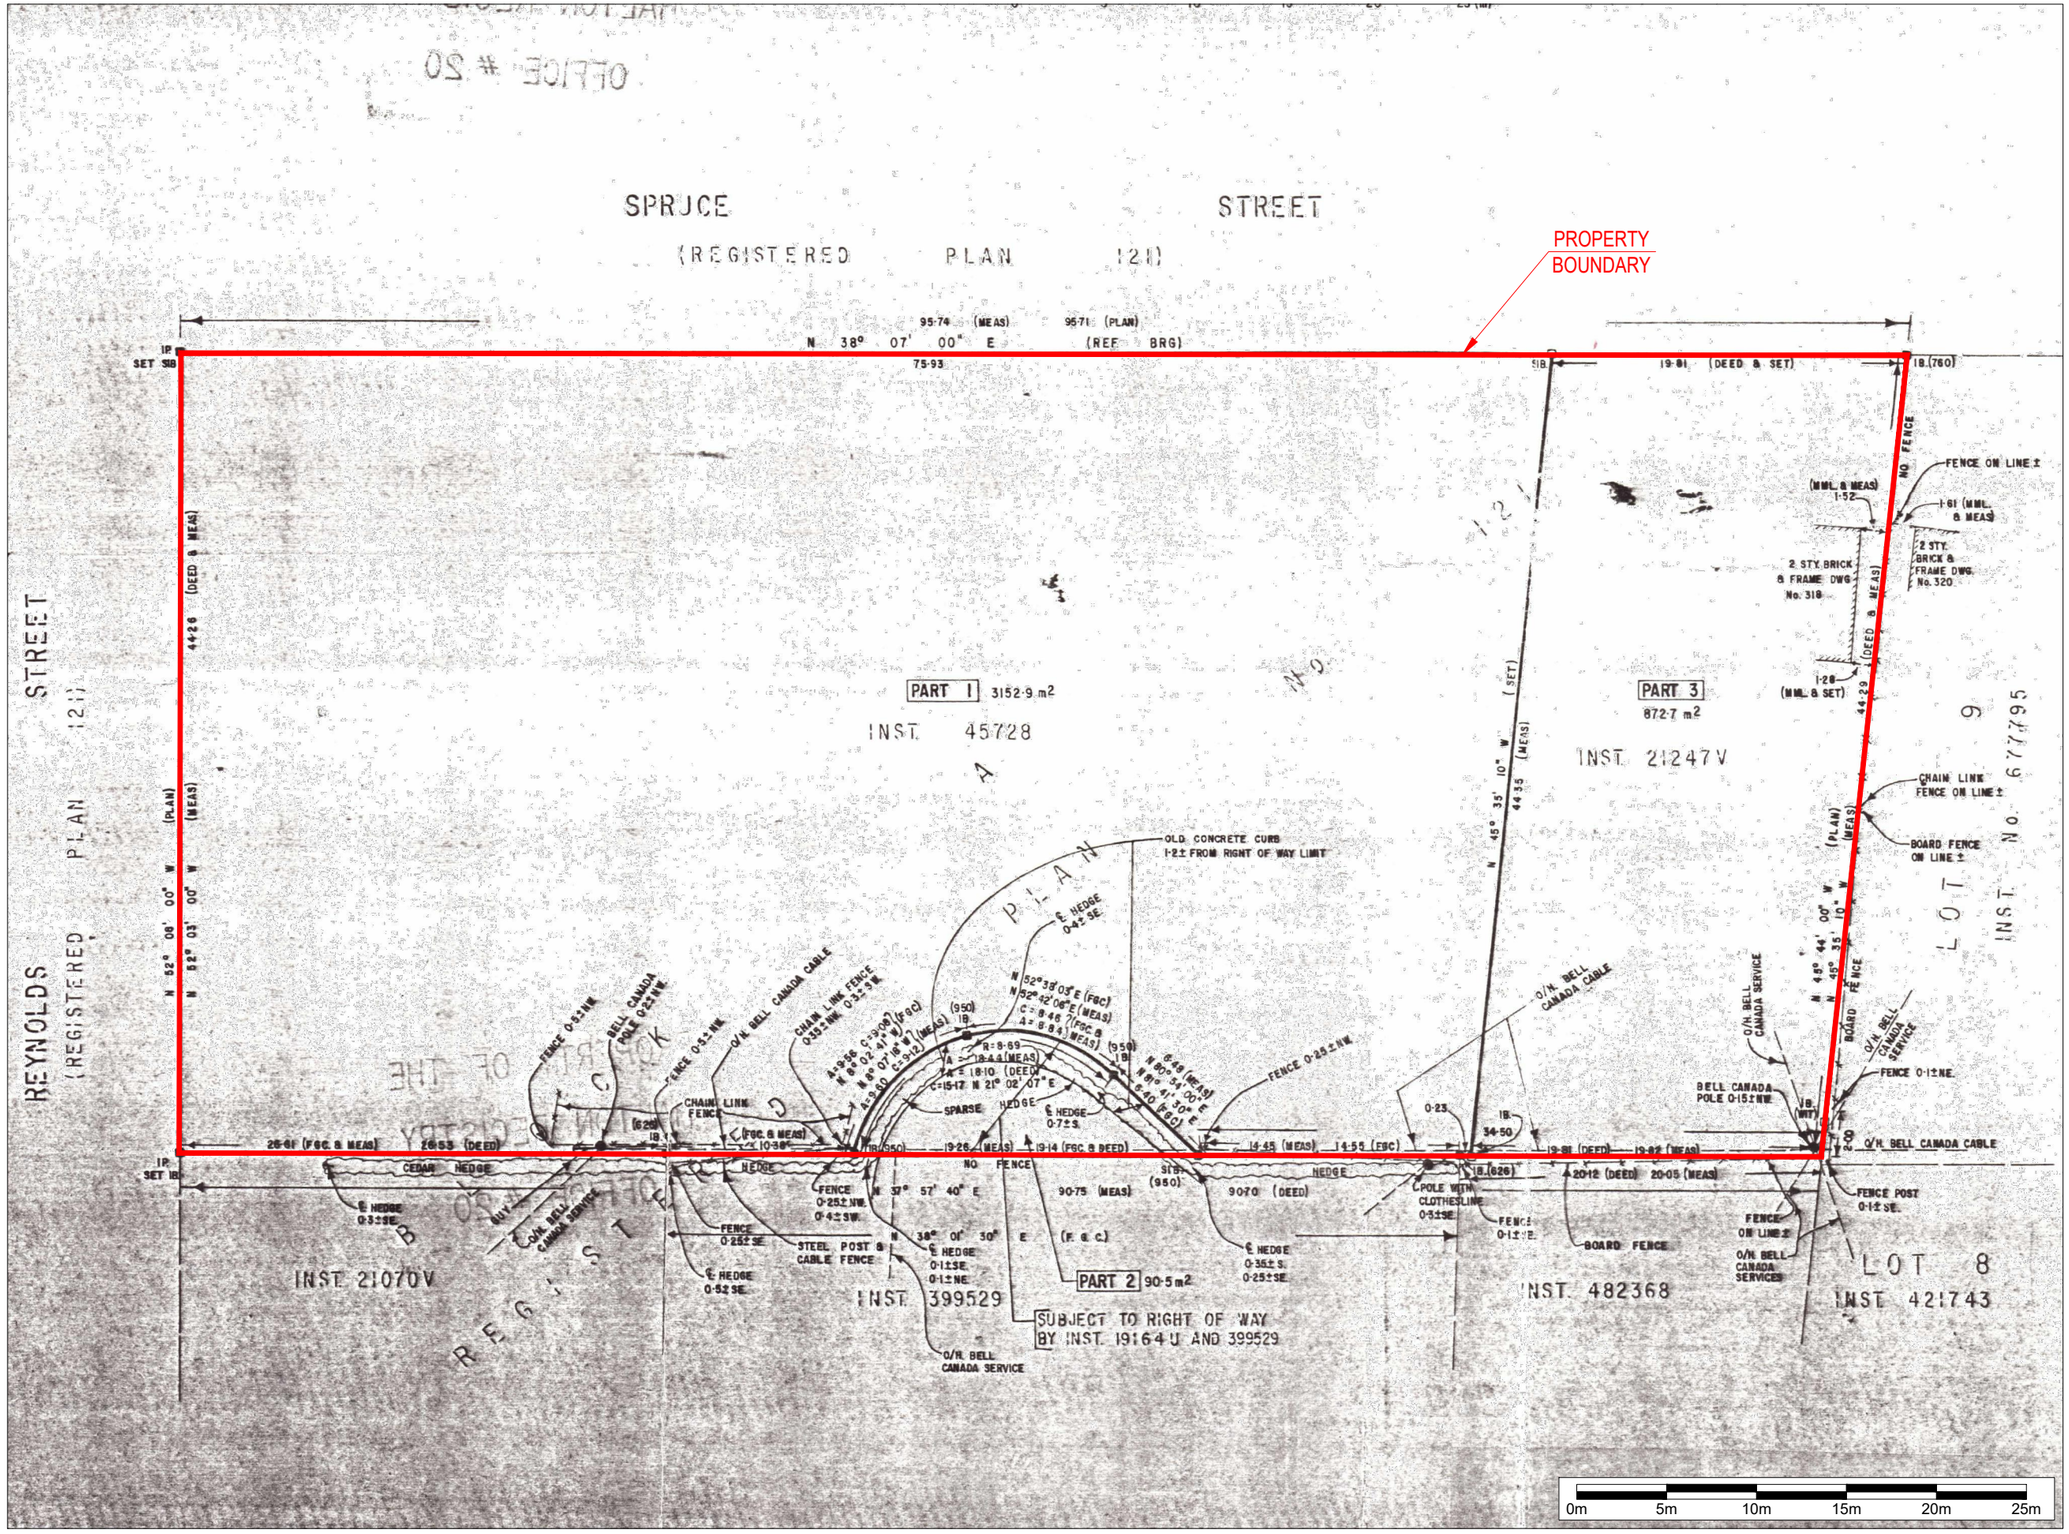
3. View of the wall-mounted cooling unit observed in the office area of 304 Spruce Street.

4. Original vinyl floor tile observed in the basement at 304 Spruce Street

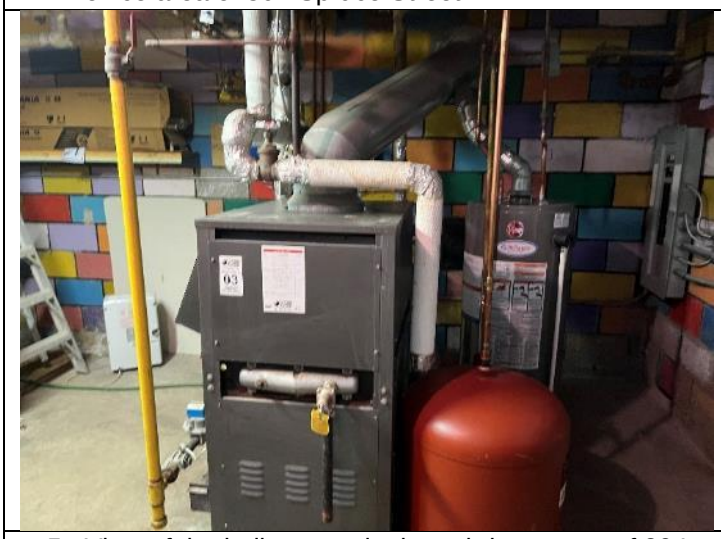
5. View of the boiler room in the sub-basement of 304 Spruce Street.

6. Small quantities of household cleaners observed in the boiler room of 304 Spruce Street.

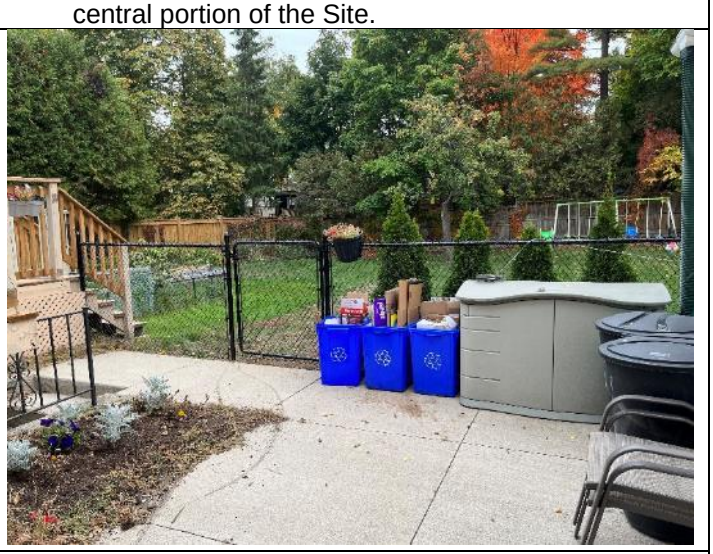
16. Non-hazardous waste bins of 318 Spruce Street.

17. Air-conditioning unit, located on the west exterior wall of 318 Spruce Street.
