PHASE TWO ENVIRONMENTAL SITE ASSESSMENT

166 South Service Road East, Oakville, Ontario

BIGC-ENV-457B

November 14, 2022

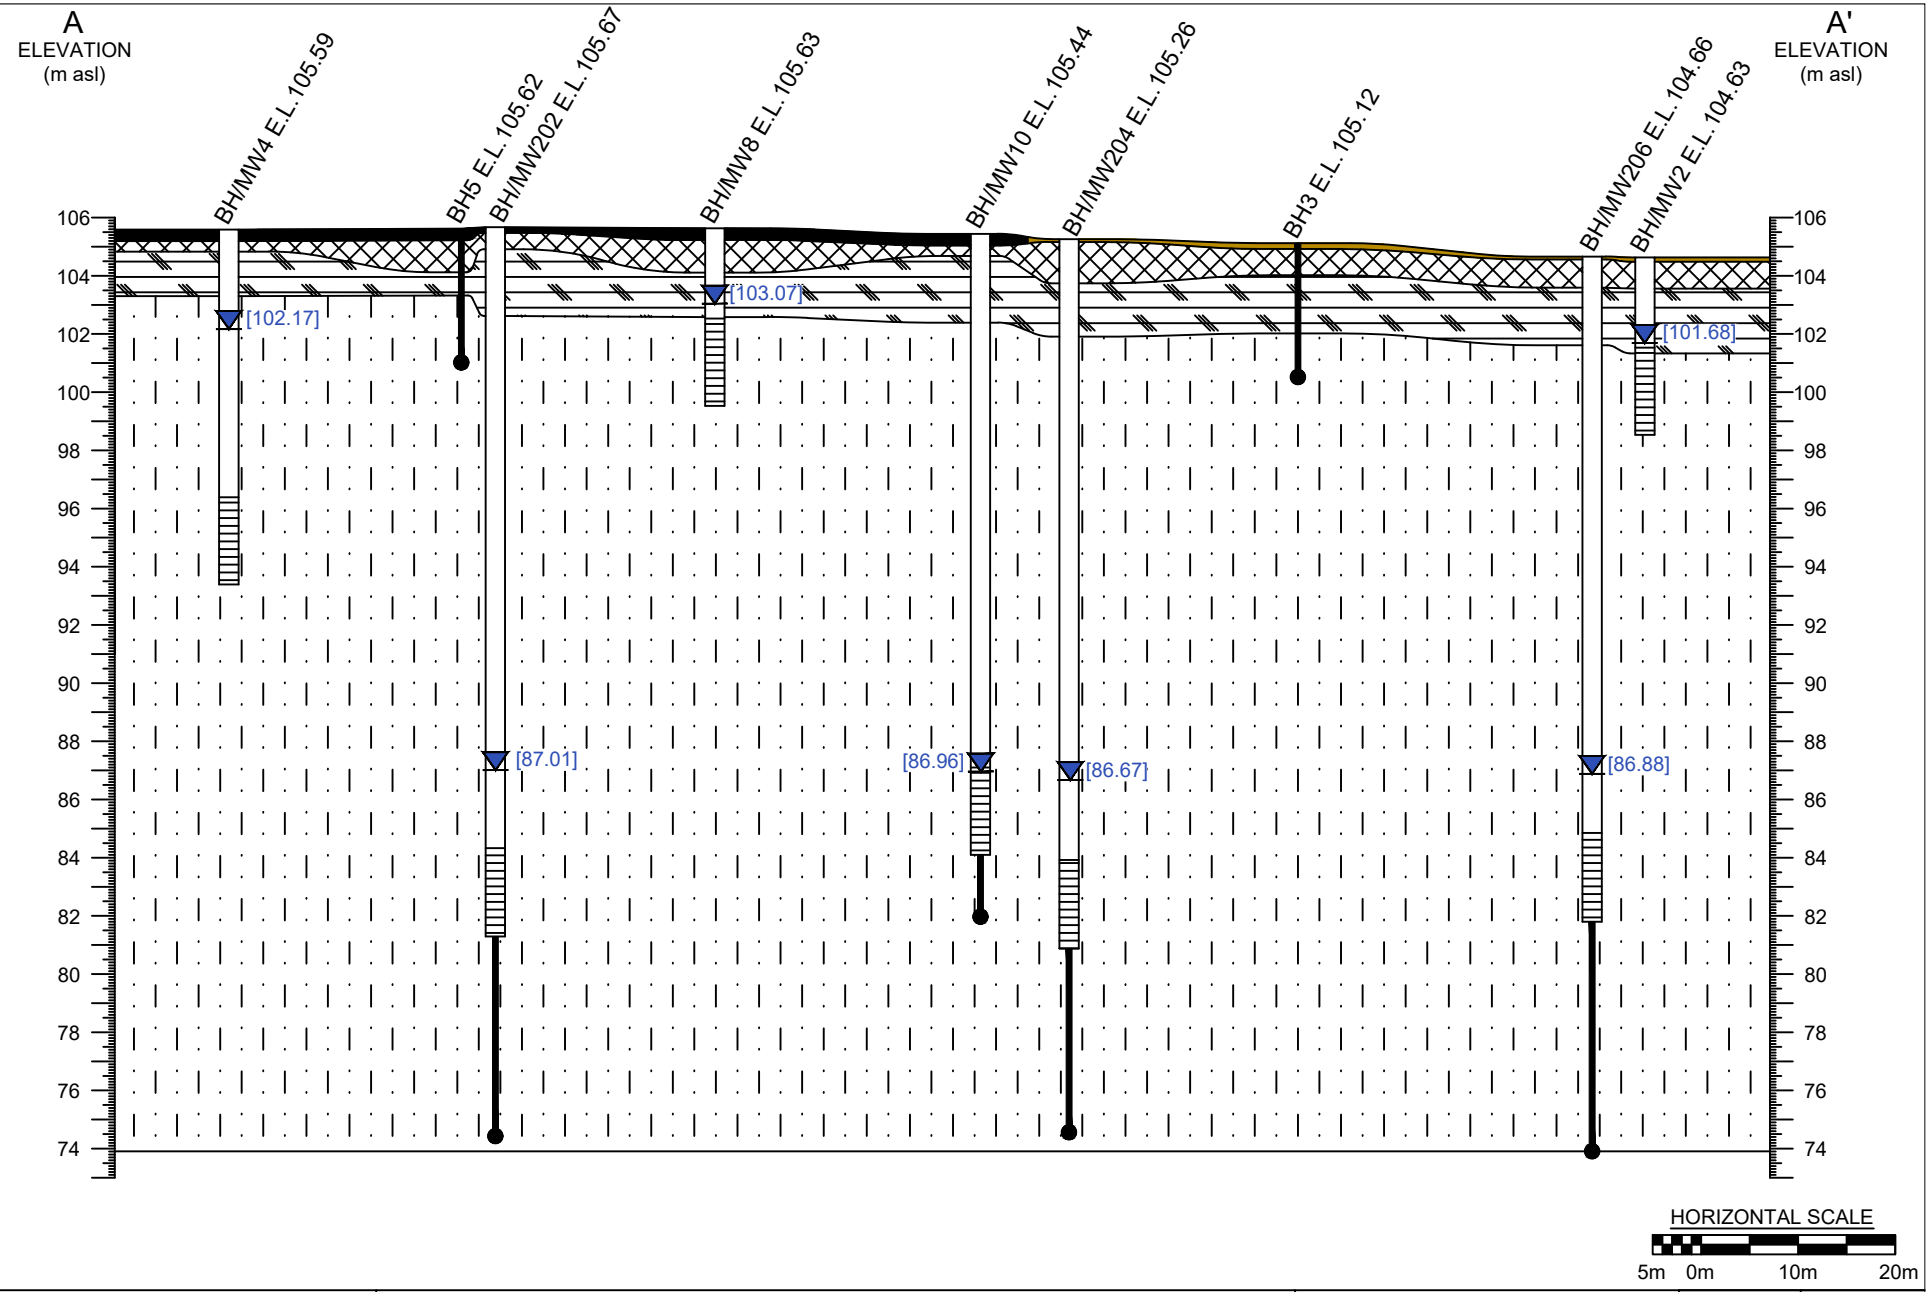
PROJECT NO.	DWN.
BIGC-ENV-457B	T.S.
SCALE	CK.
AS NOTED	R.M.
DATE	FIG NO.
NOVEMBER 2022	6B

Based on the topography and the distance of the Site to Lake Ontario, the inferred groundwater flow direction was considered to be to the south/southeast in the Phase One ESA. Based on the static water levels observed, the interpreted predominant deep groundwater flow was towards the southwest and the interpreted shallow groundwater flow was towards the northeast. The interpreted deep groundwater flow was used to determine if any off-Site PCAs were to be considered as APECs as the deep groundwater flow direction is consistent with the local groundwater flow towards Sixteen Mile Creek located approximately 330 m southwest of the Site. The interpreted deep groundwater flow direction is presented on Figure 6A and the interpreted shall groundwater flow direction is presented on Figure 6B.

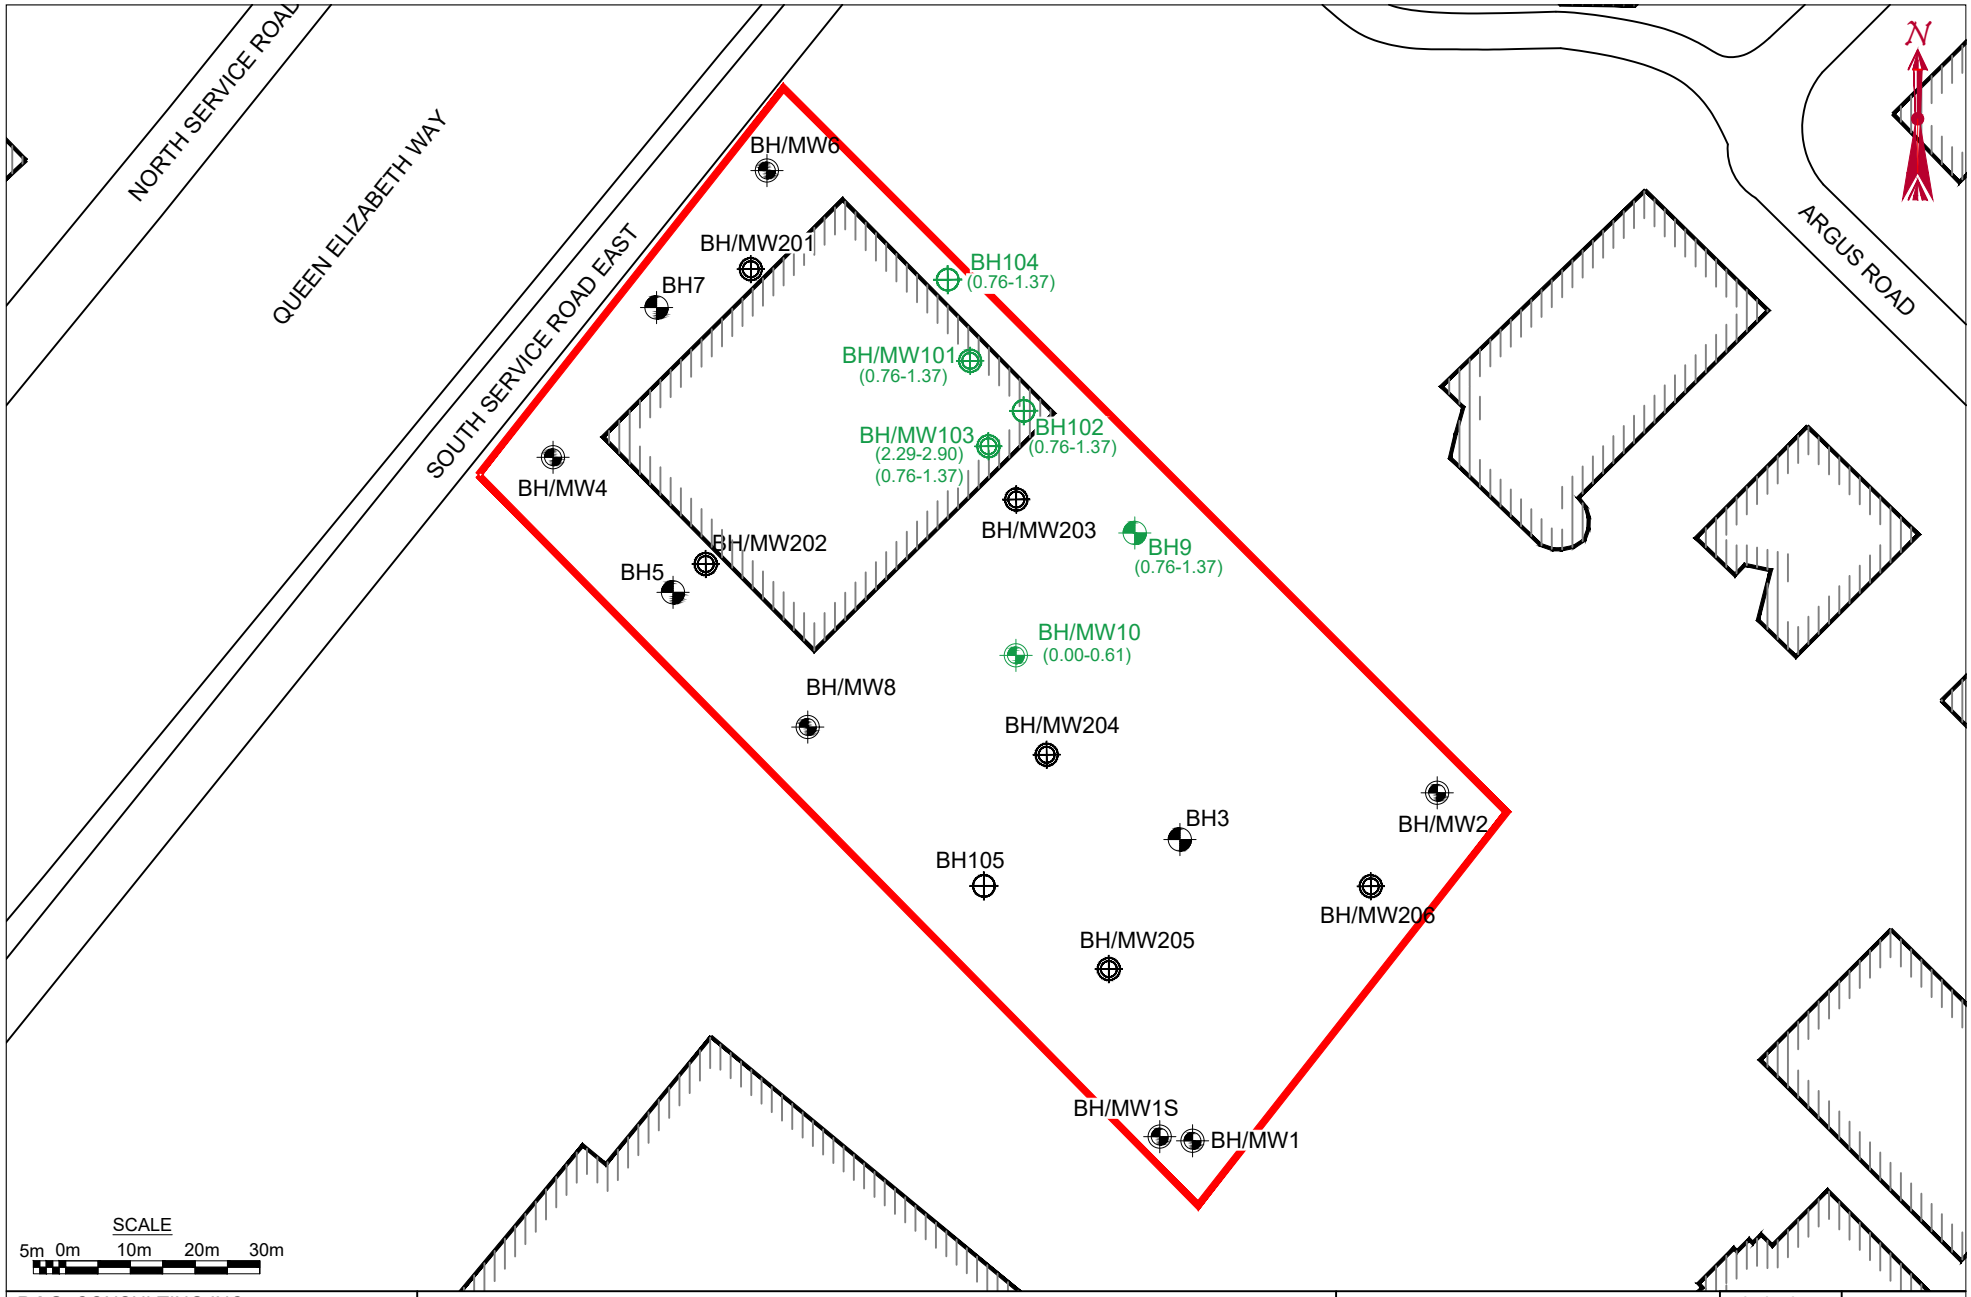
PHC CONCENTRATIONS IN SOIL
PHASE TWO ESA
166 SOUTH SERVICE ROAD EAST,
OAKVILLE, ONTARIO

4. The soil analytical results indicated that all soil samples submitted for PHCs, BTEX, VOCs, PAHs, metals and inorganics analyses were either non-detect or detected below the applicable MECP (2011) Table 2 SCS; and all laboratory RDLs were below the applicable SCS.

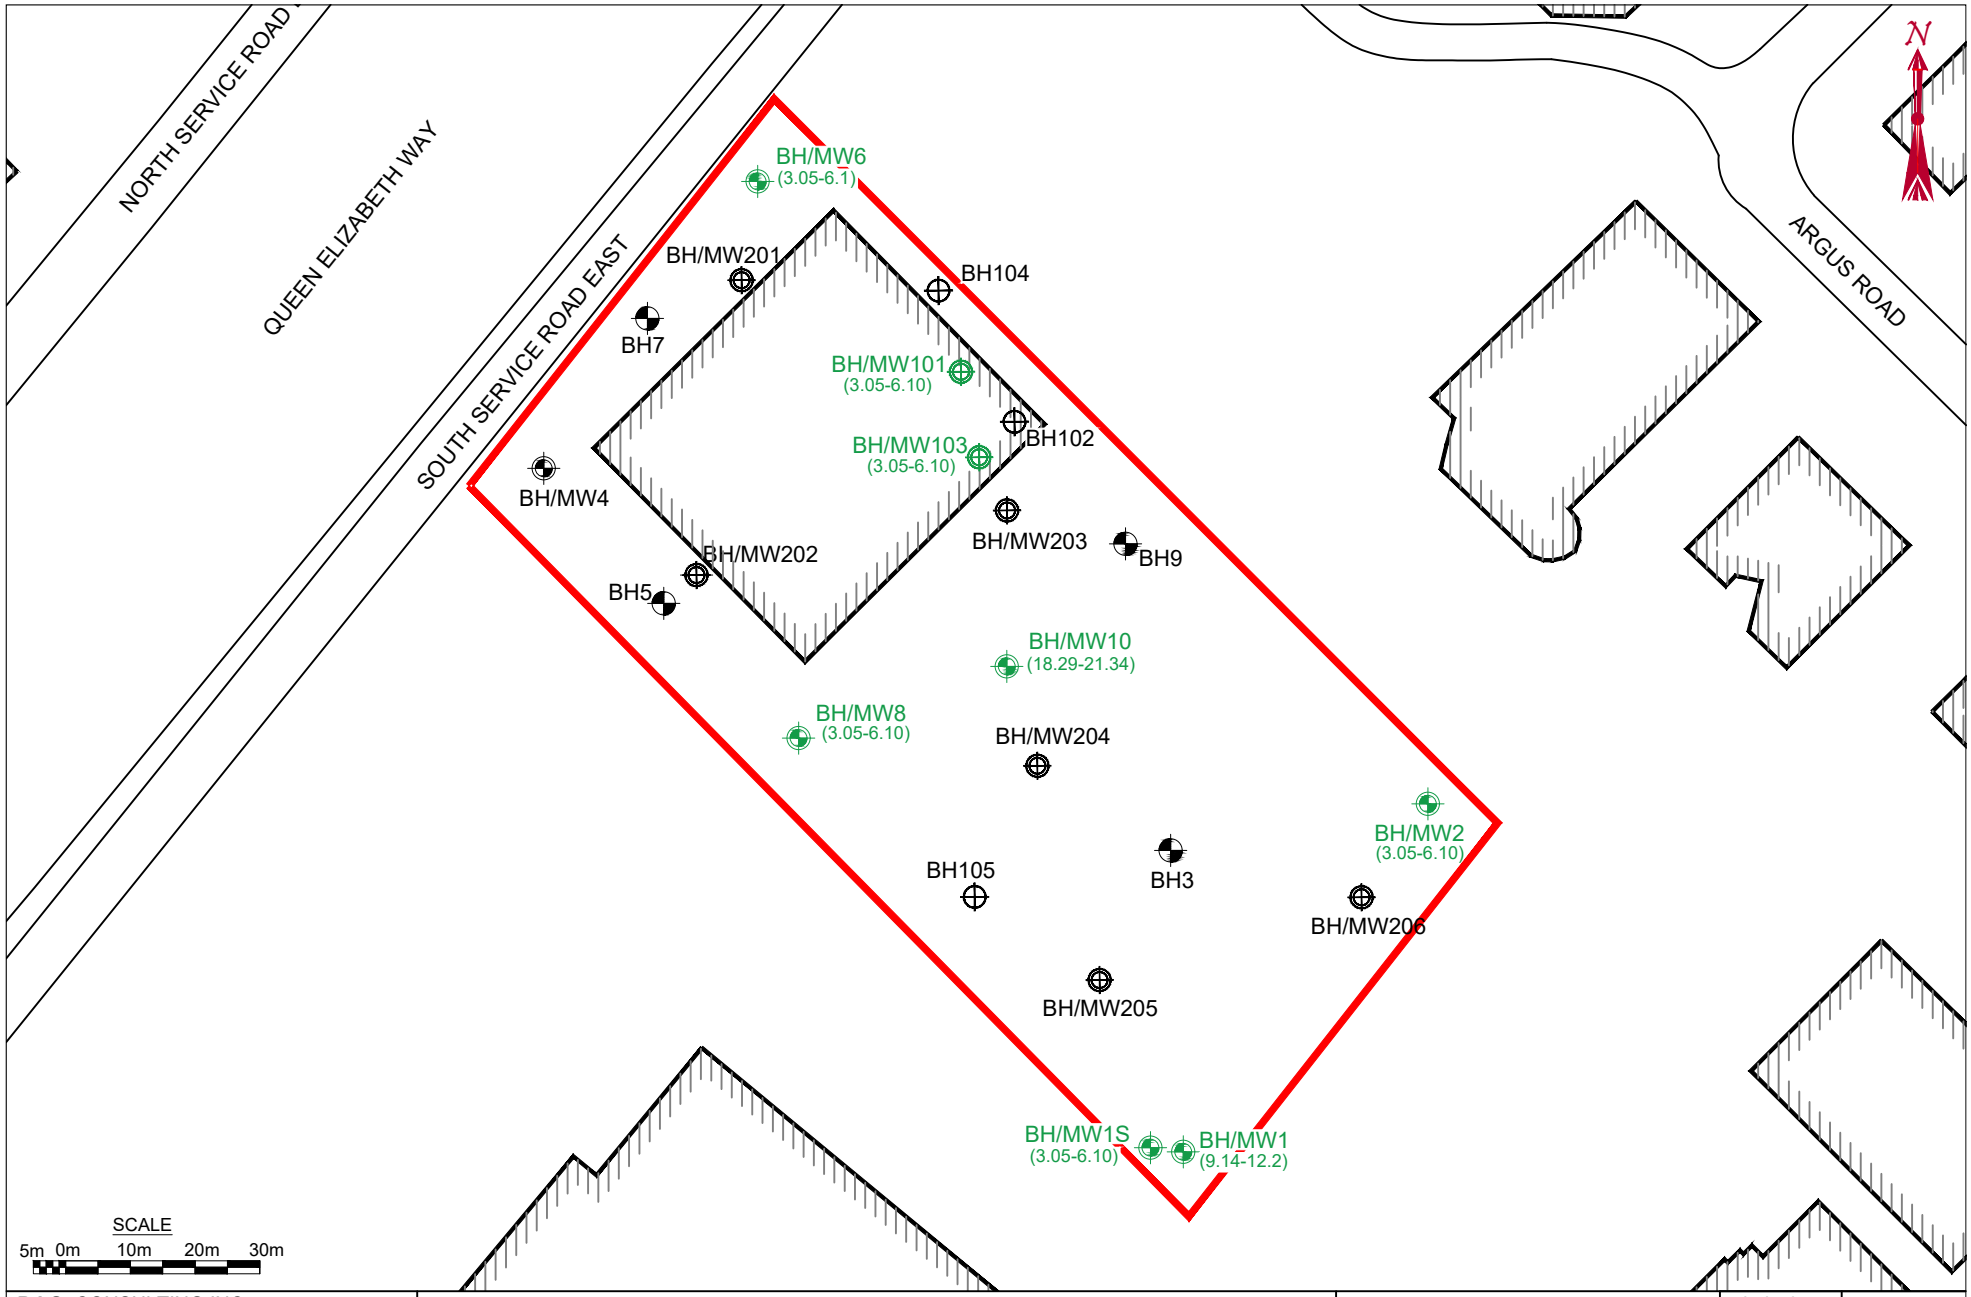
EC AND SAR CONCENTRATIONS IN SOIL
PHASE TWO ESA
166 SOUTH SERVICE ROAD EAST,
OAKVILLE, ONTARIO

Electrical conductivity (EC) and sodium adsorption ratio (SAR) exceedances were identified in soil at the Site at BH/MW6, BH102 and BH/MW201. EC and SAR are not considered as contaminants of concern (COC) at the Site as under the newly amended O.Reg.153/04 (O.Reg.407/19) Section 49.1 (1), if a substance has been applied to surfaces for the safety of vehicular or pedestrian traffic under the conditions of snow or ice or both (i.e., application of de-icing salts), its related parameters are not deemed to be in exceedance of the MECP Table 2 SCS. It is noted that BH102 is located within the portion of the building where the former autobody was located, in close proximity to the garage door. As such, this portion of the Site will have had de-icing salts applied to the ground surface to safely drive cars in and out of the autobody during the winter months.
