Conceptual Channel Design and Erosion Assessment Bronte River Limited Partnership (BRLP) Property Town of Oakville, Ontario

March 2023 PN23026

Report Title: Conceptual Channel Design and Erosion Assessment

Project Number: PN23026

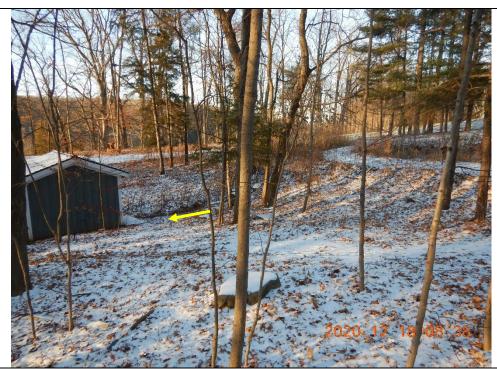
Adjacent to the small outbuilding on site, the outlet from Pond 2 directs flows to the ravine feature. Immediately downstream of this, evidence of erosion was observed in the form of fluvial entrainment, valley wall contact, and an exposed building foundation. Erosion in this location is likely attributable to reworking of the pond over time, loss of sediment supply, and concentration of flows from the outlet structure. Flows in the ravine feature pass between valley walls towards the Bronte Creek floodplain in a straight, mixed-load channel with a steep gradient. Bed substrate in the ravine ranges from gravel to large cobbles. The valley walls contain high amounts of gravel and sand material.

Photo taken from the south bank of pond and berm feature. Note location of pond (right), berm, and small outbuilding. Arrow depicts flow direction from pond outfall.

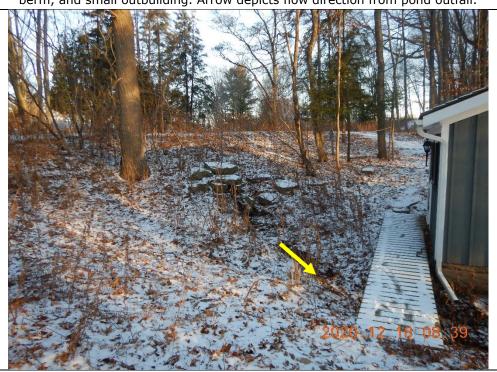
Photo facing north towards pond outfall.

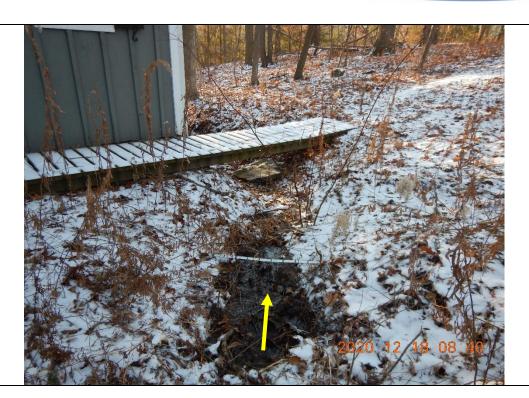
Photo 4 Main Ravine Feature: View Downstream

Photo taken from the pond outfall facing the small outbuilding on site.

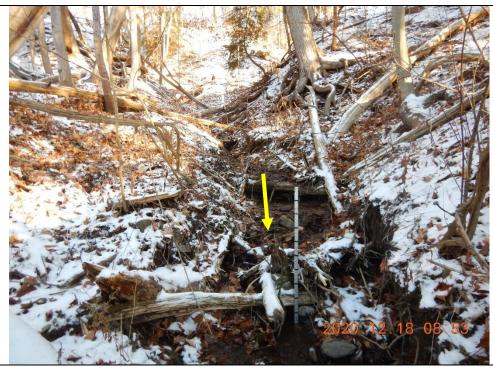
Photo 11 Transfer Zone: View Upstream

The channel in the transfer zone has a continuous, wide riparian buffer comprised mainly of established trees. The channel lacks diverse velocity and depth conditions and is dominated by riffle-type geomorphologies. Multiple knickpoints created by small woody debris jams were observed. Channel geometry is more defined in this section, with a measured average bankfull width and depth of 2.25 m and 0.51 m.

Multiple knickpoints created by small woody debris jams were present throughout the transfer zone section of the channel.

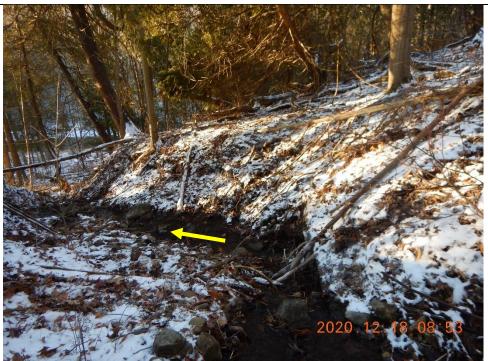
Moving downstream, the ravine opens into the transfer zone and the channel gradient became less steep. Cobbles and boulders, gravel deposits, and minor exposures of the shale were observed throughout the channel bed. Evidence of channel erosion was not as severe in this section but was still observed with localized patches of exposed shale, occasional exposed tree roots, and multiple occurrences of large organic debris. Leaning and fallen trees, as well as J-trunk trees were observed throughout this section of the valley, indicating a sustained level of slope

Evidence of erosion in the form of fluvial entrainment. Bank materials in the channel consisted of mainly sand and gravel with some silt.

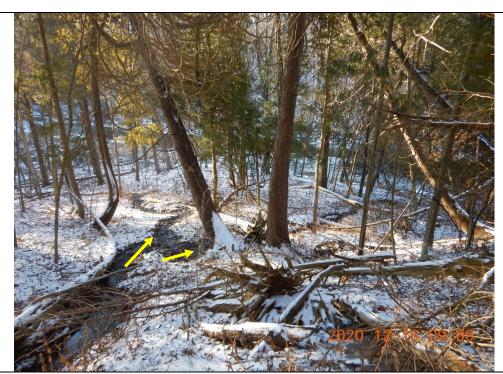
Photo 15 Alluvial Fan: View Downstream

Immediately below the transfer zone section, the channel enters the floodplain of Bronte Creek, where it eventually outlets. At this location, an active, open alluvial sediment fan was observed. Bed substrate in this section is considerably finer, consisting mostly of sand and gravel. The floodplain is also open, providing good communication with multiple distributary channels within the fan that drain into the main branch of Bronte Creek. Evidence of erosion in this section was not present.

Photograph taken from the right bank at the upstream extent of the alluvial fan section of the channel.

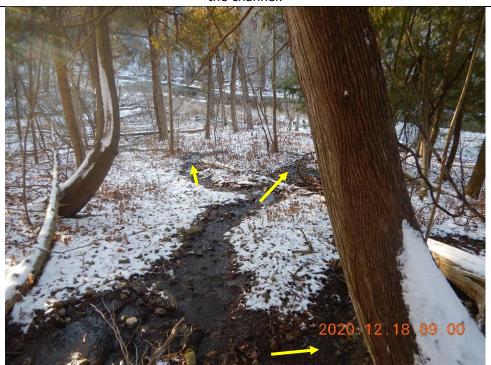
Channel splits into multiple flow paths. Photo taken viewing left side of alluvial fan.

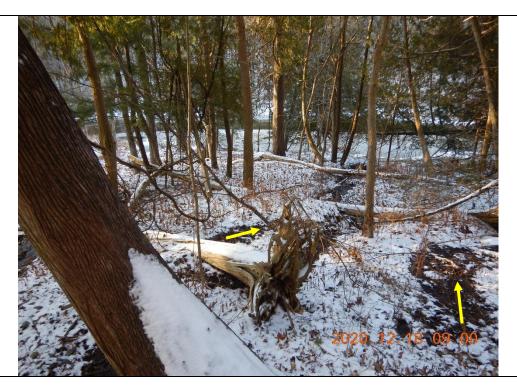
Photo 17 Alluvial Fan: View Downstream

Channel splits into multiple flow paths. Photo taken viewing right side of alluvial fan.

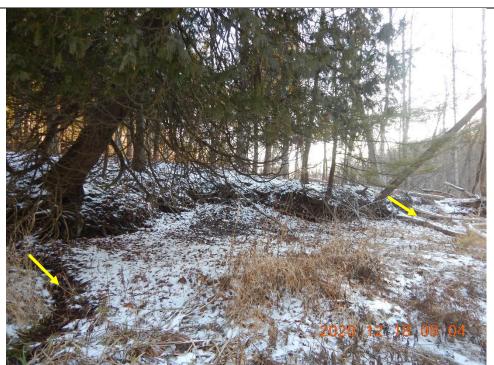
Photo taken from left bank of Bronte Creek facing the alluvial fan.

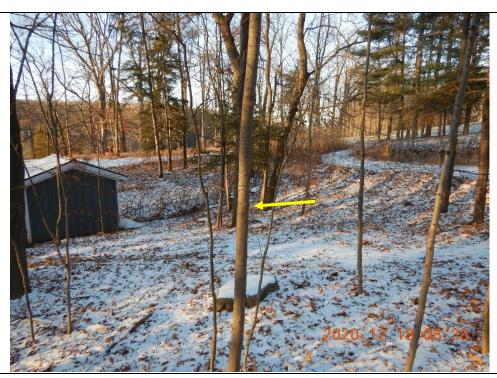
Proposed Outlet Location A

Approximate outlet location at the downstream extent of the proposed LID features, at the top of the Bronte Creek Valley.
