# **Geotechnical Slope Stability Hazard and Risk Assessment - Desktop Study & Site Inspection Report**

**East Morrison Creek Erosion Mitigation Study  
Town of Oakville, Ontario**

**Client:** Matrix Solutions Inc.

**Date:** April 11, 2025

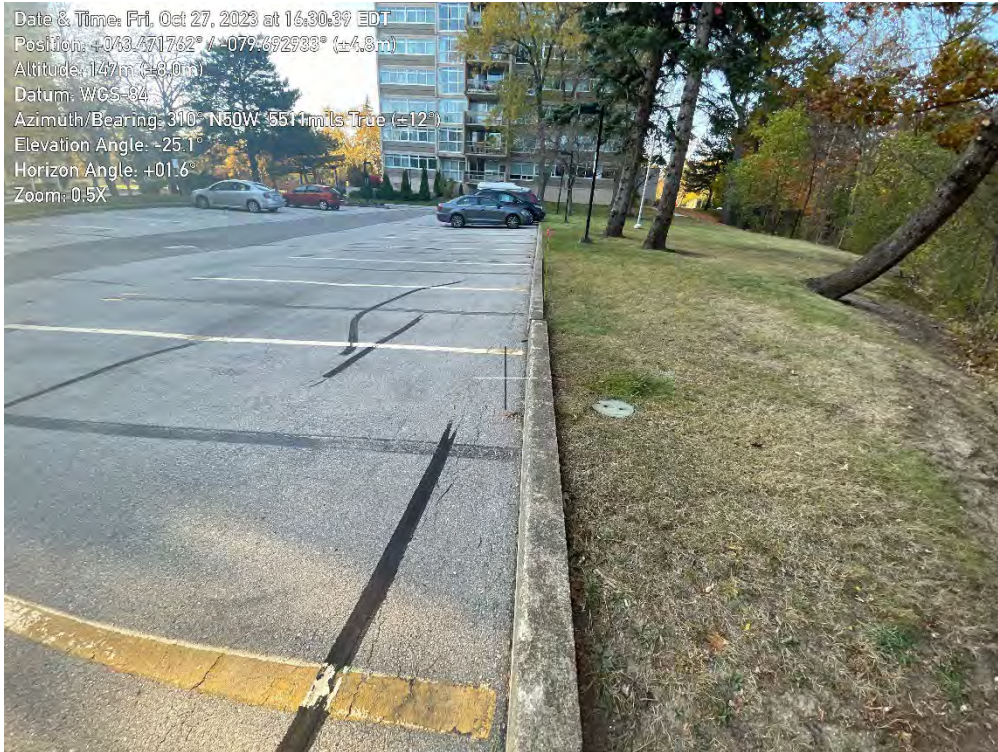
**Photo 133. View of separating parking lot curbs at 1359 White Oaks Boulevard, slope crest of Zone A7, looking Northwest.**

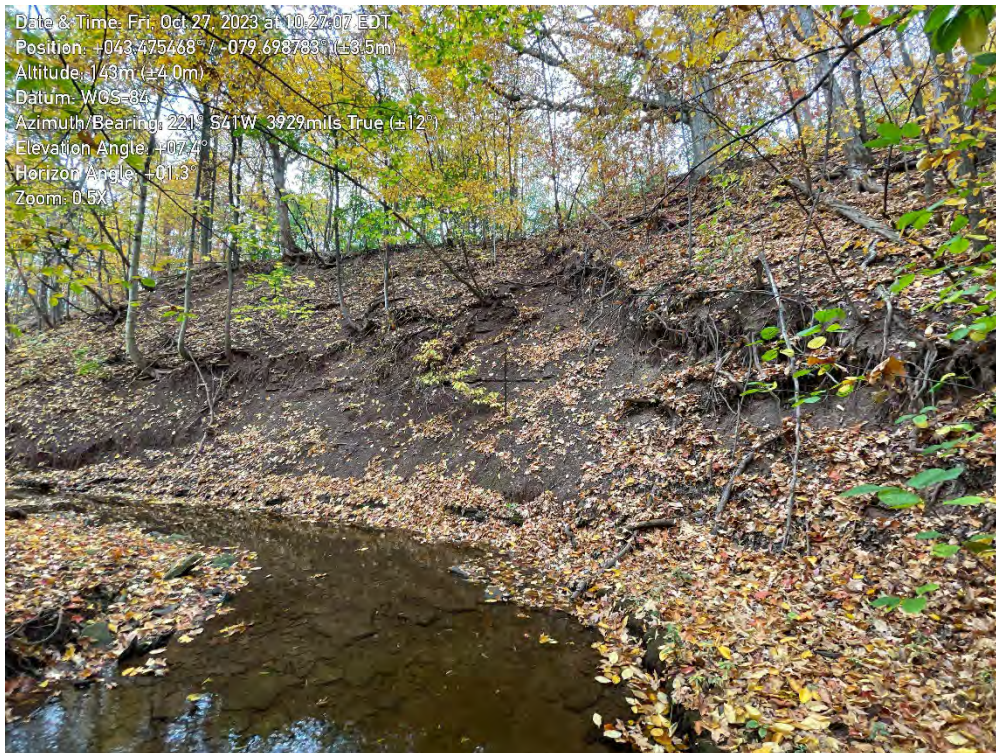
Photo 30. View of erosion in Zone A13 of the East Morrison Creek, looking Southwest.

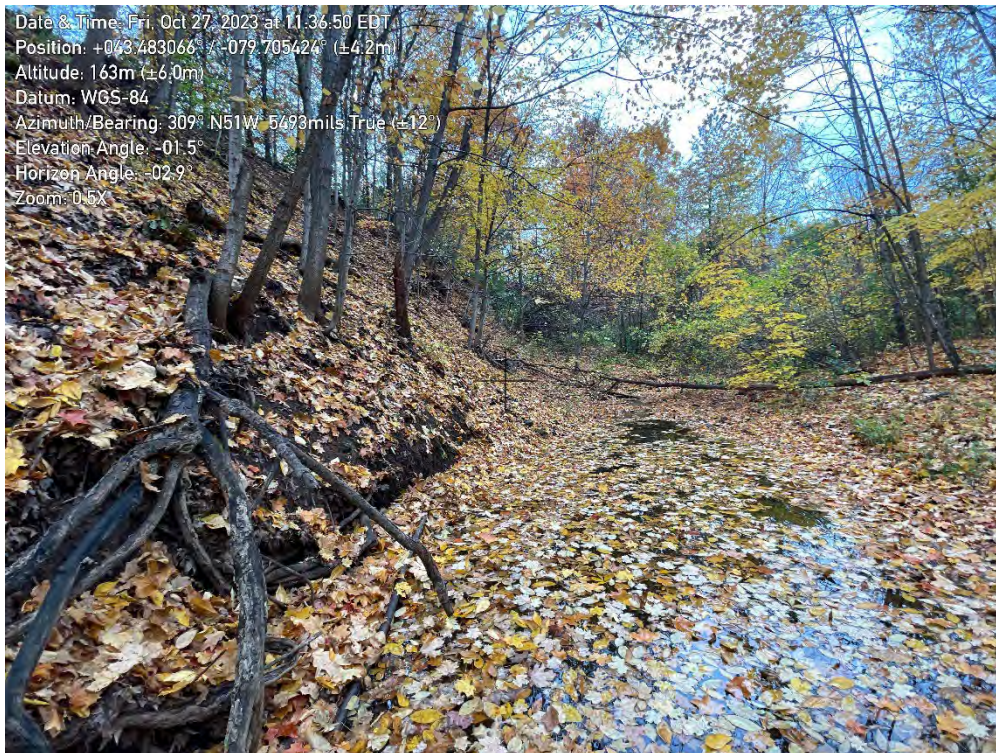
Photo 34. View of valley wall slopes in Zone A22-2 of the East Morrison Creek, looking Northwest.

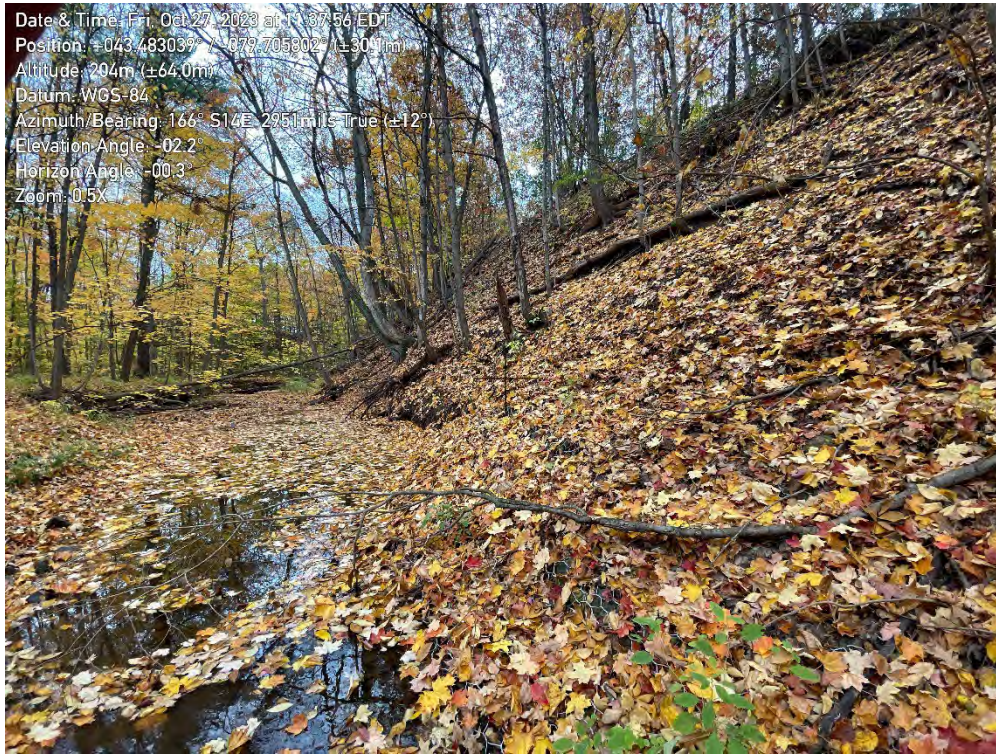
Photo 35. View of valley wall slopes in Zone A22-2 of the East Morrison Creek, looking Southeast.

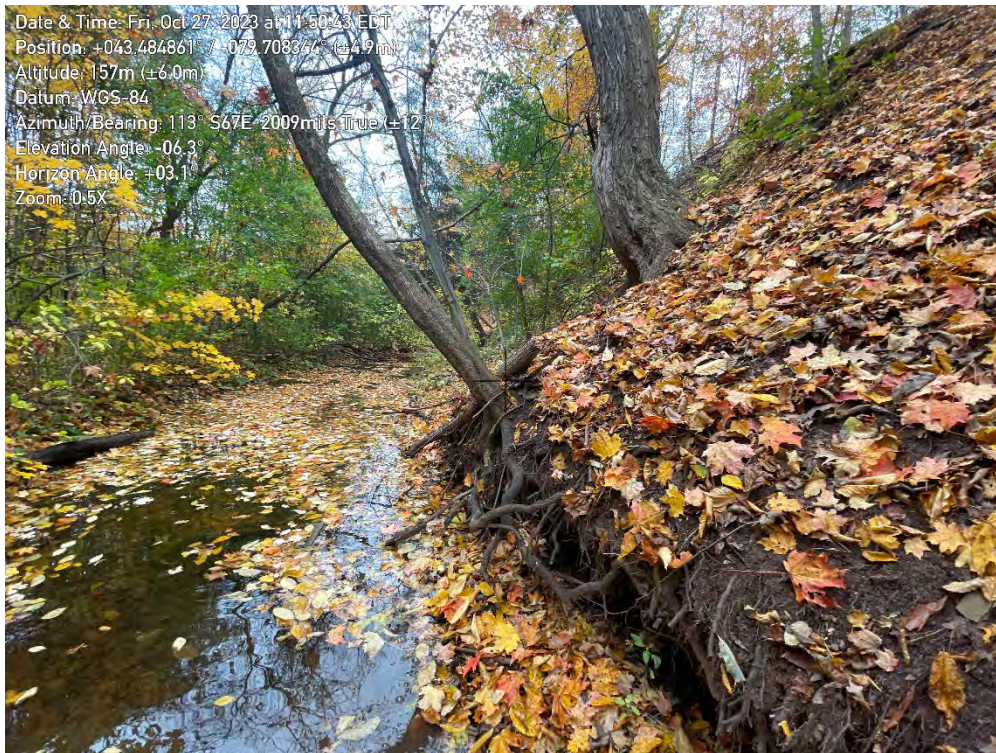
Photo 36. View of erosion in Zone A23 of the East Morrison Creek, looking Southeast.

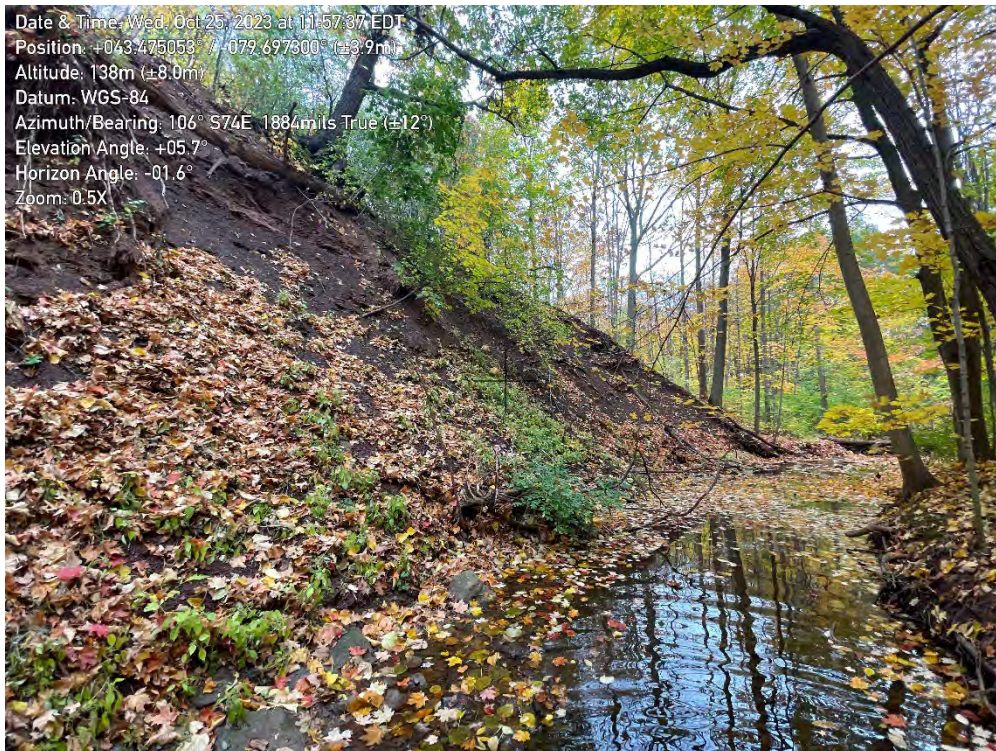
Photo 40. View of erosion in Zone B11 of the East Morrison Creek, looking Southeast.
