# **Arborist Report**

**Pre-Construction Assessment**

2360 Bristol Cir, Oakville, ON L6H 6M5

Revised May 30th, 2023

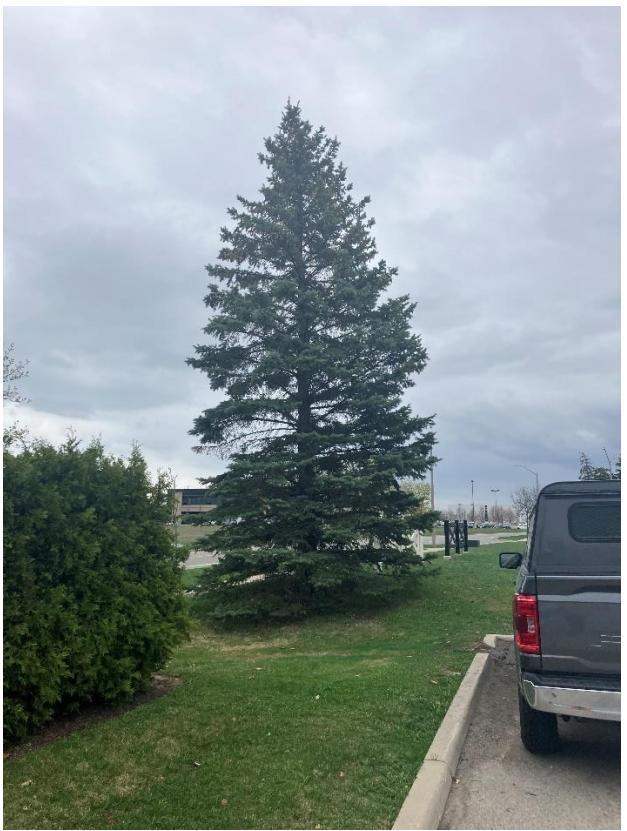
Figure 19 Trees49-50

- **Trees #48-50** are on the west side of the existing building of the city's property. These trees' overall condition is good. Tree #50 is within the proposed construction area and recommended for removal and Tree #49 TPZs encroach within the proposed construction zone and Tree Protection Fencing (TPF) should installed to prevent injury.

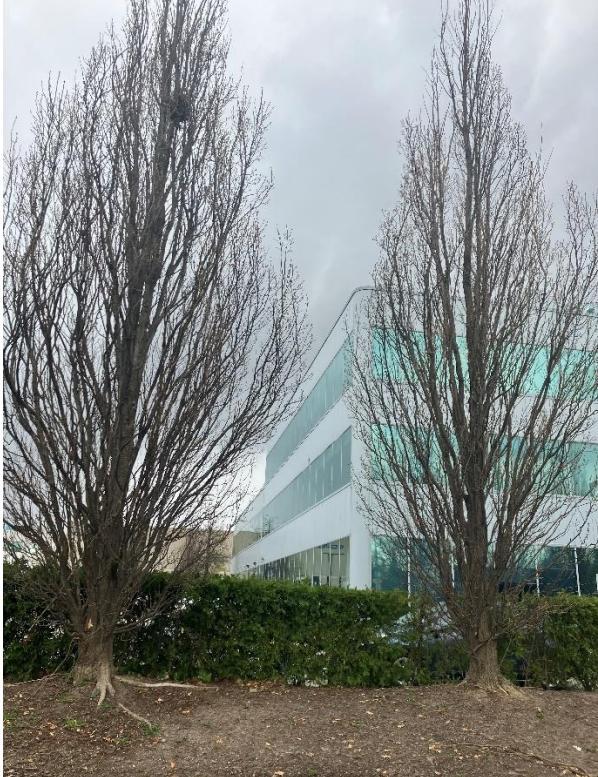
Figure 22 Tress 555-56

- **Trees #51-65** are in front of the existing building on the property. These trees' overall condition is good. Tree #51 is within the proposed construction area and recommended for removal and the proposed construction should not harm these trees. Trees (# 52-55) are protected with TPF and hoarding.
