UPDATED SLOPE **STABILITY ASSESSMENT**

Proposed Development

1260 & 1280 Dundas Street West, Oakville, ON

BIGC-GEO-185E

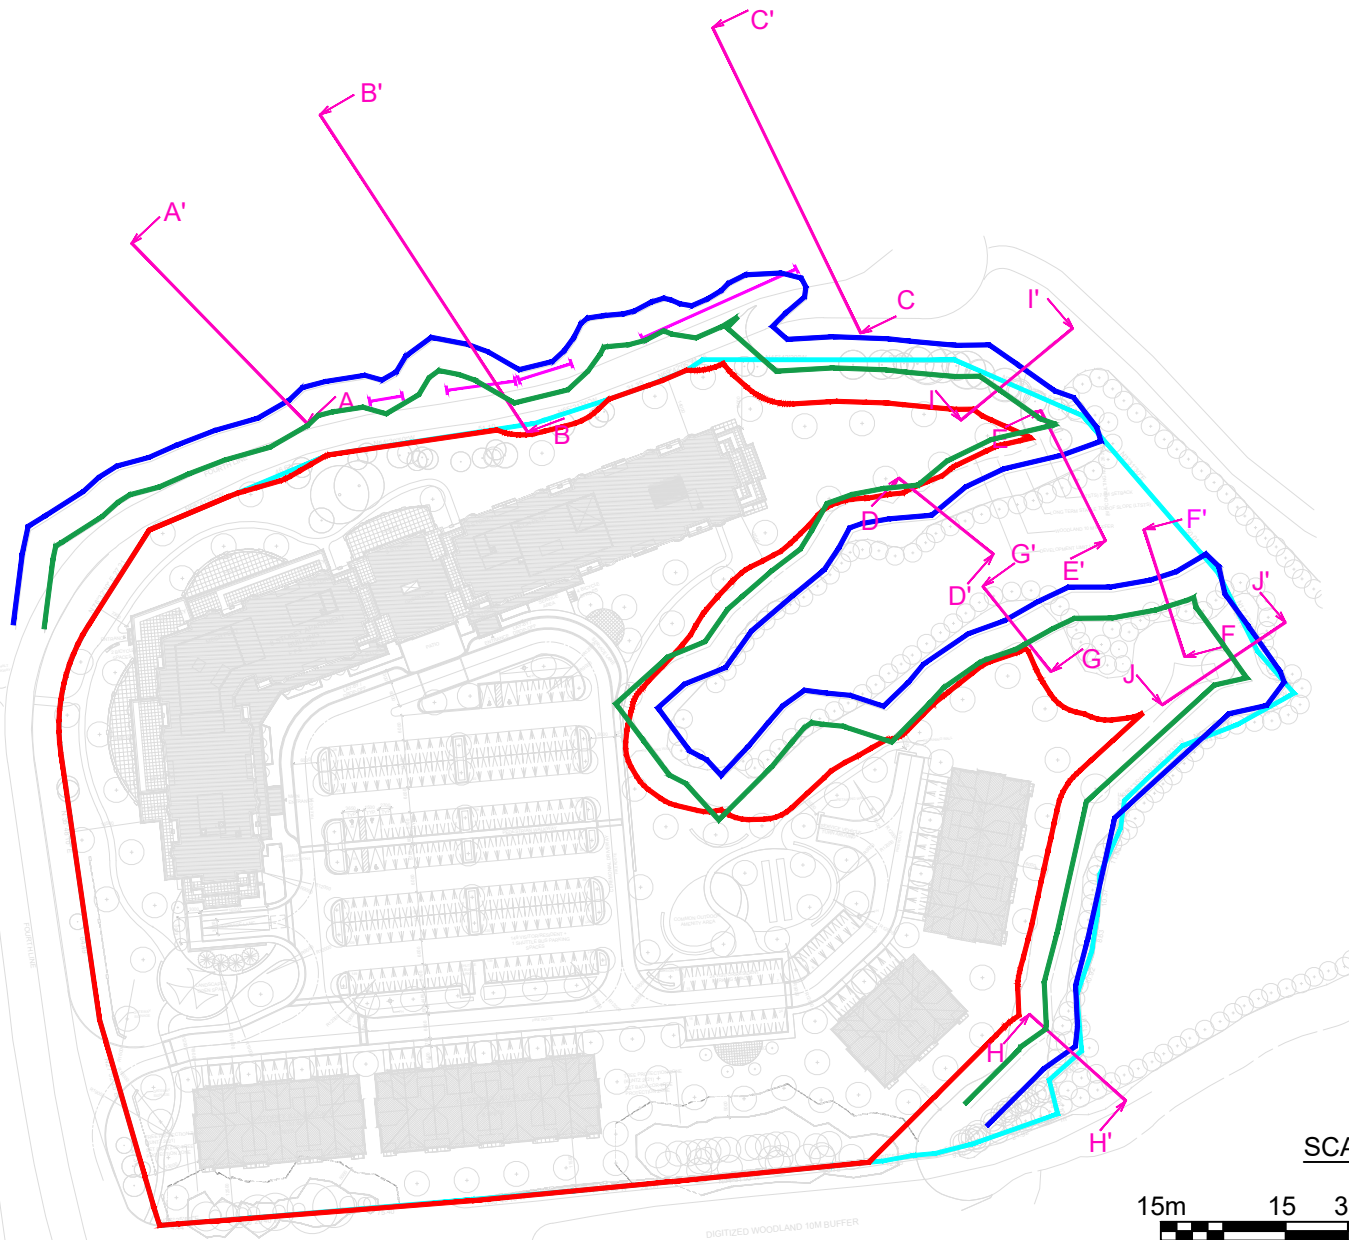
PROJECT NO.	DWN.
BIGG-GEO-185E	O.A.
SCALE	CK.
AS NOTED	O.L.
DATE	FIG. NO.
MARCH 2022	1C

Based on the long-term stable top of slope at the analyzed sections, and our field observations, the recommended Long-Term Stable Top of Slope (LTSTS) line is shown on Figure 1C. It should be noted that for the proposed development, Conservation Halton (CH) will require additional setback from the LTSTS line. We understand that currently a 15 m setback is required from the Long-Term Stable Top of Slope for Sixteen Mile Creek and its tributaries. However, it is our opinion that a minimum 7.5 m setback is appropriate as required along the internal valley given the encountered soil conditions, higher minimum factors of safety ranging from 1.9 to 4.6 at the analyzed slope sections and supplemental geomorphic analysis by GEO Morphix Ltd.

For reference purpose, a 7.5 m development setback is presented on Figure 1C.

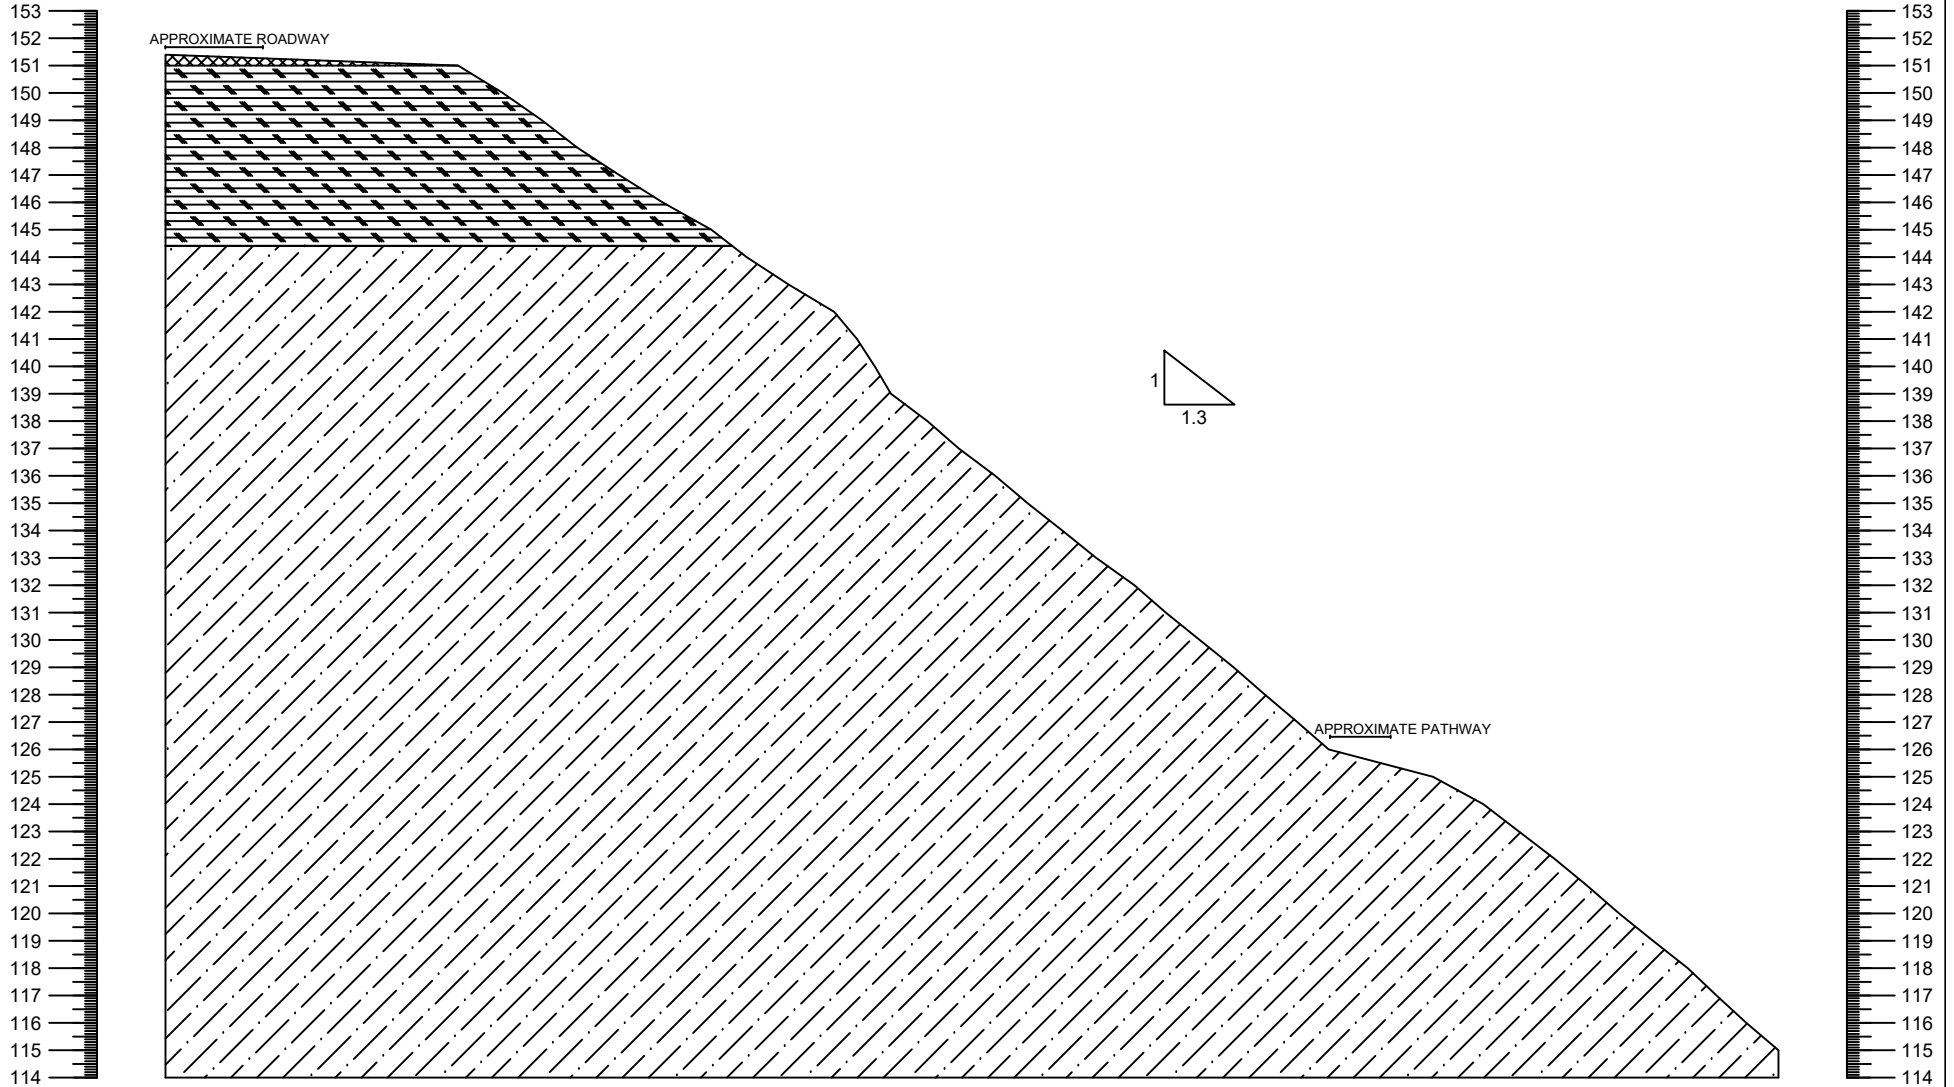
PROJECT NO. BIGC-GEO-185E	DWN. S.M.
SCALE AS NOTED	CK. O.L.
DATE NOVEMBER 2021	FIG NO. 2

TITLE AND LOCATION
GEOLOGICAL CROSS SECTION A-A'
UPDATED SLOPE STABILITY ASSESSMENT
 1260 AND 1280 DUNDAS STREET
 WEST, OAKVILLE, ONTARIO

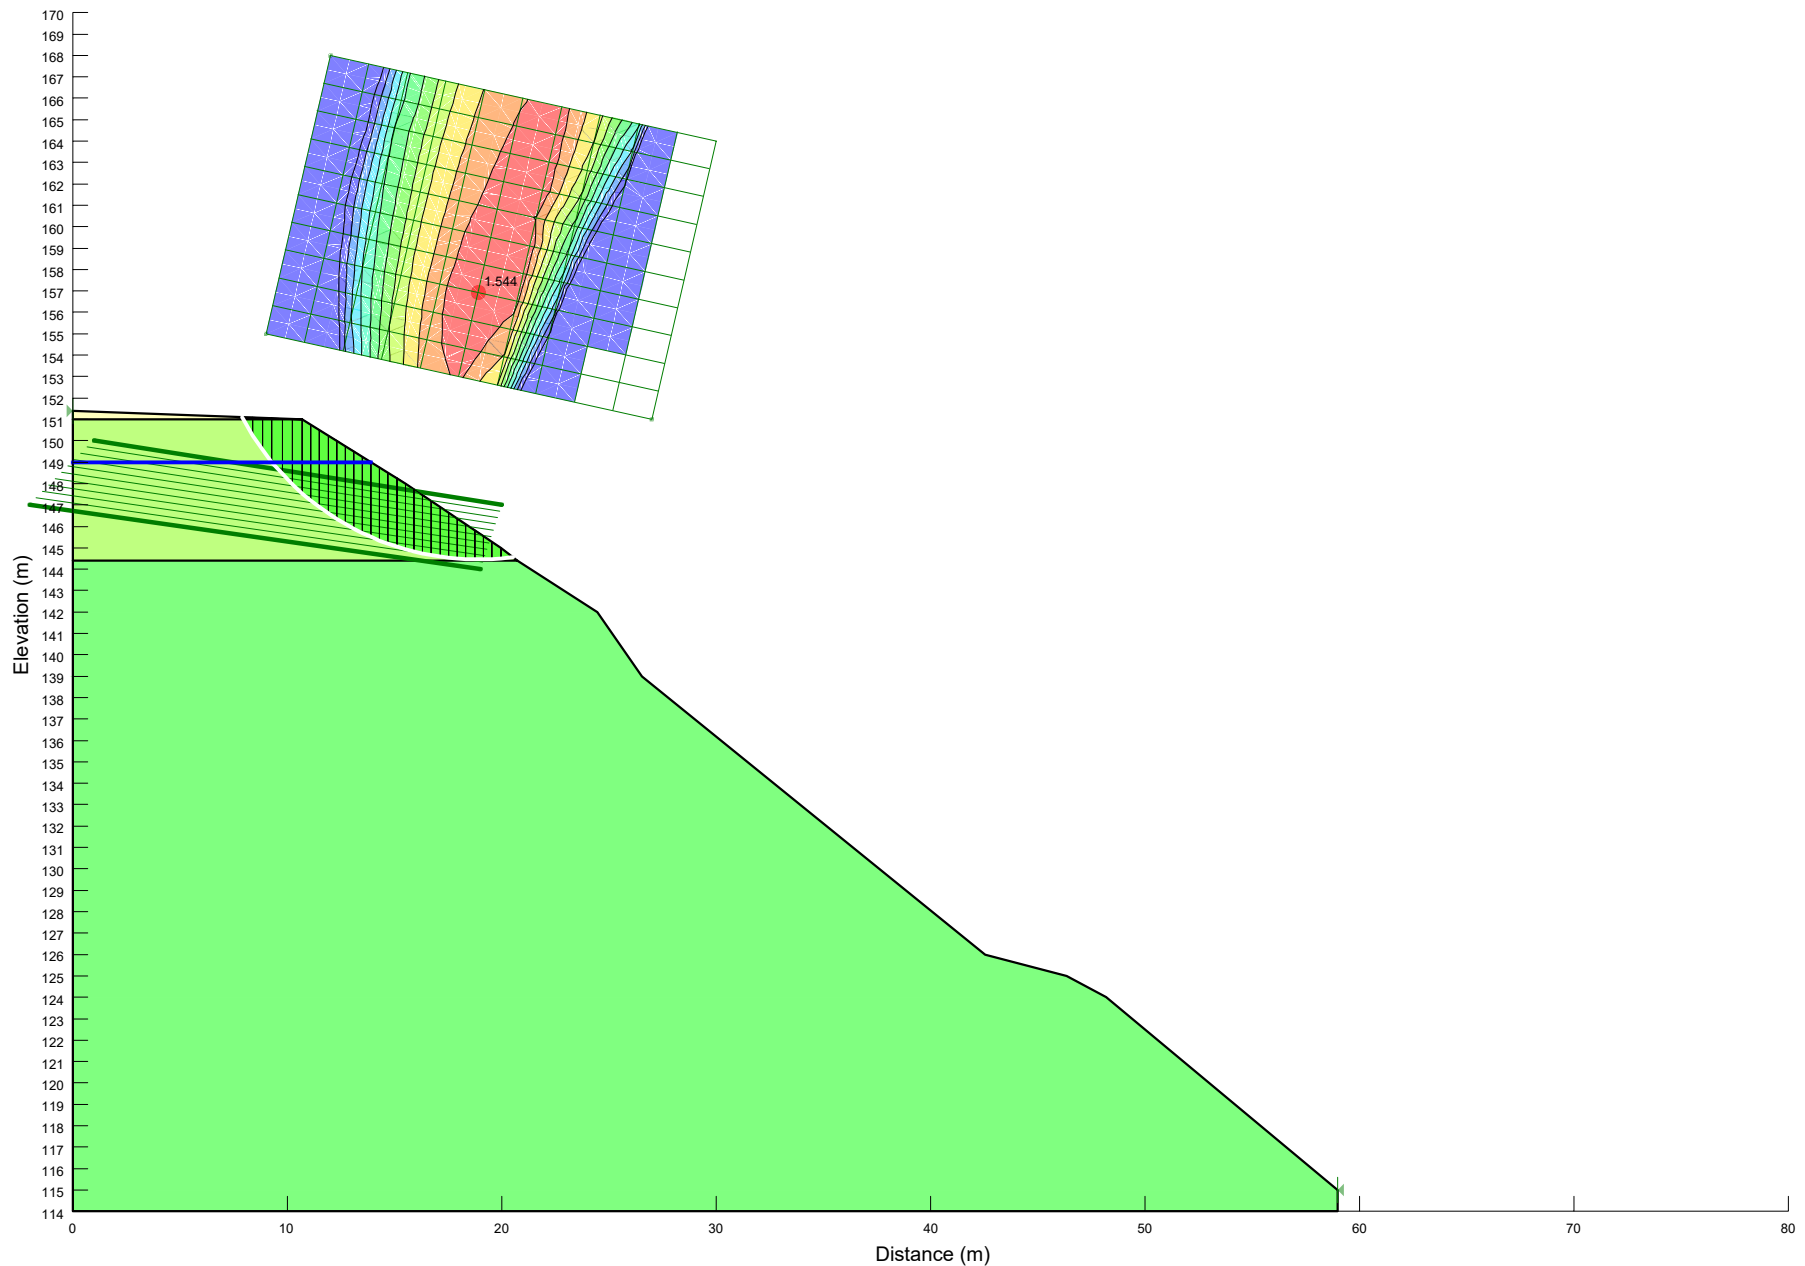
Analysis Scenario	Slope Profile	Minimum Factor of Safety (FS) (Long-Term Stability)	For Slope Stability Analysis Result
Scenario 1	Section A-A	1.544	See Figure 12
Scenario 2	Section B-B	1.518	See Figure 13
Scenario 3	Section C-C	2.386	See Figure 14
Scenario 4	Section D-D	1.996	See Figure 15
Scenario 5	Section E-E	2.059	See Figure 16
Scenario 6	Section F-F	4.069	See Figure 17
Scenario 7	Section G-G	4.681	See Figure 18
Scenario 8	Section H-H	4.303	See Figure 19
Scenario 9*	Section I-I	2.266	See Figure 20
Scenario 10*	Section J-J	1.510	See Figure 21

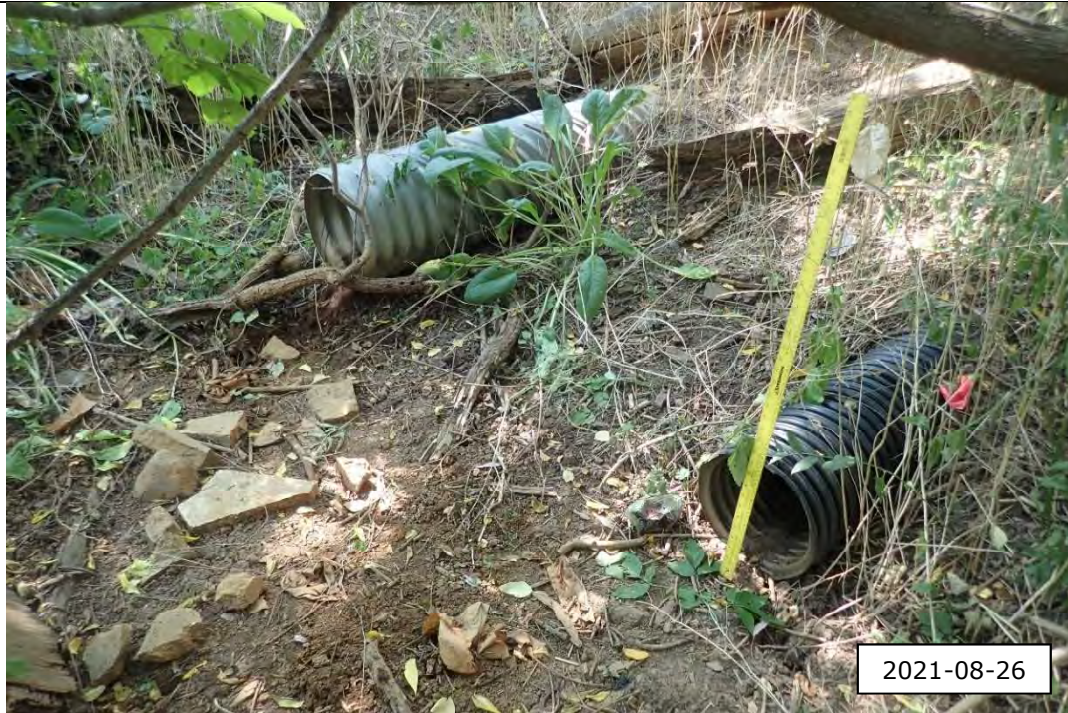
Photo 1
Reach GCT-1 – Tributary of Sixteen Mile Creek

Upstream view towards the upstream extent of the ravine feature. The two culverts, left to right, were approximately 0.40 m and 0.30 m in diameter.

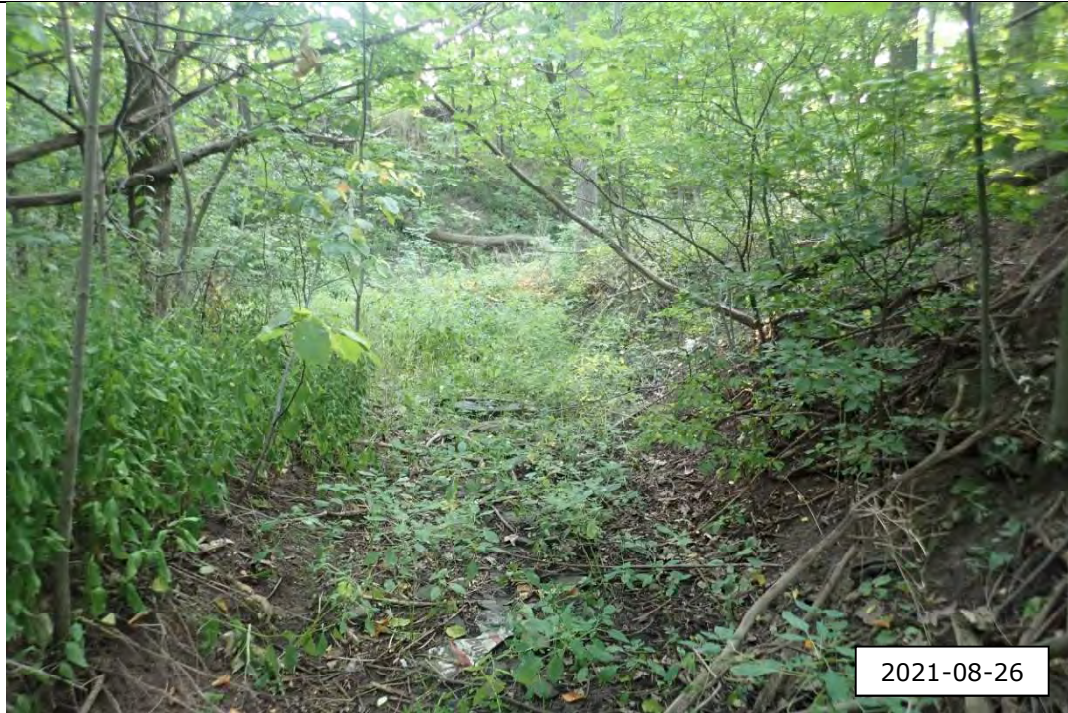
Photo 2
Reach GCT-1 – Tributary of Sixteen Mile Creek

Photograph taken in the upper section of the reach looking downstream where the channel gained definition.

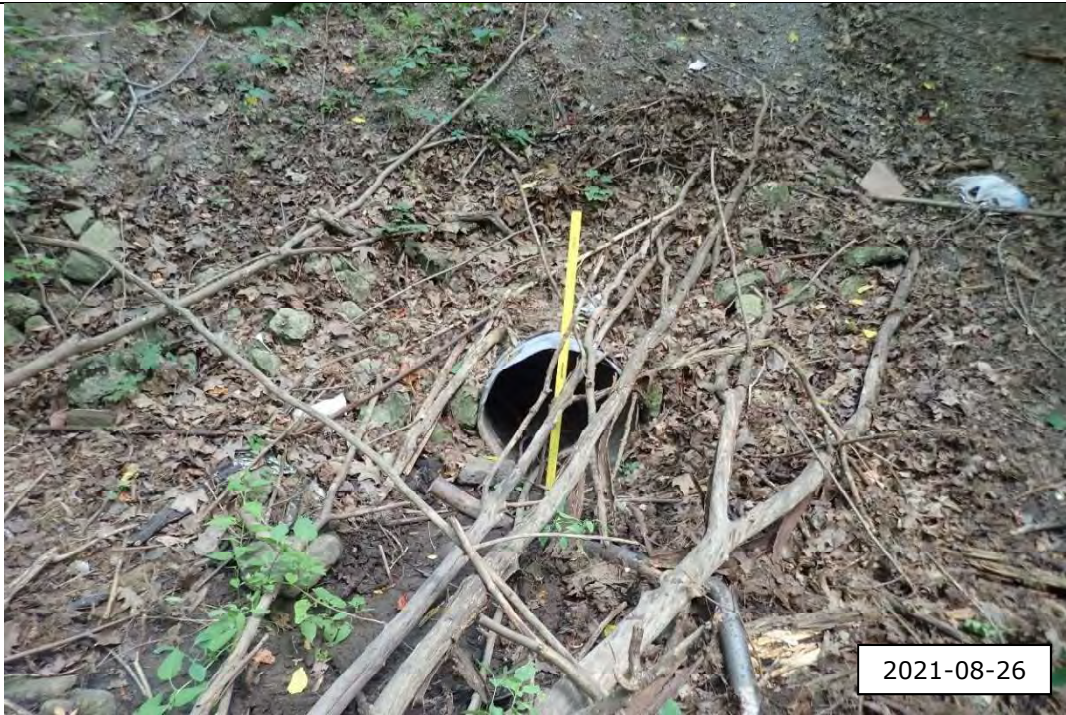
Photo 6
Reach GCT-1 – Tributary of Sixteen Mile Creek

Photo taken at the downstream extent of reach, facing downstream. The culvert connected to Reach GC2 and was approximately 0.5 m in diameter.

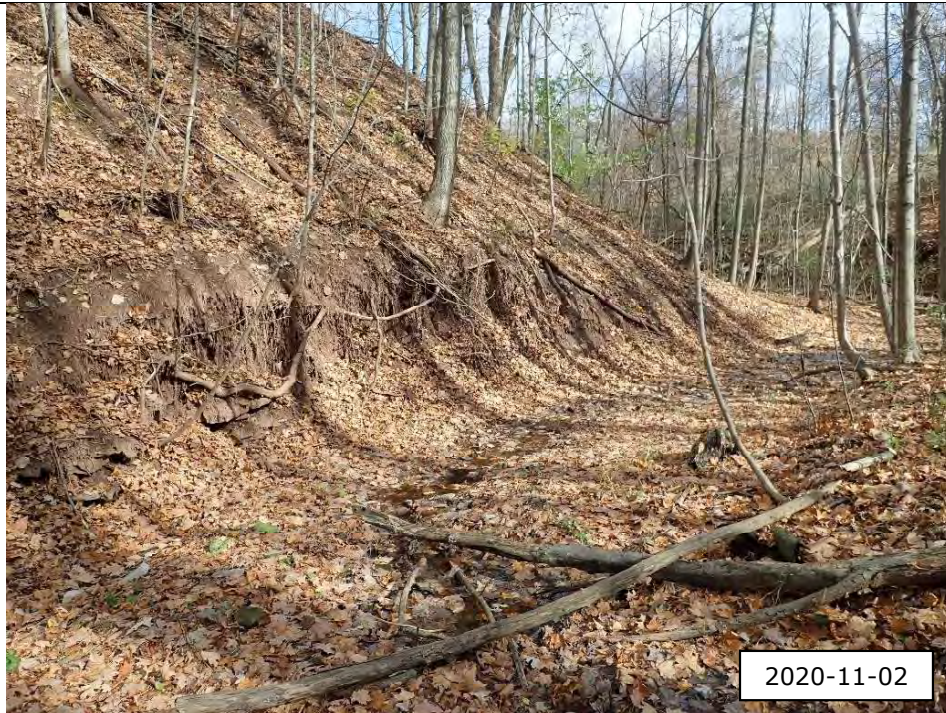
Photo 12
Reach GC-3 – Tributary of Sixteen Mile Creek

The meandering planform was constricted by the narrow valley corridor. Valley wall slopes were steep but well vegetated with mature trees. Grasses were largely absent.

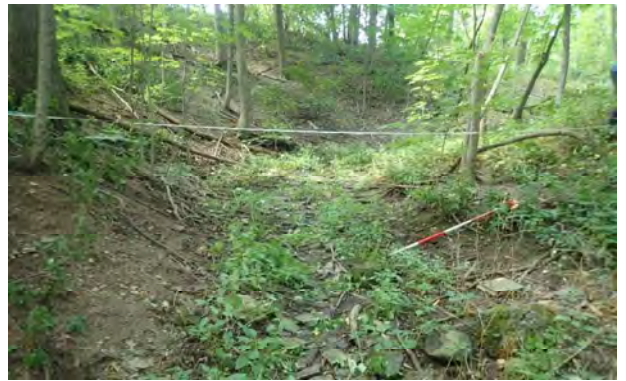
Representative Cross-Section #5

Photograph at cross section 5 (looking upstream)

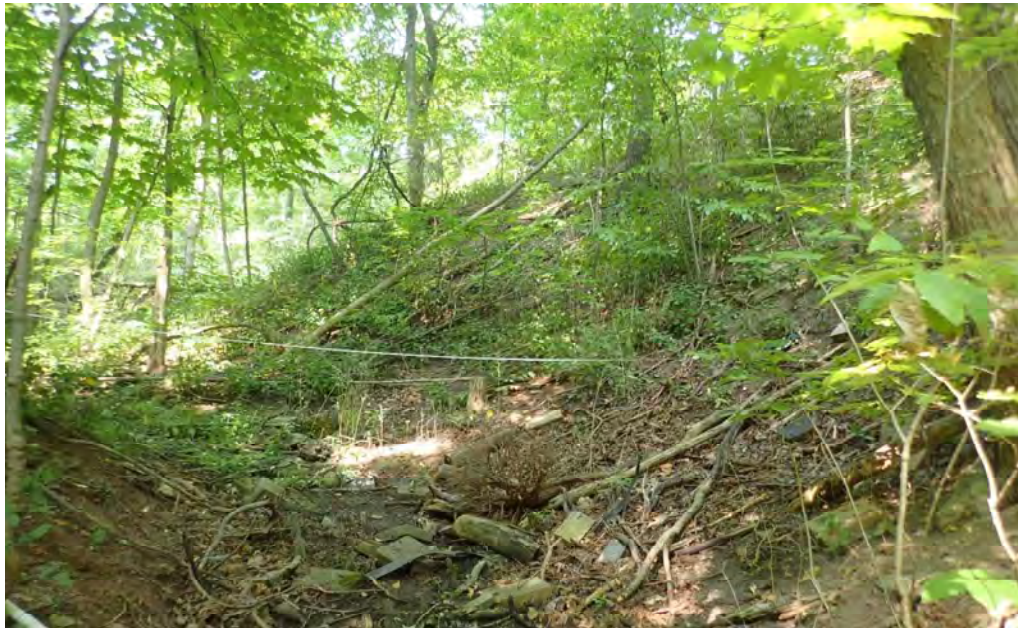
Cross Section 6 - Facing Upstream

Reach GCT1 flows through the ravine central to the subject property. The channel follows a meandering planform, confined within the valley and making contact with the valley walls in several locations. Evidence of active erosion was minimal, with undercutting up to only 0.06 m noted at two cross-sections. The channel was dry during the time of assessment. The riparian zone is confined to the valley extent, and is characterized by mature trees. Approximately 30% of the channel bed was encroached by herbaceous and grassy vegetation. Average bankfull width and depth were 3.08 and 0.24 m, respectively. Bed substrate ranges from silt to platy cobbles, while the bank material is characterized as a silty-clay loam throughout.

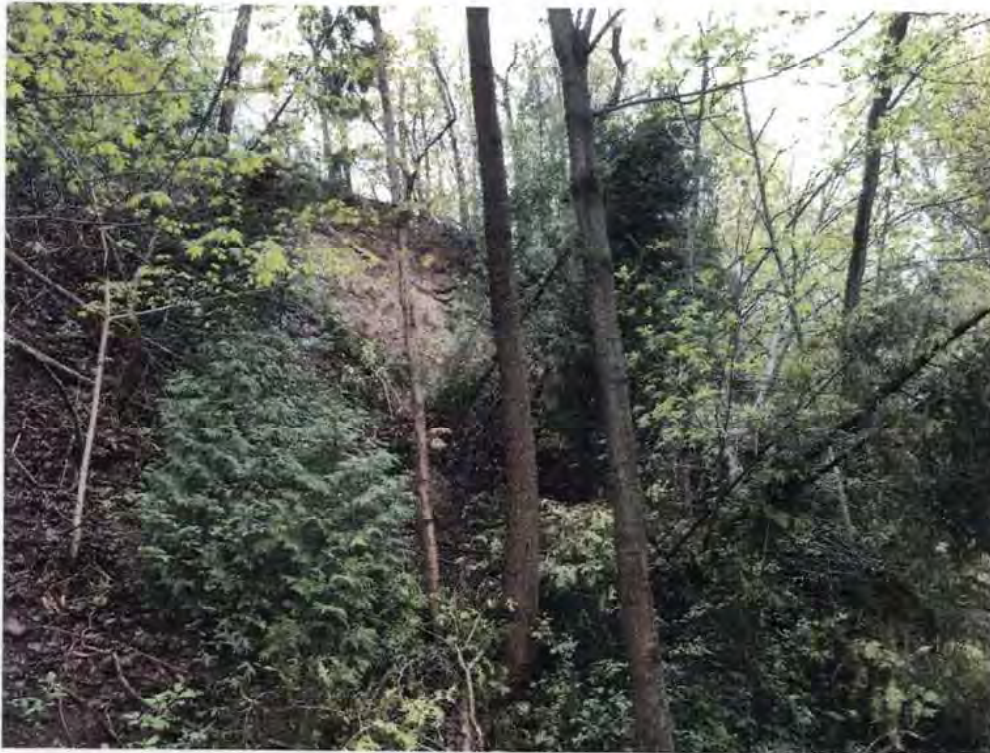
Sixteen Mile Creek Slope – Looking Northwest, slope overburden erosion, Cross Section B

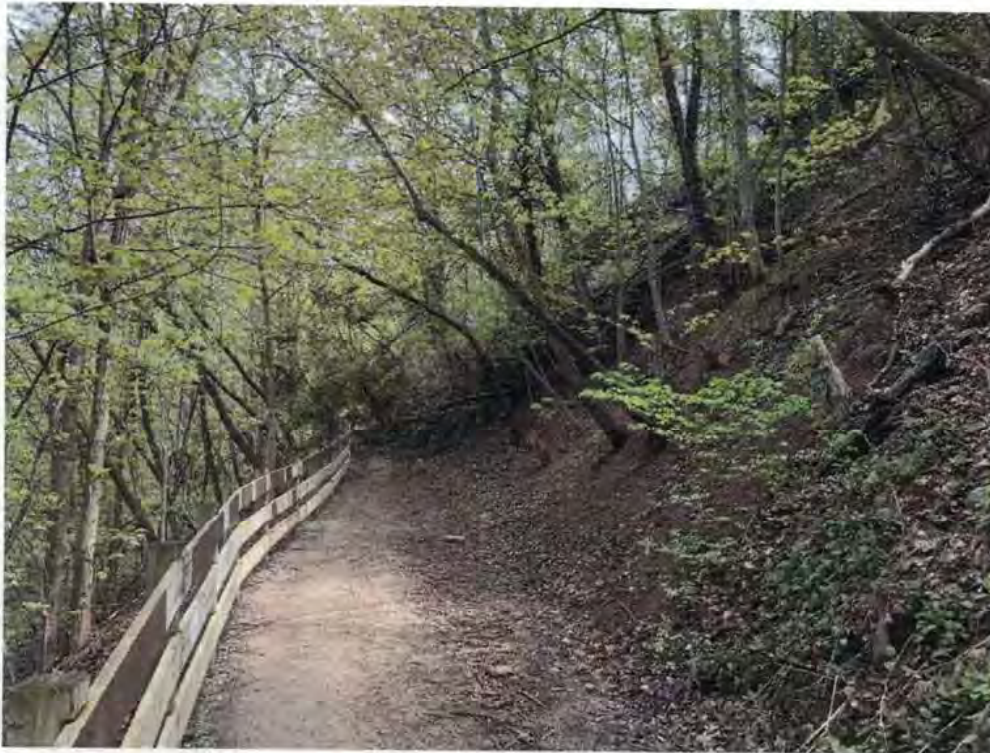
Sixteen Mile Creek Slope – Trail dividing the slope impeded by upper slope overburden erosion, looking South, Cross Section B

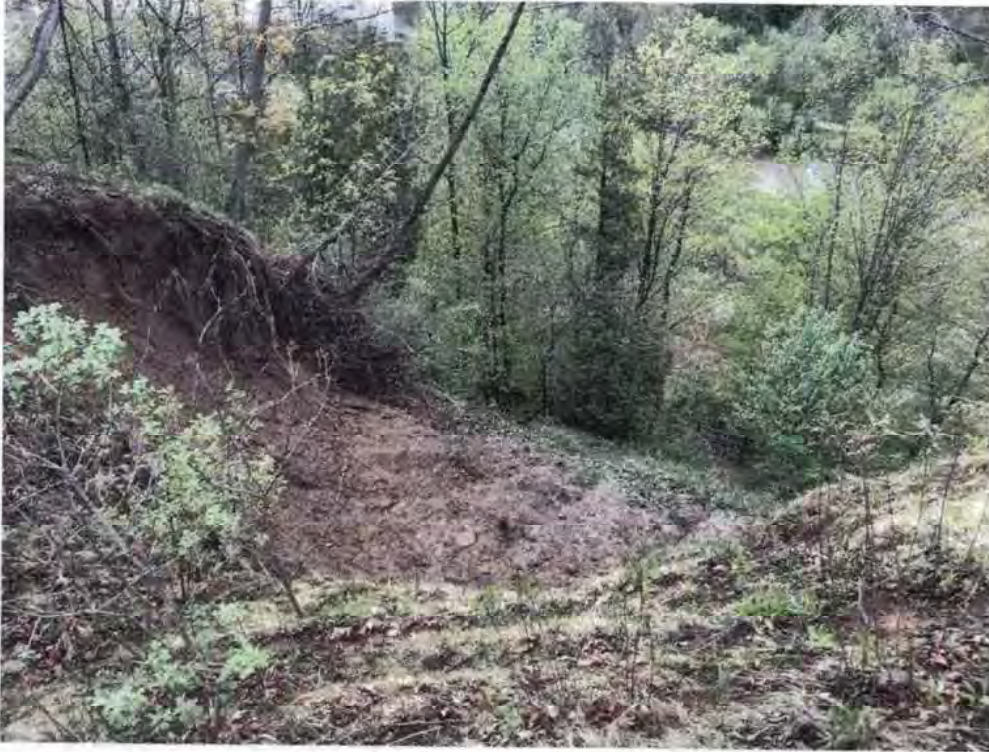
Sixteen Mile Creek Slope – Slope overburden erosion, looking East

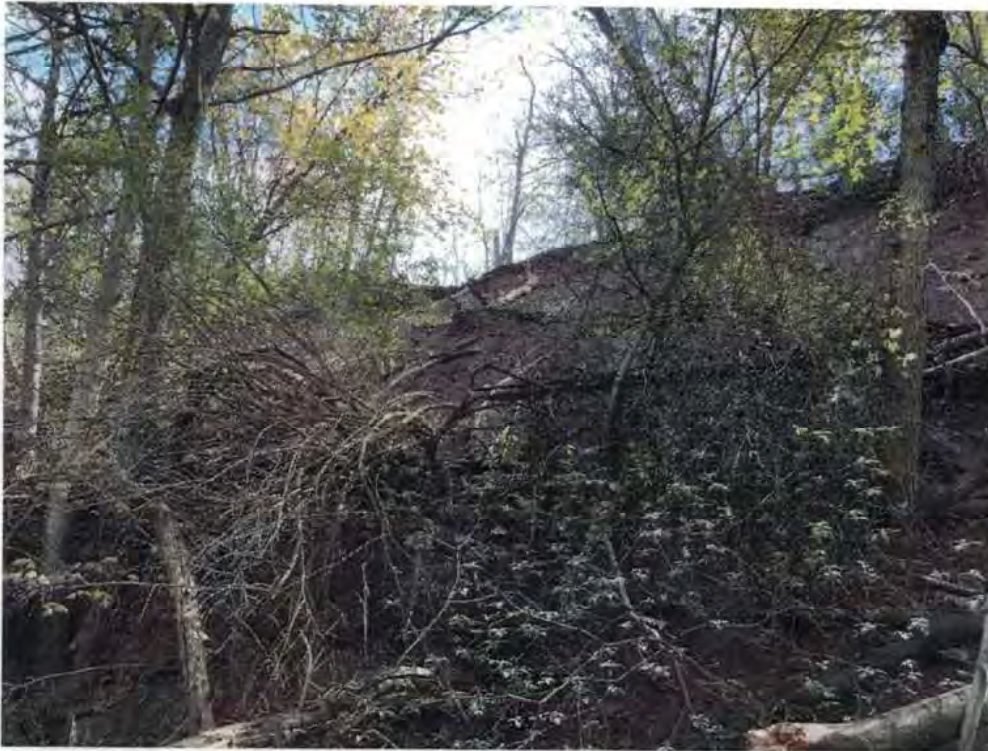
Sixteen Mile Creek Slope – Slope overburden erosion, looking West

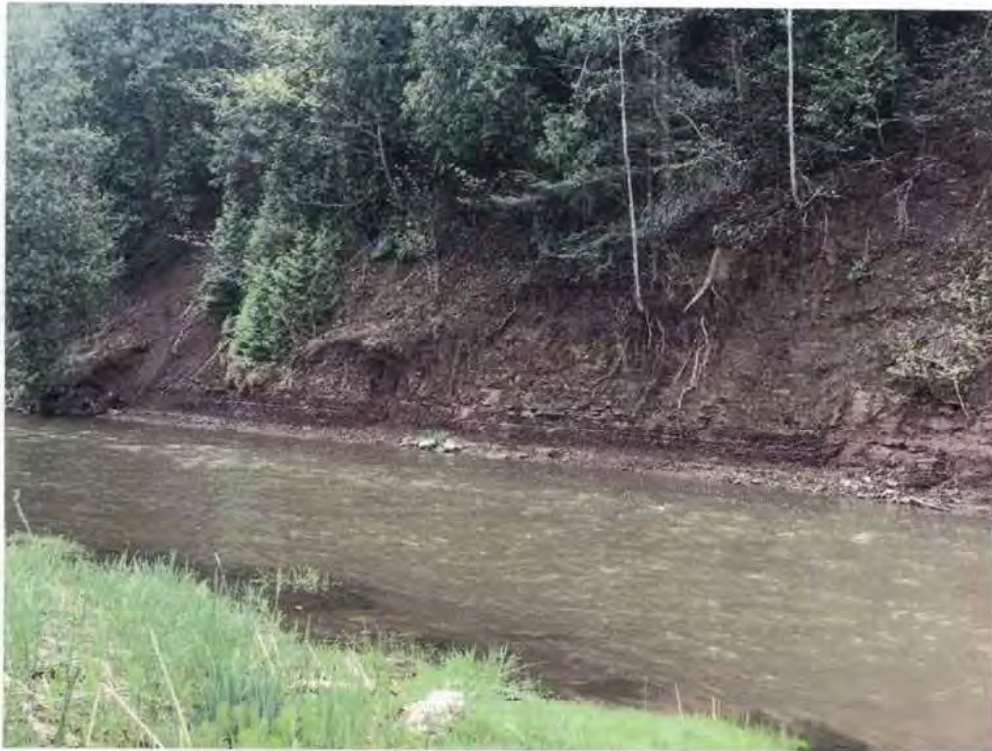
Sixteen Mile Creek Slope – Toe of slope, looking southwest, Cross Section C

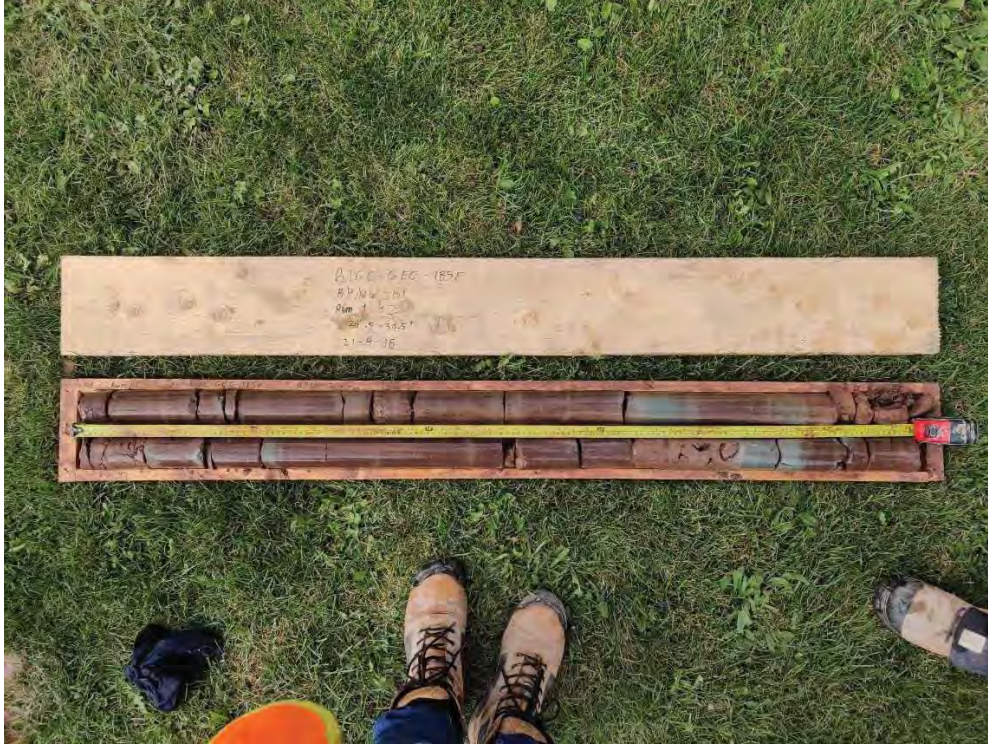
BH201 Rock Core Run 1 & Run 2 (26.5' to 36.5') / RQD 71% to 57% Fair Quality

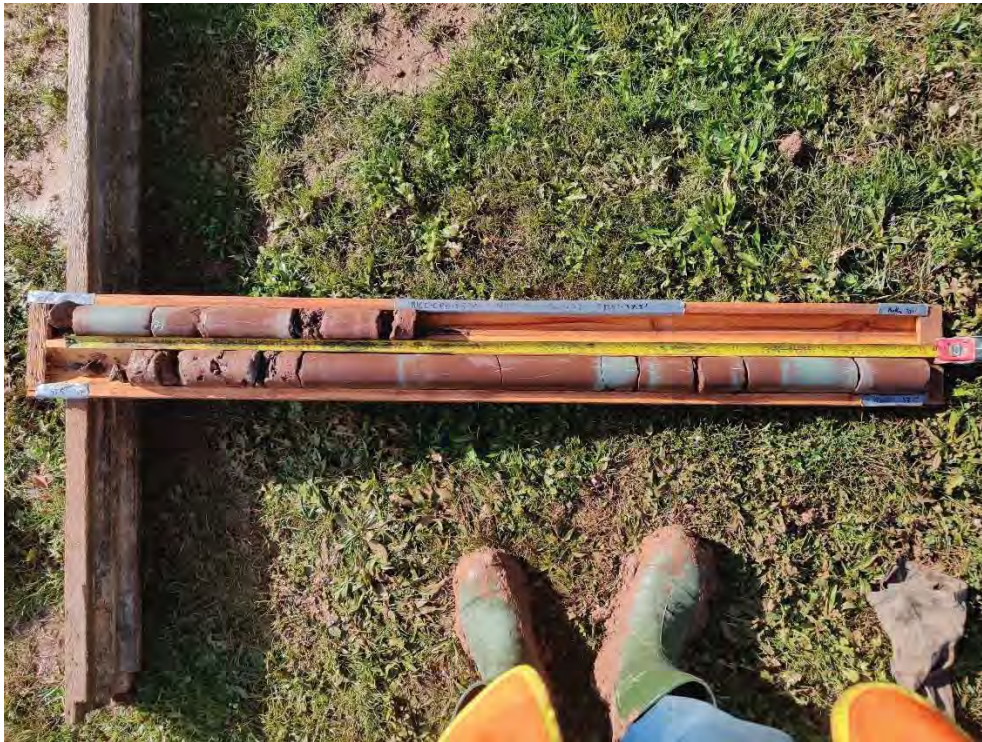
BH209 Rock Core Run 1 & Run 2 (30.5' to 37.5') / RQD 46% to 59% Poor to Fair Quality

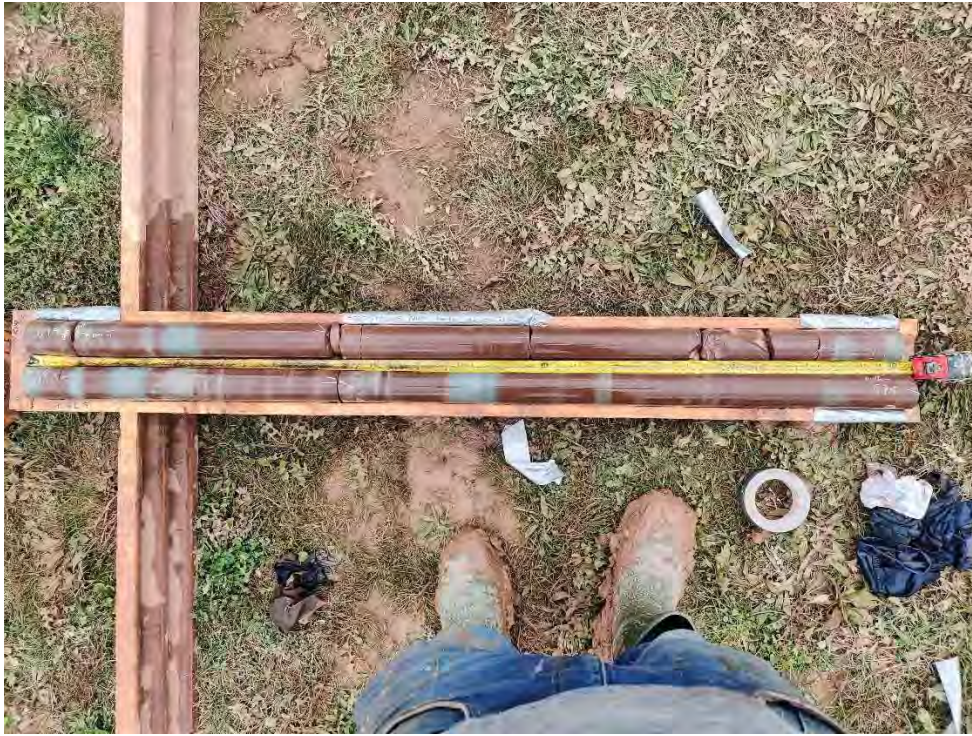
BH209 Rock Core Run 5 & Run 6 (47.5' to 57.5') / RQD 91% to 97% Excellent Quality

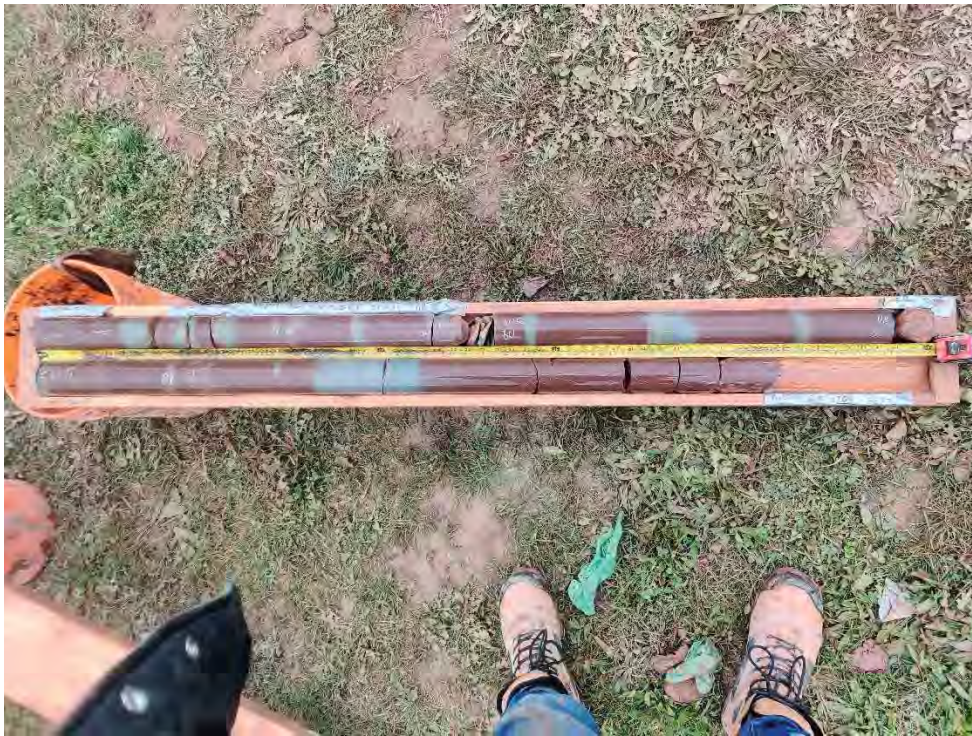
BH209 Rock Core Run 7 & Run 8 (57.5' to 66.6') / RQD 86% to 88% Good Quality
