**GEOTECHNICAL SLOPE STABILITY
AND STREAMBANK EROSION STUDY
LONG TERM STABLE SLOPE CREST UPDATE
1300 BRONTE ROAD
OAKVILLE, ONTARIO**

Prepared for: Bronte River LP
c/o Argo Development Corporation
4900 Palladium Way, Unit 105
Burlington, Ontario
L7M 0W7

File No. 1-16-0035-02
December 21, 2021
© **Terraprobe Inc.**

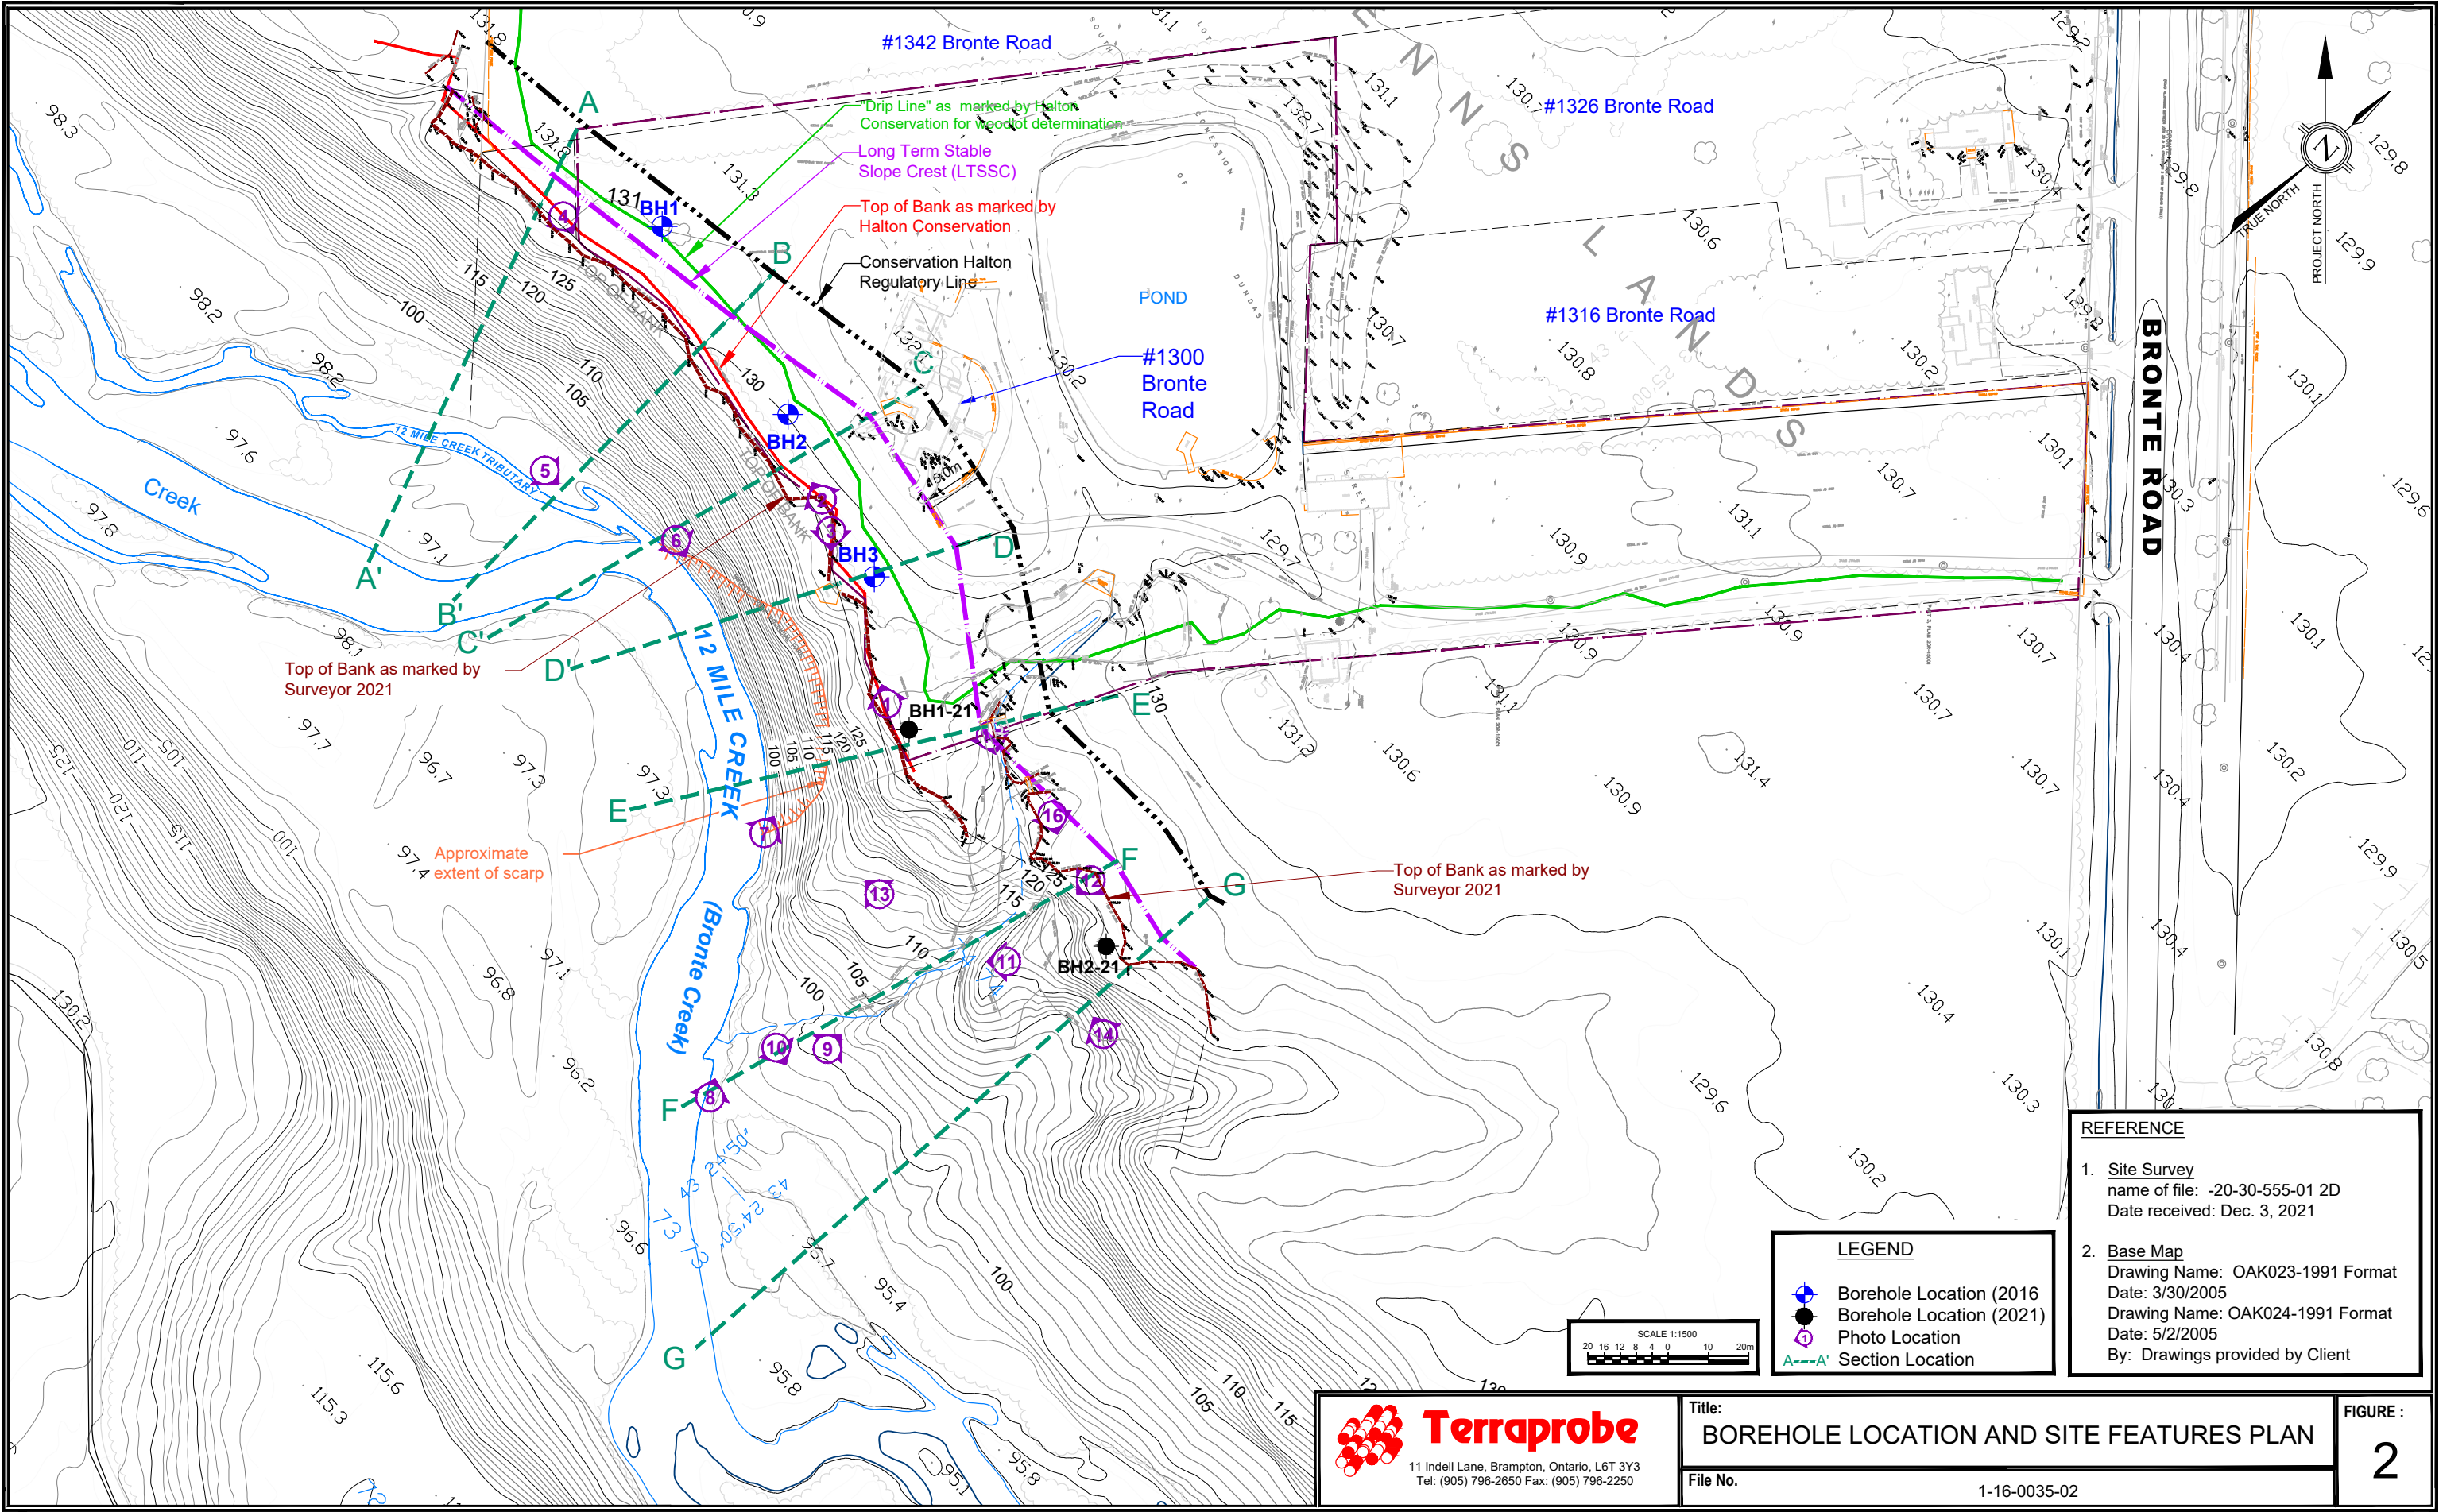
FIGURE :
2

sufficient coverage of the subject slope. These sections extended through the tableland, across the slope surface extending down to the Bronte Creek floodplain and to the watercourse. The locations of the slope cross-sections are presented on Figure 2 (in plan), and the details of the slope profiles along with the floodplain (where applicable) and watercourse, are presented on Figures 3A to 3C.

The location of the Long-Term Stable Slope Crest was determined in accordance with the Long-Term Stable Slope Crest model (see enclosed) and is presented on Figure 2 (in plan) and Figures 3A to 3D (in section) extending the existing LTSSC from the 2016 report to cover the full site. For planning purposes, the long-term refers to a 100 year planning horizon.

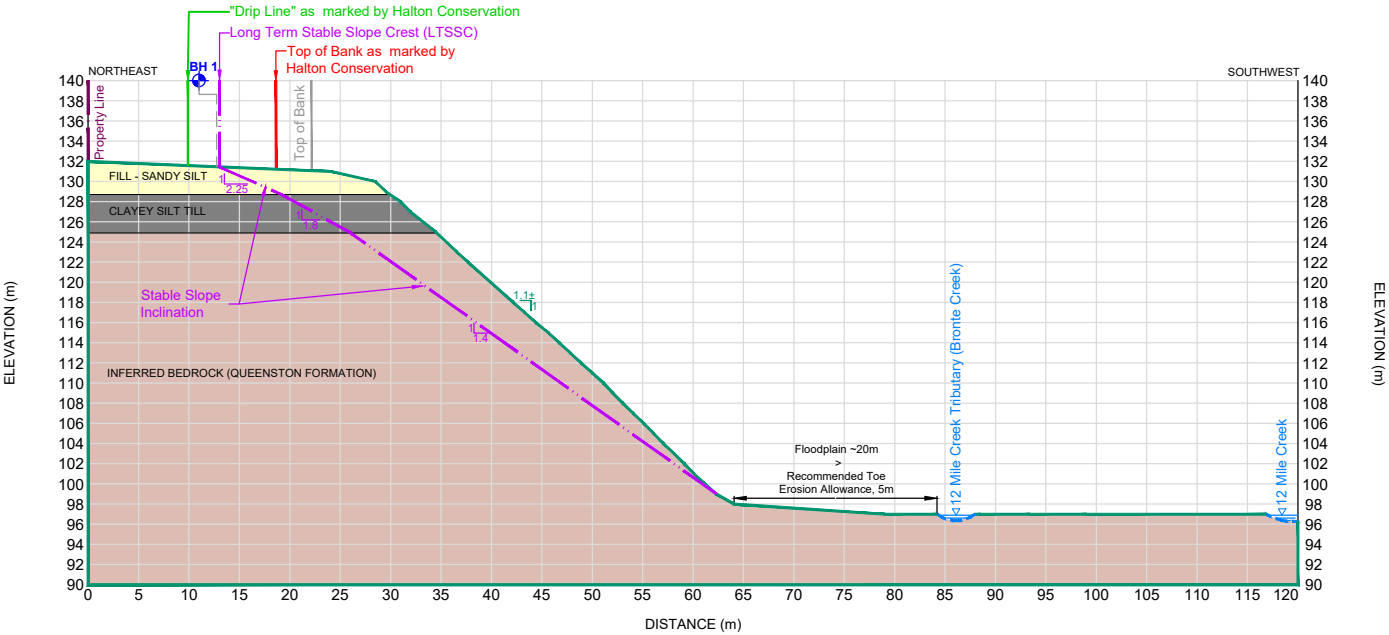
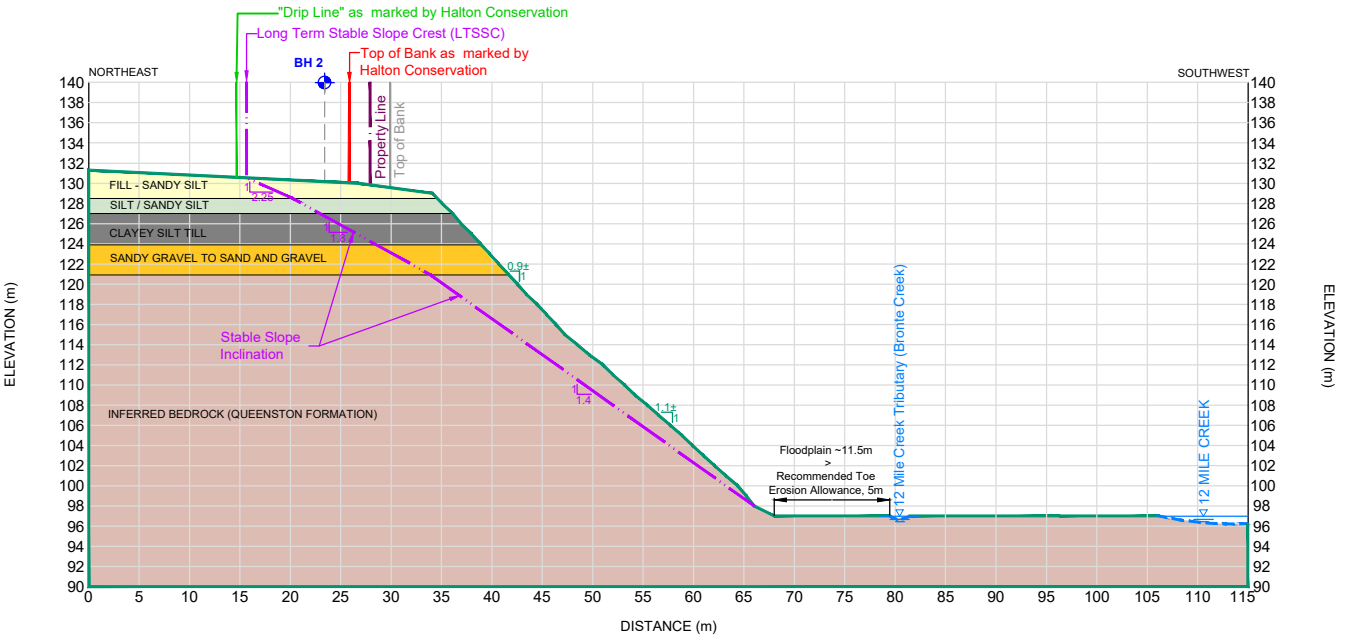
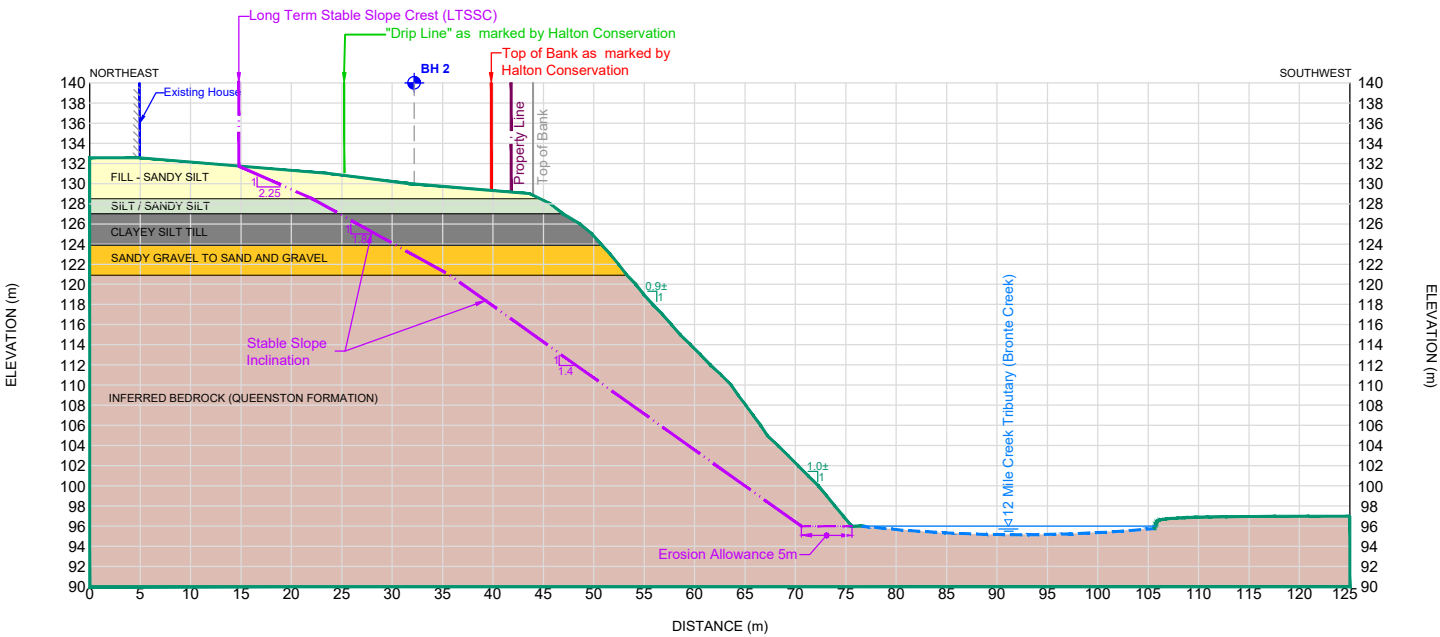
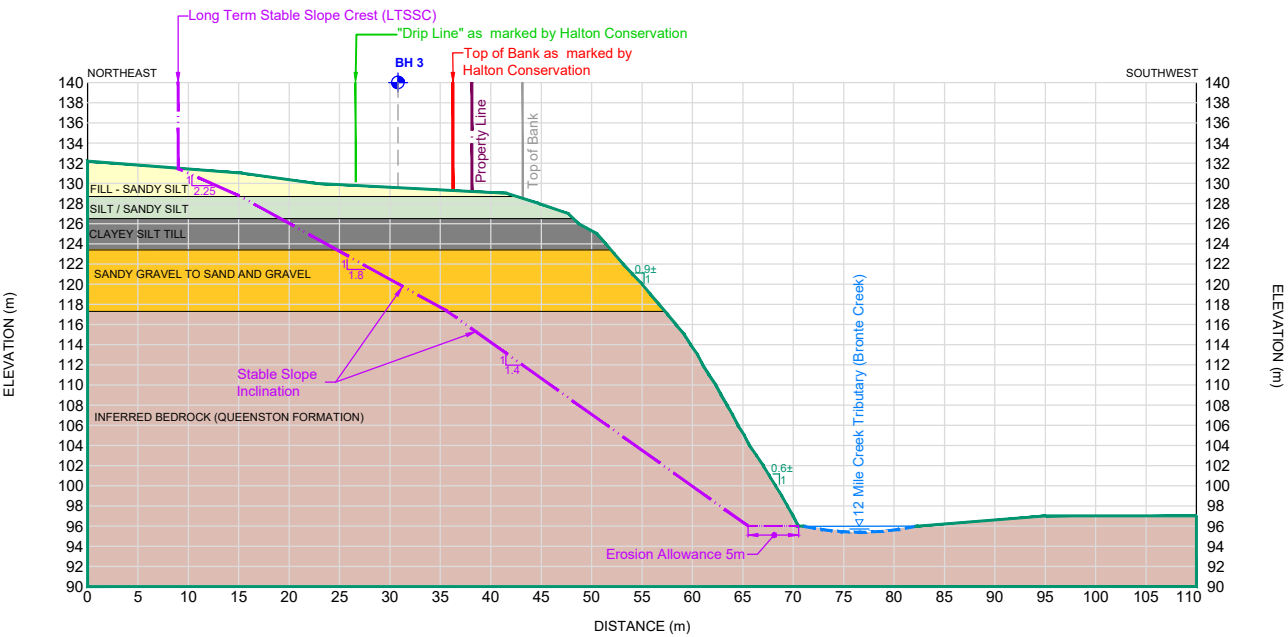
Title: SLOPE CROSS SECTIONS		FIGURE : 3A
File No.	1-16-0035-02

Therefore, the long-term stable slope crest location at this site can be determined by applying a toe erosion setback of 5 m at the slope toe (as applicable), and extending a stability setback line from the toe erosion setback drawn at 1.4 horiz. to 1 vert. inclination through the shale (where applicable), at 1.8 horiz. to 1 vert. inclination through the native overburden portion of the slope. The location of the estimated Long-term Stable Slope crest is shown on Figure 2 in plan, and Figures 3A to 3C in sections, respectively. For planning purposes the long-term refers to a 100 year planning horizon.

As noted before, the slope is relatively steep (about 0.6 to 2.1 horiz. to 1 vert). Therefore, a stability setback of 1.4 horiz. to 1 vert. is recommended for the slope portion comprising shale and 1.8 horiz. to 1 vert. for the native soil overburden at this site. The slope toe within the study area, consists of shale and evident of active toe erosion was noted at the slope toe within the central portion of the slope as the watercourse is located at the slope toe in this area. Conservatively a toe erosion setback (Erosion Component) of 5 m is recommended for the site slope.

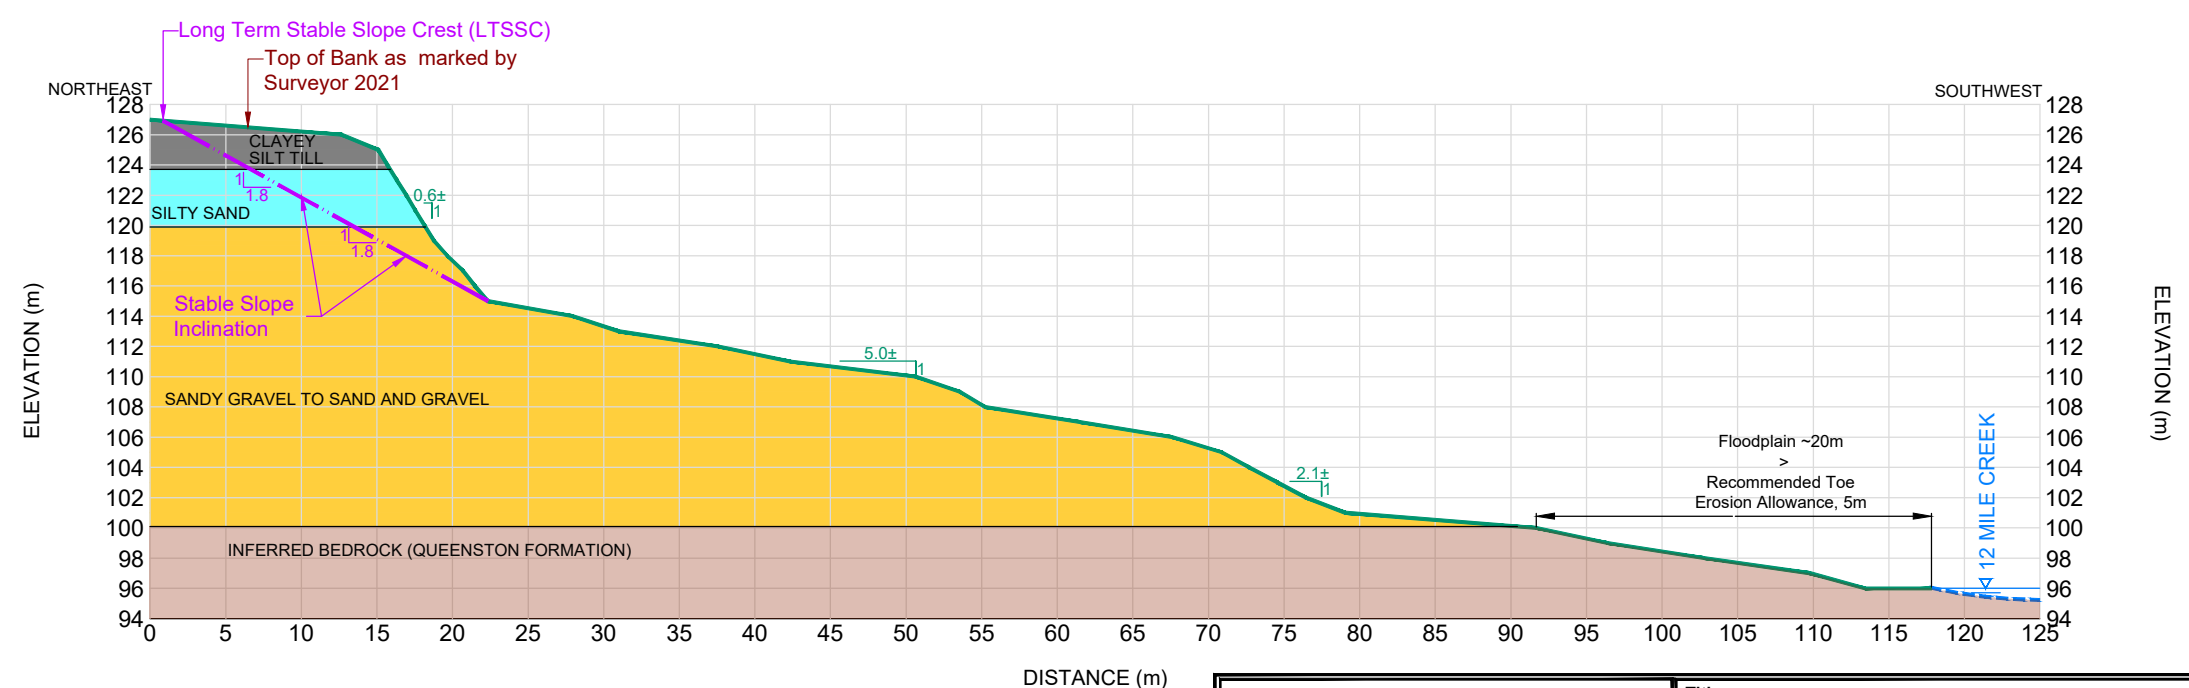
FIGURE :
3B

At this site the slope toe consists of shale bedrock. At the southerly portion of the site (Sections F-F' and G-G') of the slope toe is separated by a vegetated floodplain of about 20 to 50 m wide and there was no obvious evidence of active slope toe erosion in this area. However, at the central portion of the slope (Section E-E'), the creek is in direct contact with the valley wall resulting in active slope toe erosion. The MNR Guidelines require a toe erosion allowance of 2 to 5 m for a slope toe comprising shale for an active erosion condition.
