APPENDIX A

NASSCO PACP Condition Grading System Code Matrix

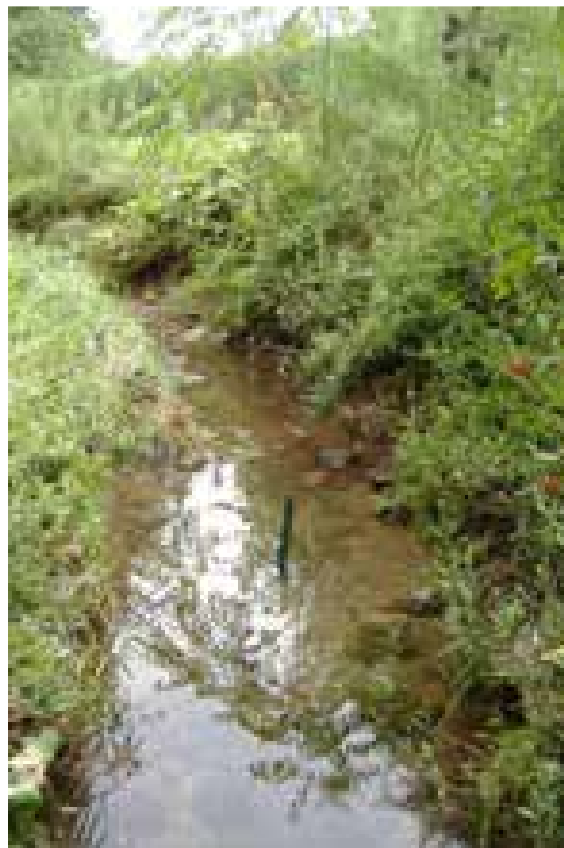
Yolanda Drive Monitoring Site looking downstream – September 6, 2011

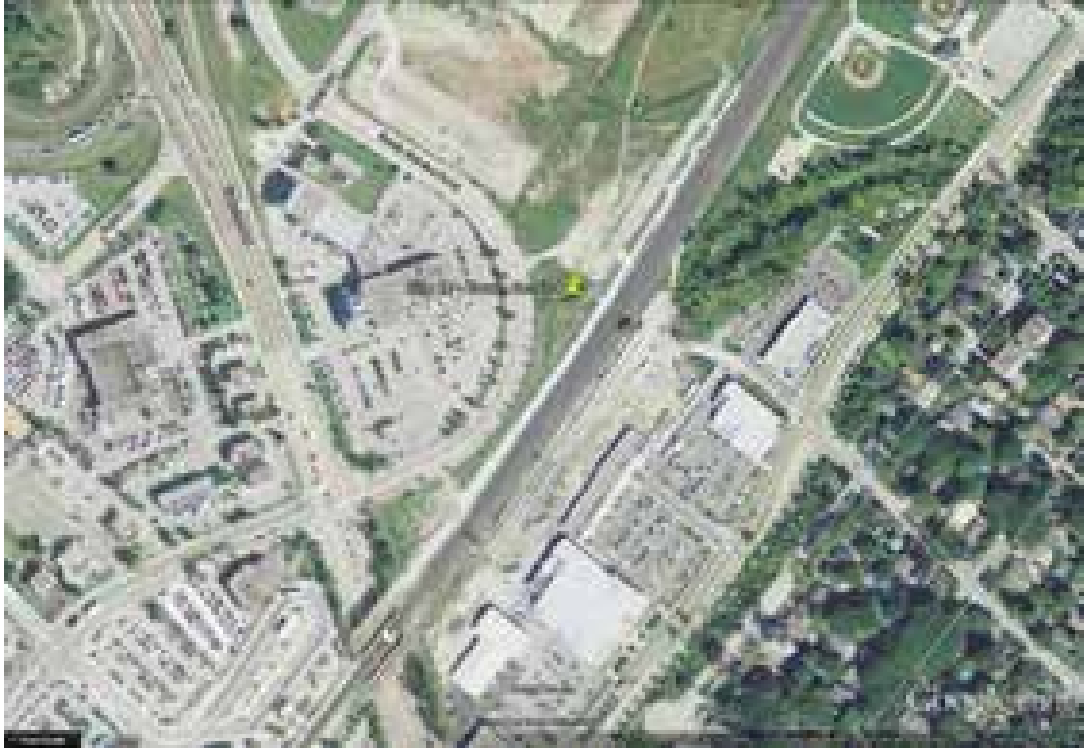
Round 1 Monitoring Site – South Service Road

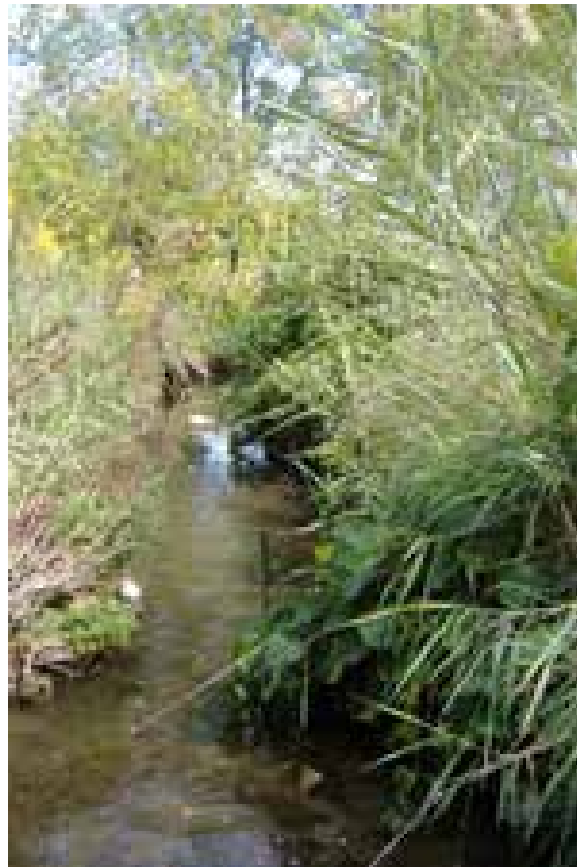
South Service Road Monitoring Site looking downstream – September 6, 2011

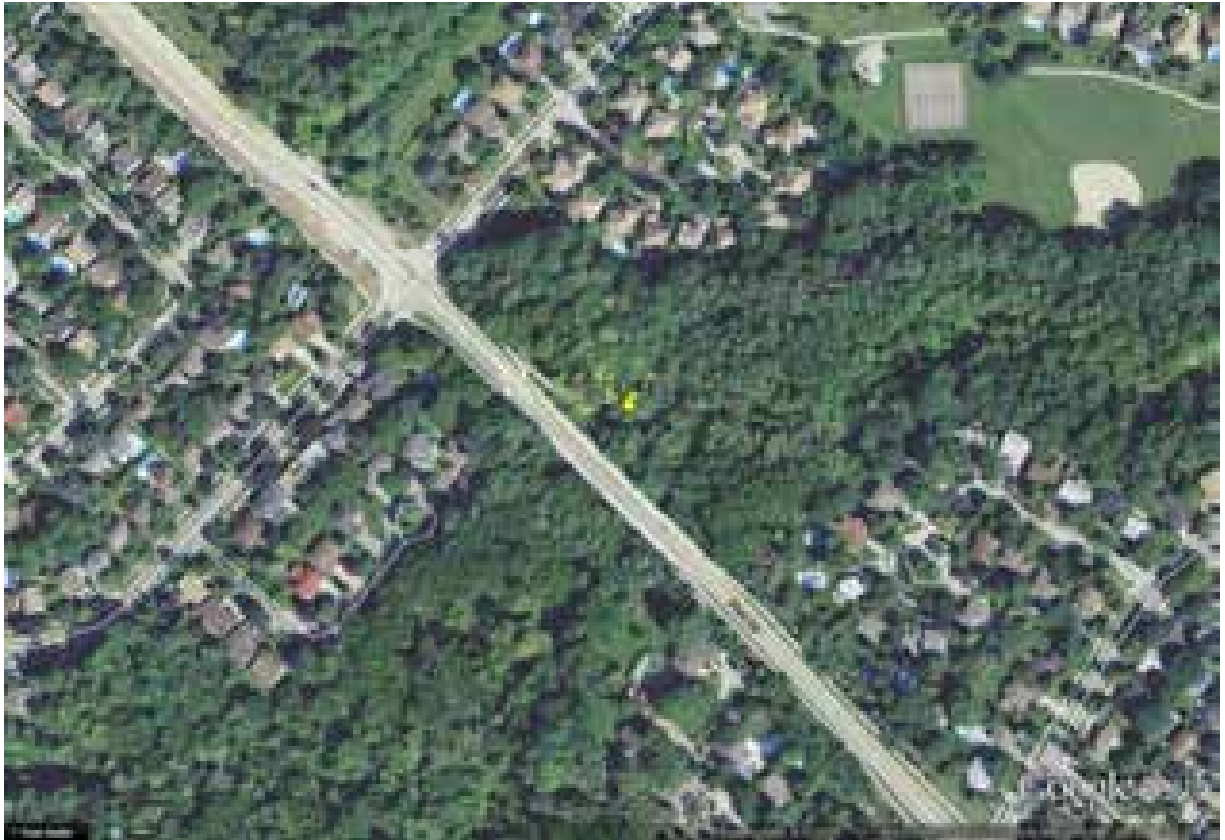
Round 1 Monitoring Site – Ford Drive

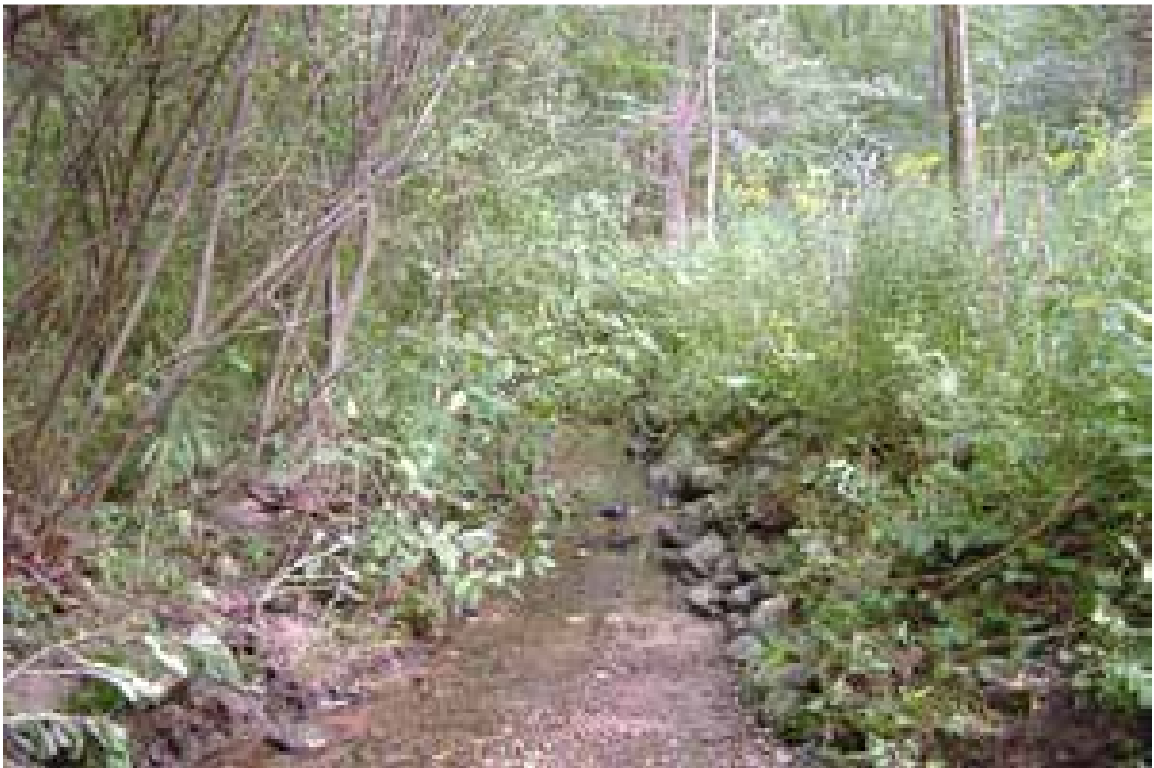
Ford Drive Monitoring Site looking downstream – September 6, 2011

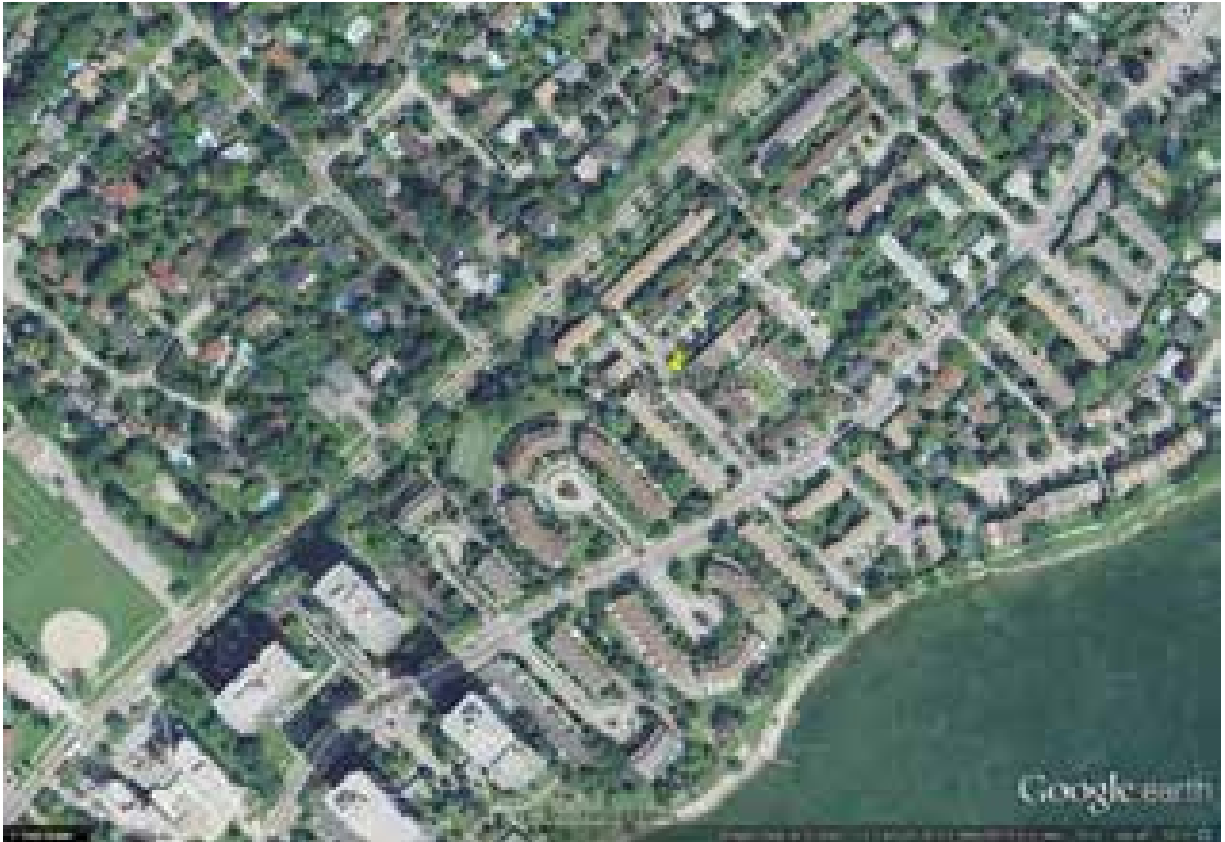
Round 2 Monitoring Site – Sarah Lane

| Round | Period | Site ID | Site Description | Type | UTM X | UTM Y |
|---|---|---|---|---|---|---|
| | Oct-Dec 2012 | 47B | Arbour Drive | Storm Sewer | 610257 | 4814297 |

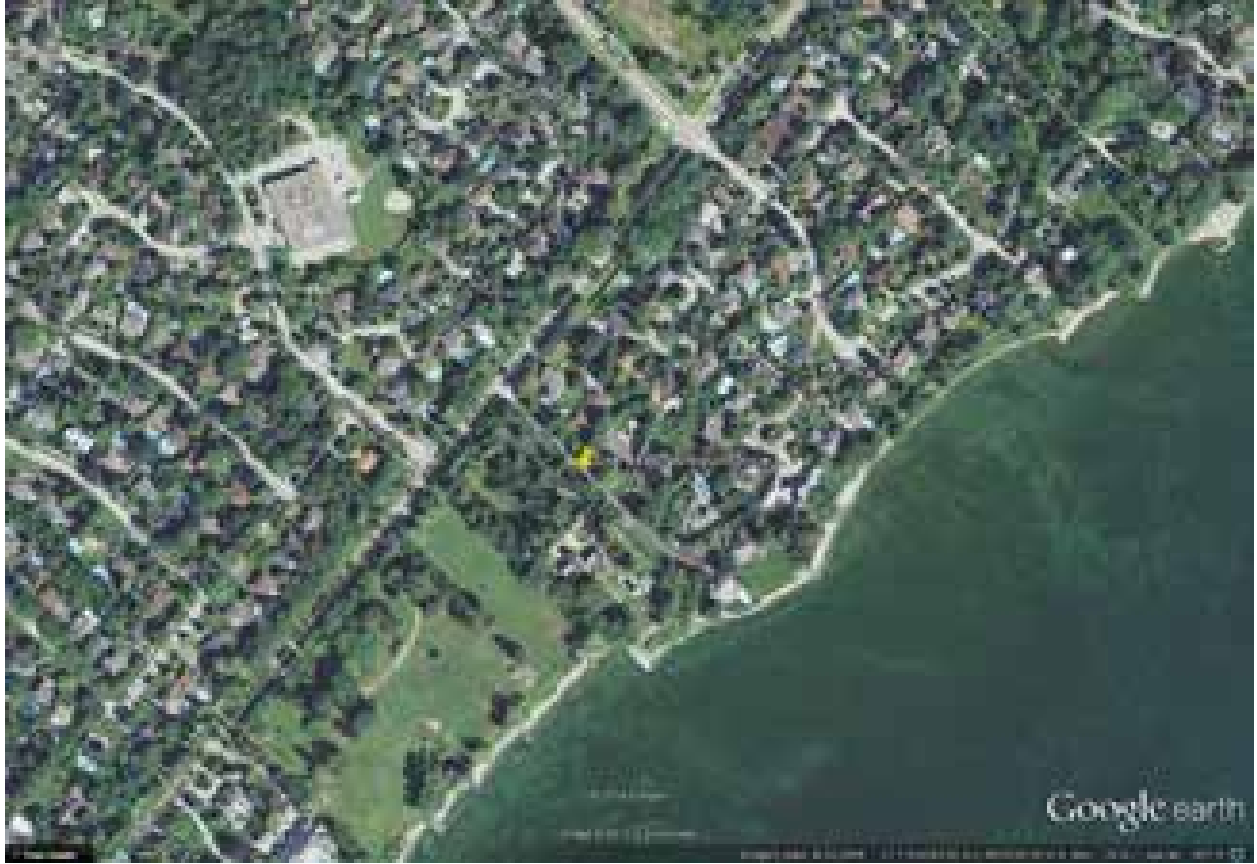
Round 2 Monitoring Site – Arbour Drive
