# URBANTECH®

## Memorandum

**Re:** **Bio-Filtration Facility and Ravine System Operations and Maintenance**  
**Bronte River Subdivision**  
**Town of Oakville, Halton Region**

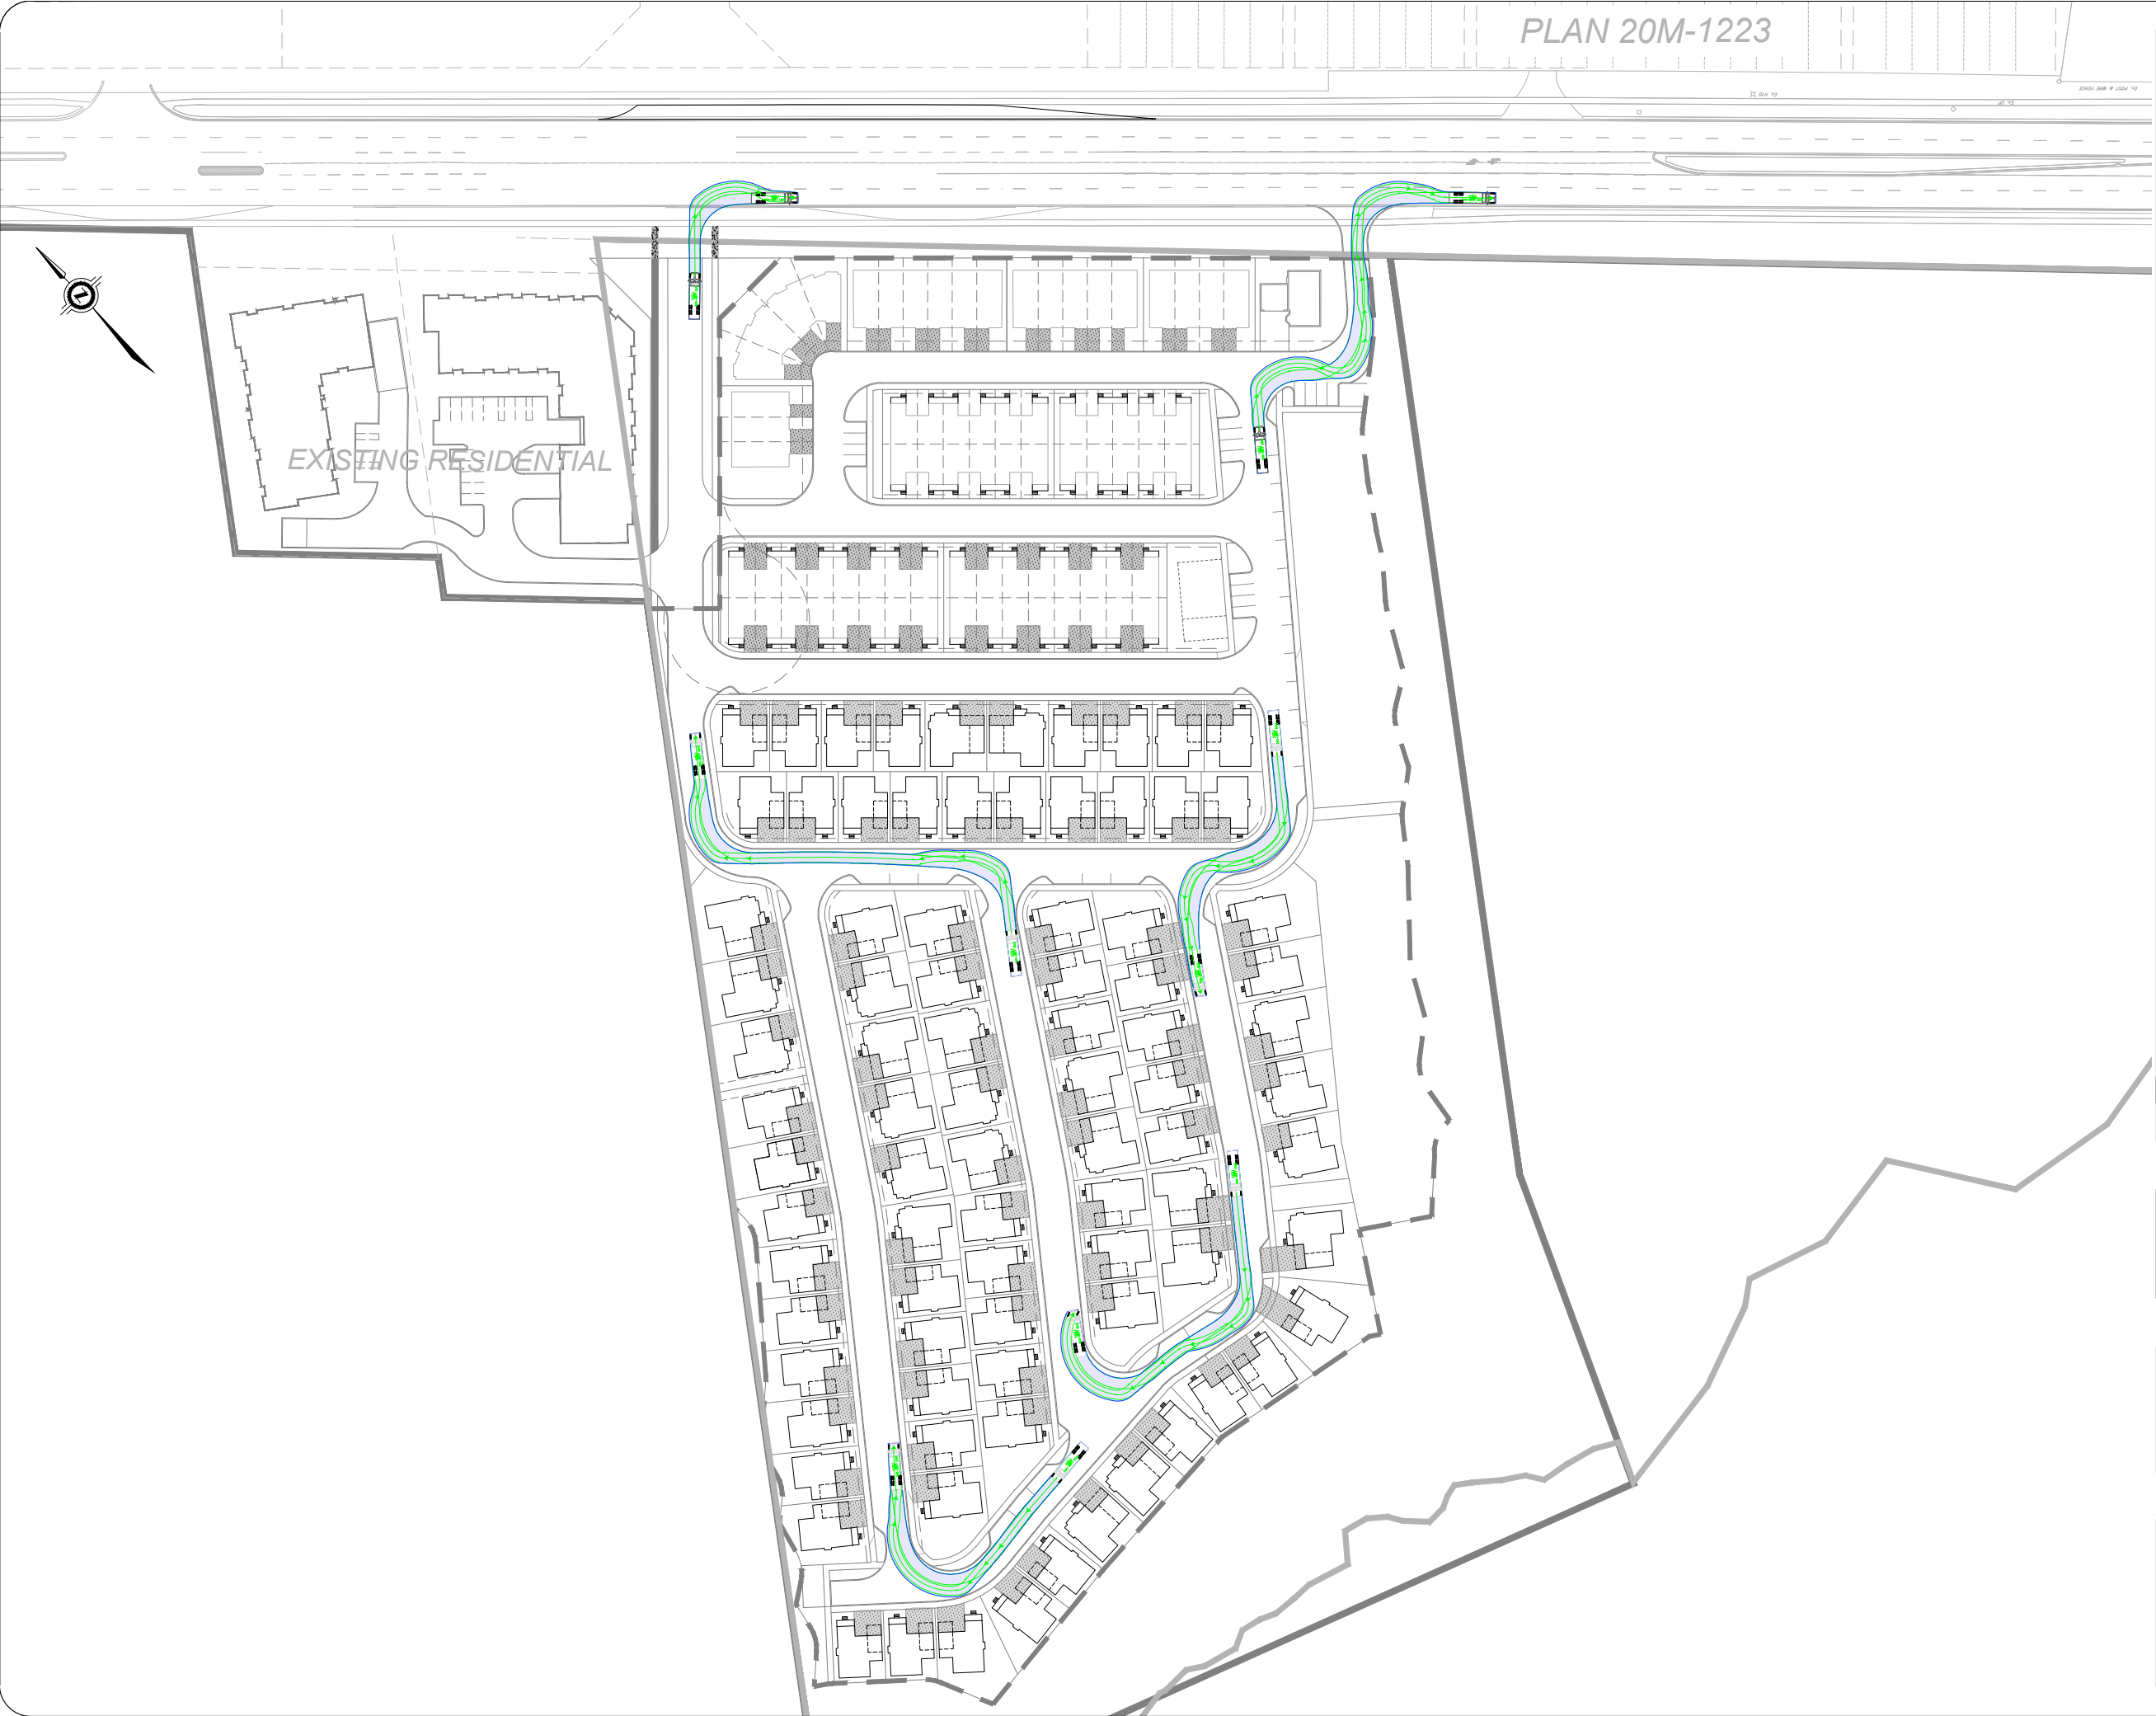
| PROJECT NO:<br>2023-101 | DRAWING NO:<br>003 | REVISION:<br>01 | |

| HSU | |
| Width | : 2.60 |
| Track | : 2.60 |
| Lock to Lock Time | : 6.0 |
| Steering Angle | : 40.0 |

adequate for truck turning movements. Refer to attached Turning Movement Analysis figures for further details.
