Appendix K

Remnant Channel
Alternative Assessment

OAKVILLE STORM SEWER MASTER PLAN PHASE II TOWN OF OAKVILLE

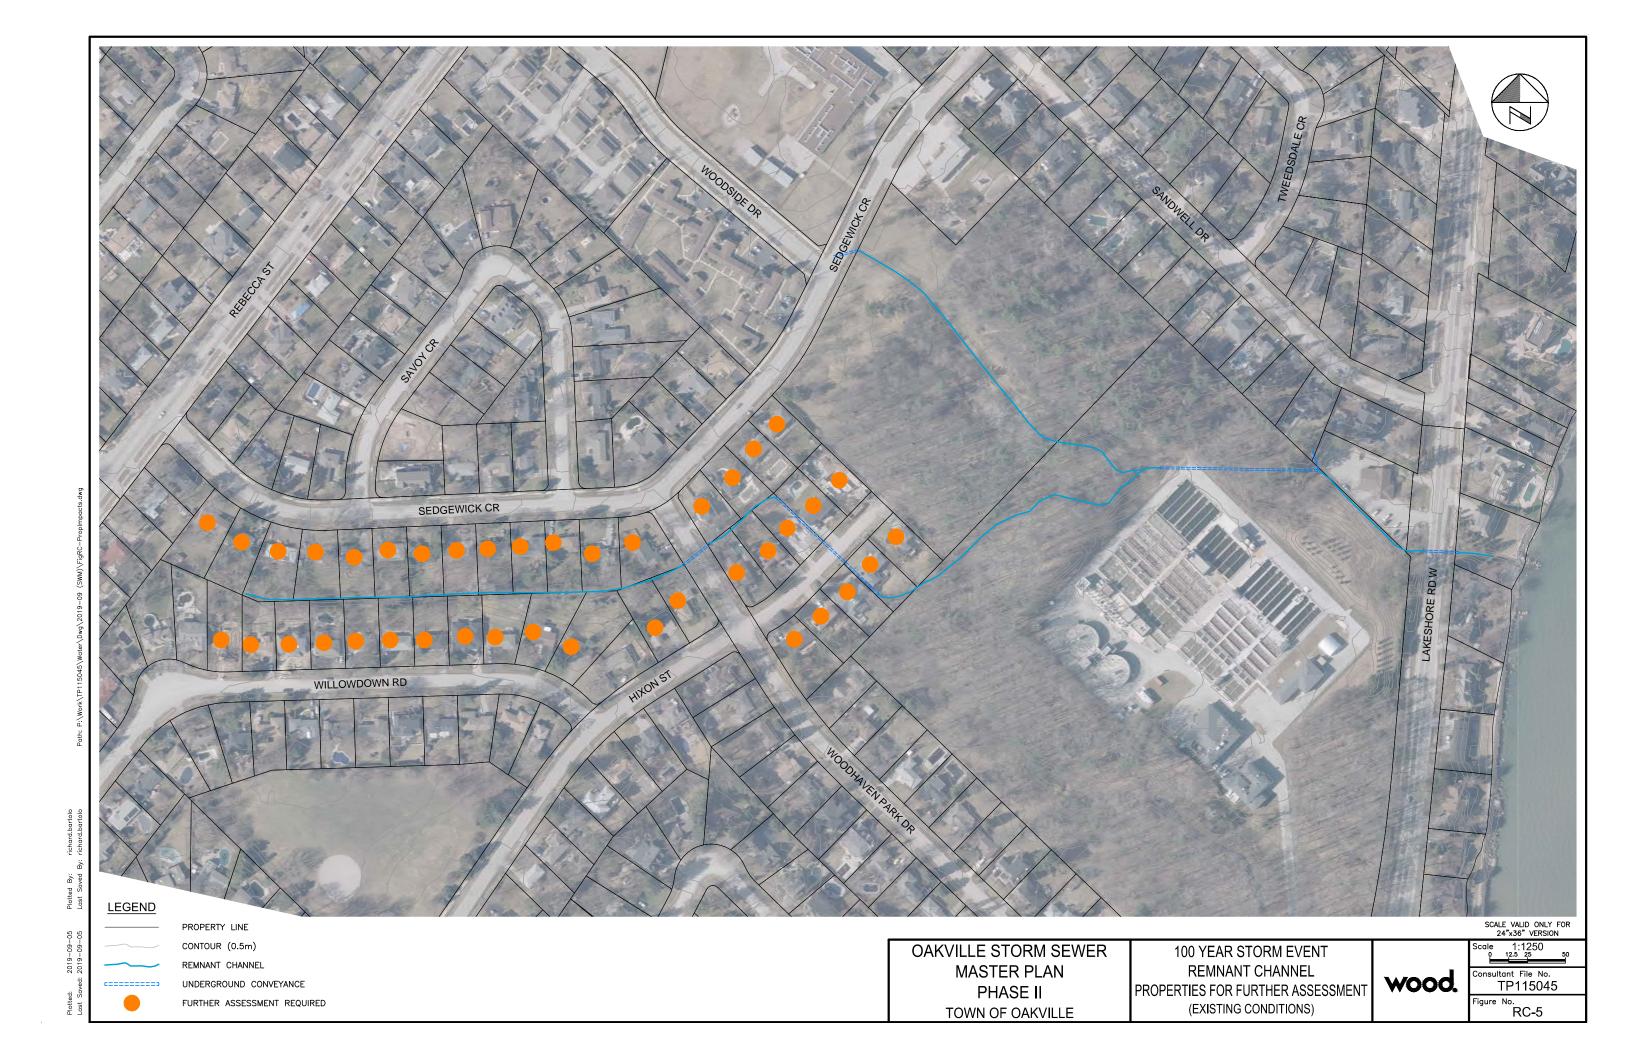
CONTOUR (0.5m)

REMNANT CHANNEL UNDERGROUND CONVEYANCE

FURTHER ASSESSMENT REQUIRED

100 YEAR STORM EVENT REMNANT CHANNEL PROPERTIES FOR FURTHER ASSESSMENT (EXISTING CONDITIONS)

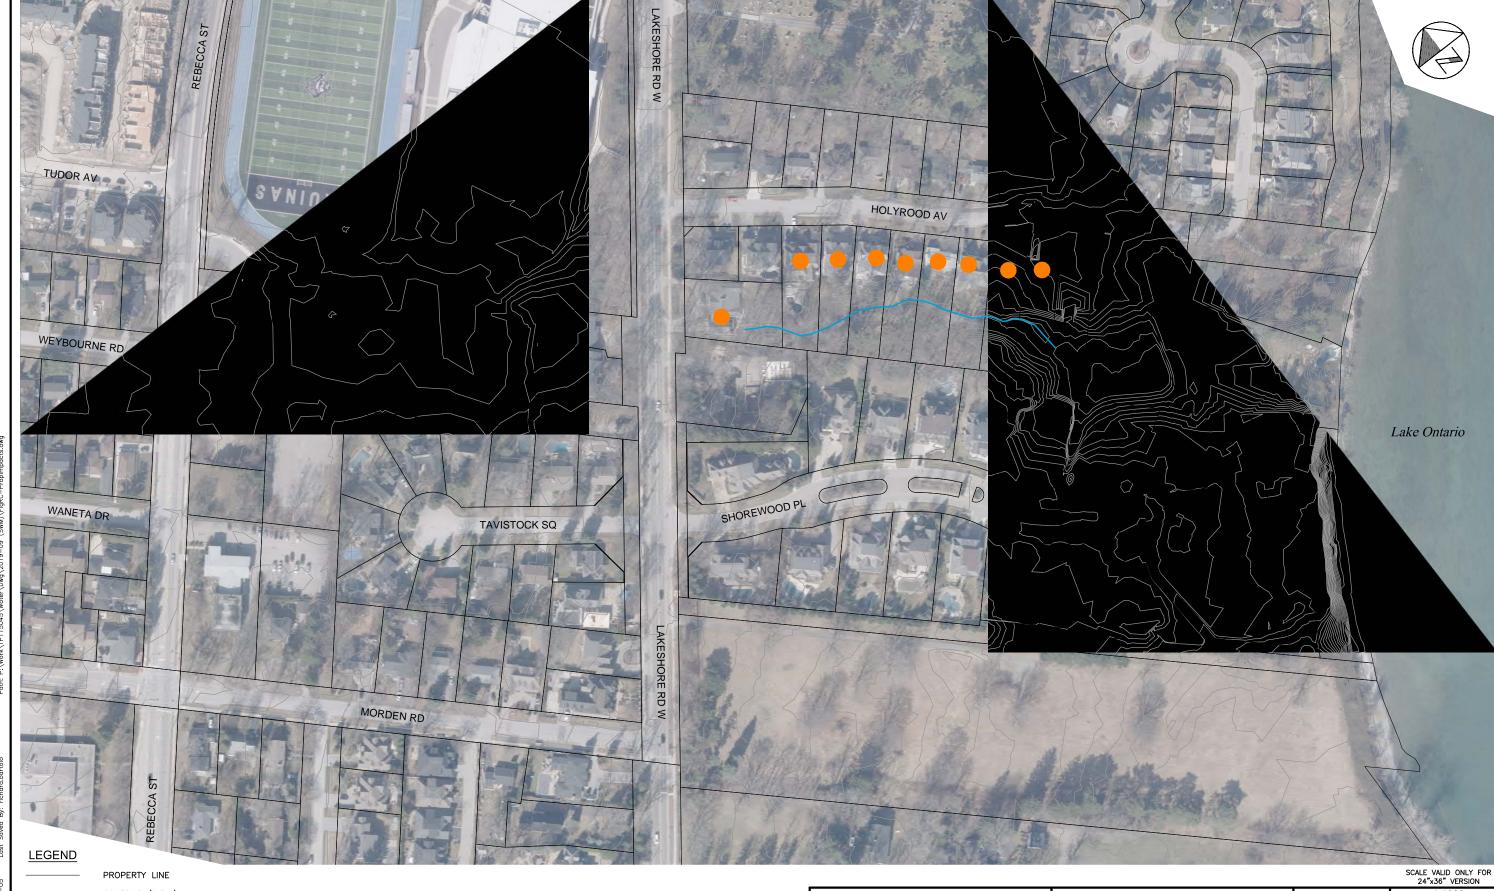
CONTOUR (0.5m) REMNANT CHANNEL

UNDERGROUND CONVEYANCE

FURTHER ASSESSMENT REQUIRED

100 YEAR STORM EVENT REMNANT CHANNEL PROPERTIES FOR FURTHER ASSESSMENT (EXISTING CONDITIONS)

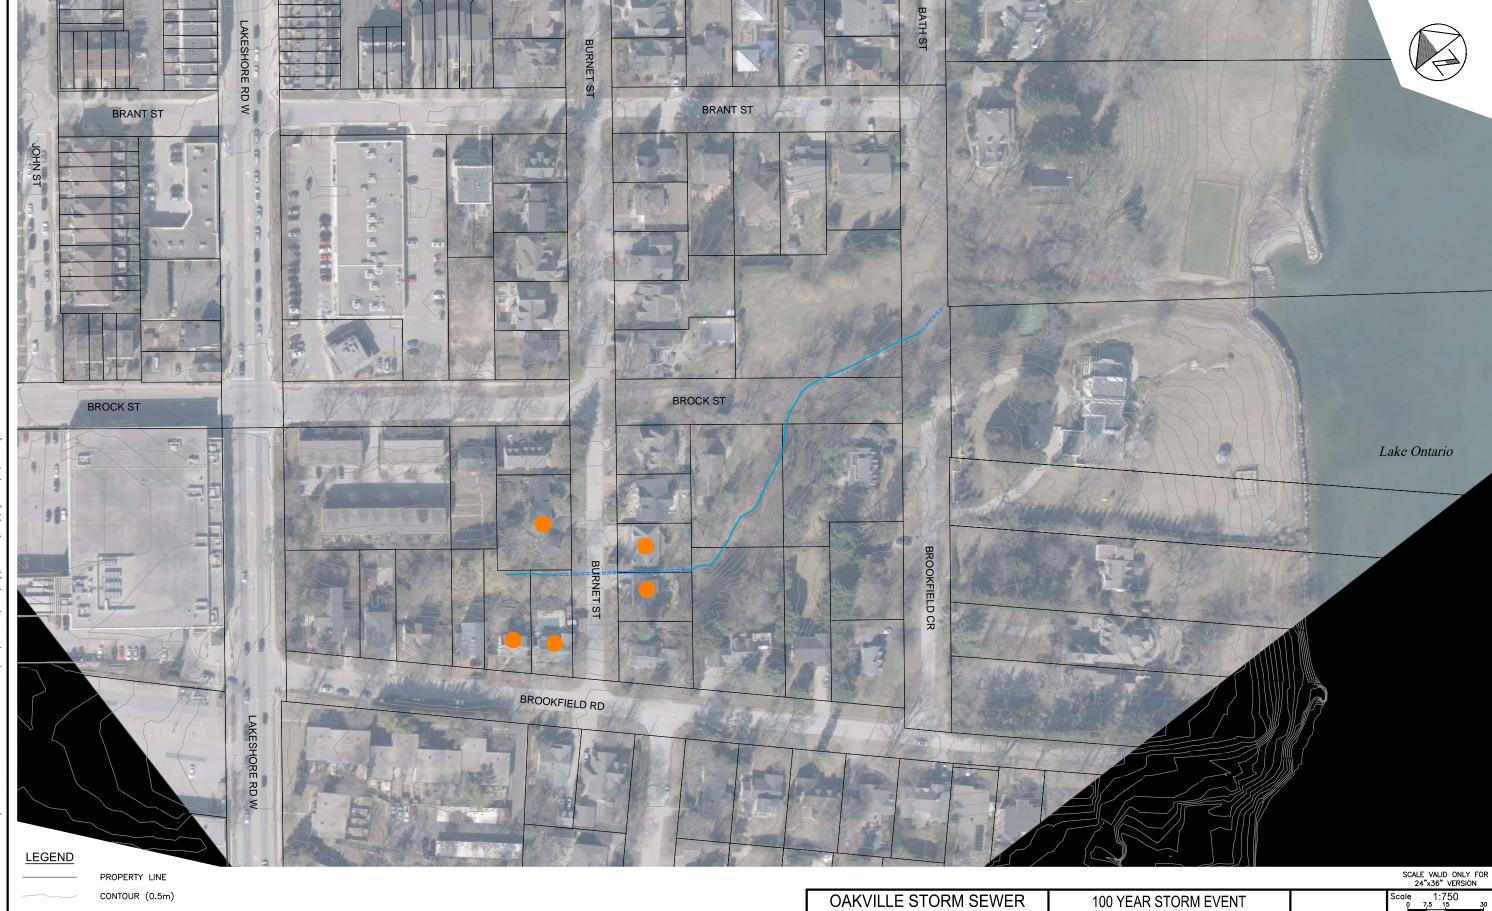
REMNANT CHANNEL

UNDERGROUND CONVEYANCE

FURTHER ASSESSMENT REQUIRED

REMNANT CHANNEL PROPERTIES FOR FURTHER ASSESSMENT (EXISTING CONDITIONS)

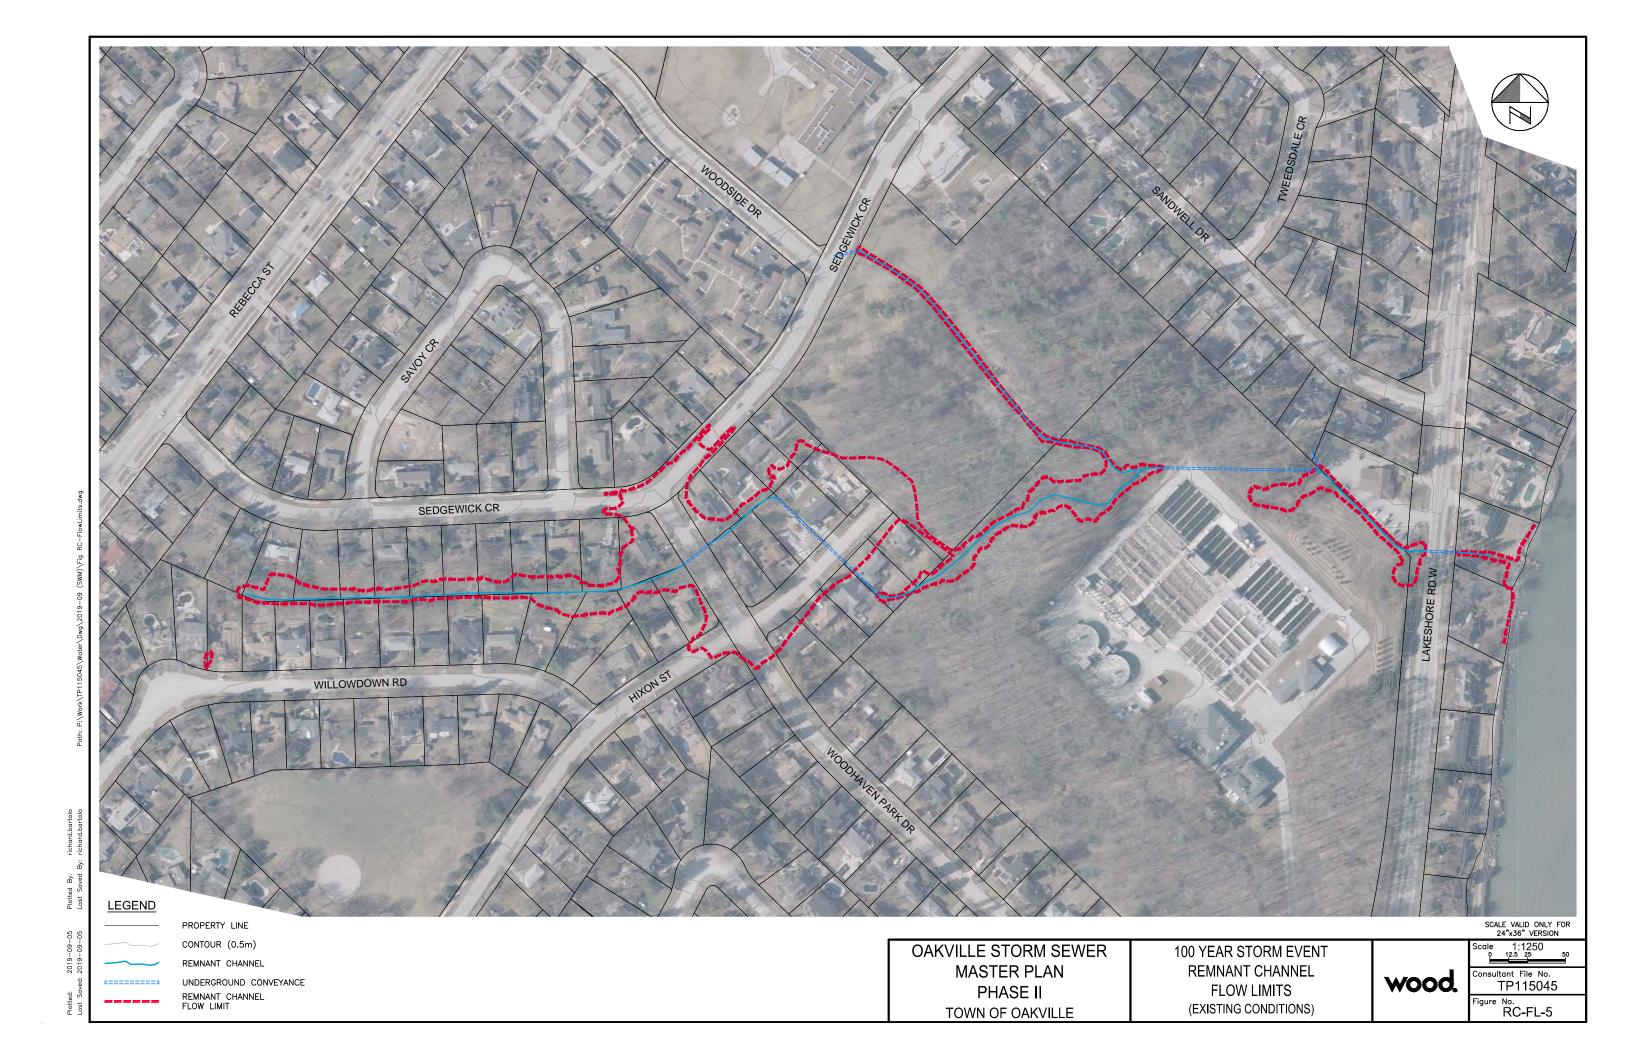
CONTOUR (0.5m)

REMNANT CHANNEL

UNDERGROUND CONVEYANCE REMNANT CHANNEL FLOW LIMIT

100 YEAR STORM EVENT REMNANT CHANNEL FLOW LIMITS (EXISTING CONDITIONS)

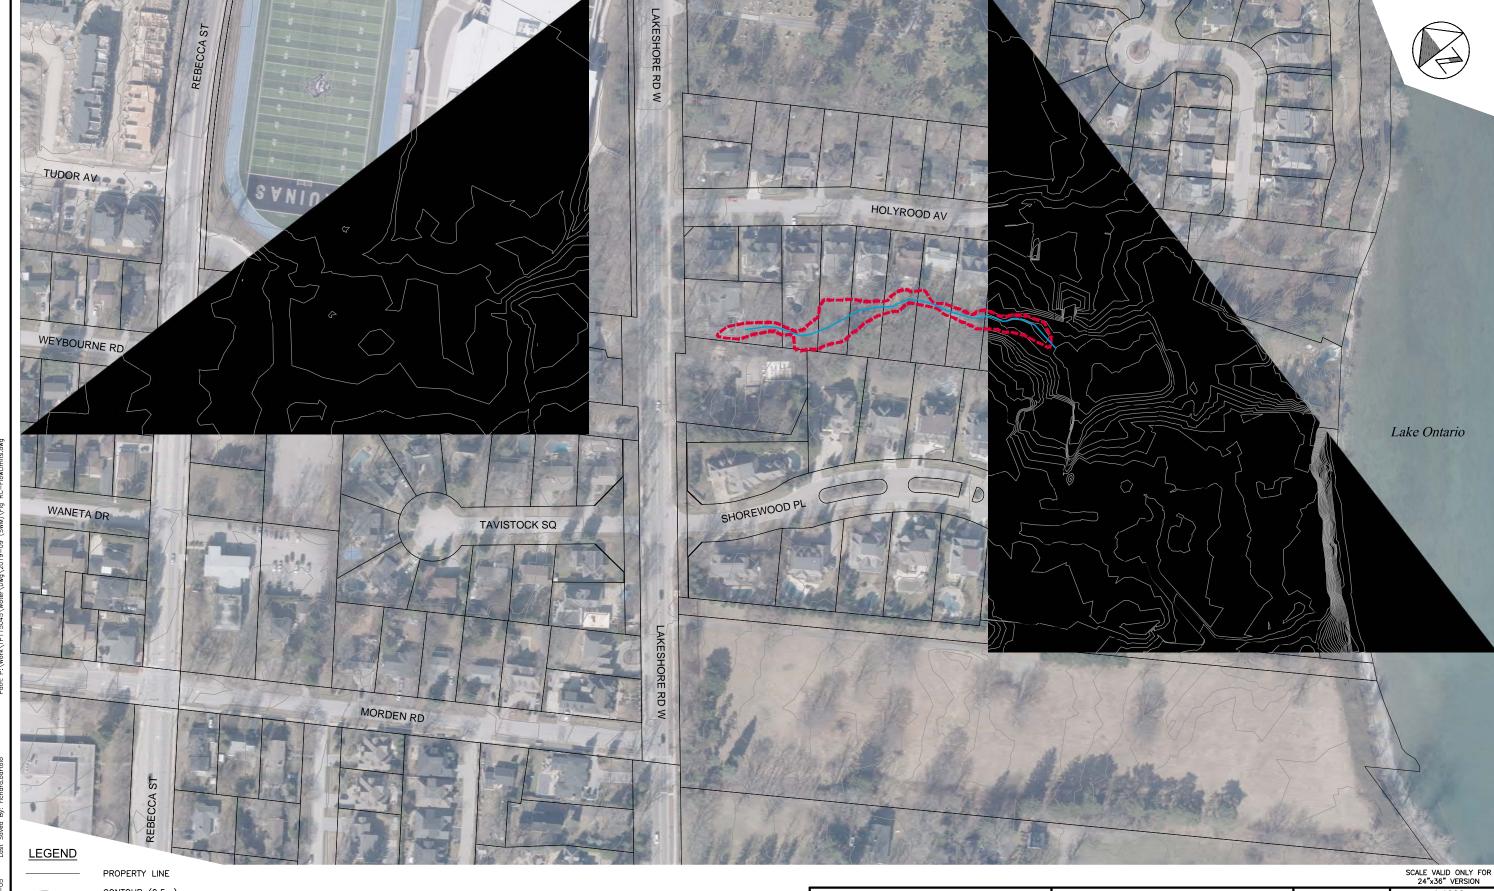
CONTOUR (0.5m) REMNANT CHANNEL

> UNDERGROUND CONVEYANCE REMNANT CHANNEL FLOW LIMIT

100 YEAR STORM EVENT REMNANT CHANNEL FLOW LIMITS (EXISTING CONDITIONS)

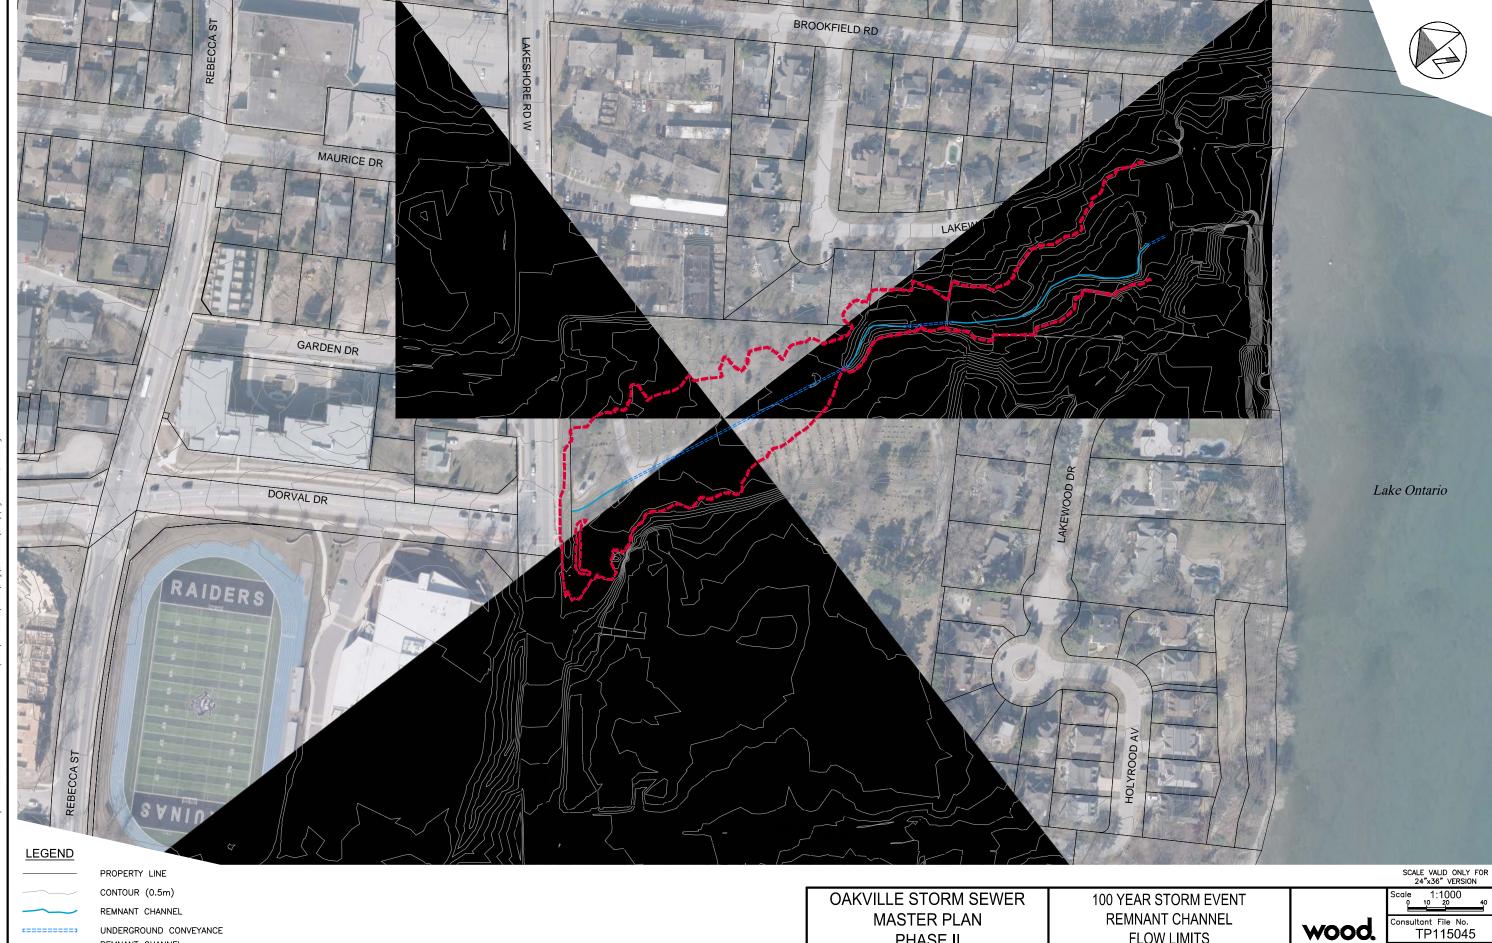
Figure No. RC-FL-8

FLOW LIMITS

(EXISTING CONDITIONS)

UNDERGROUND CONVEYANCE

REMNANT CHANNEL FLOW LIMIT

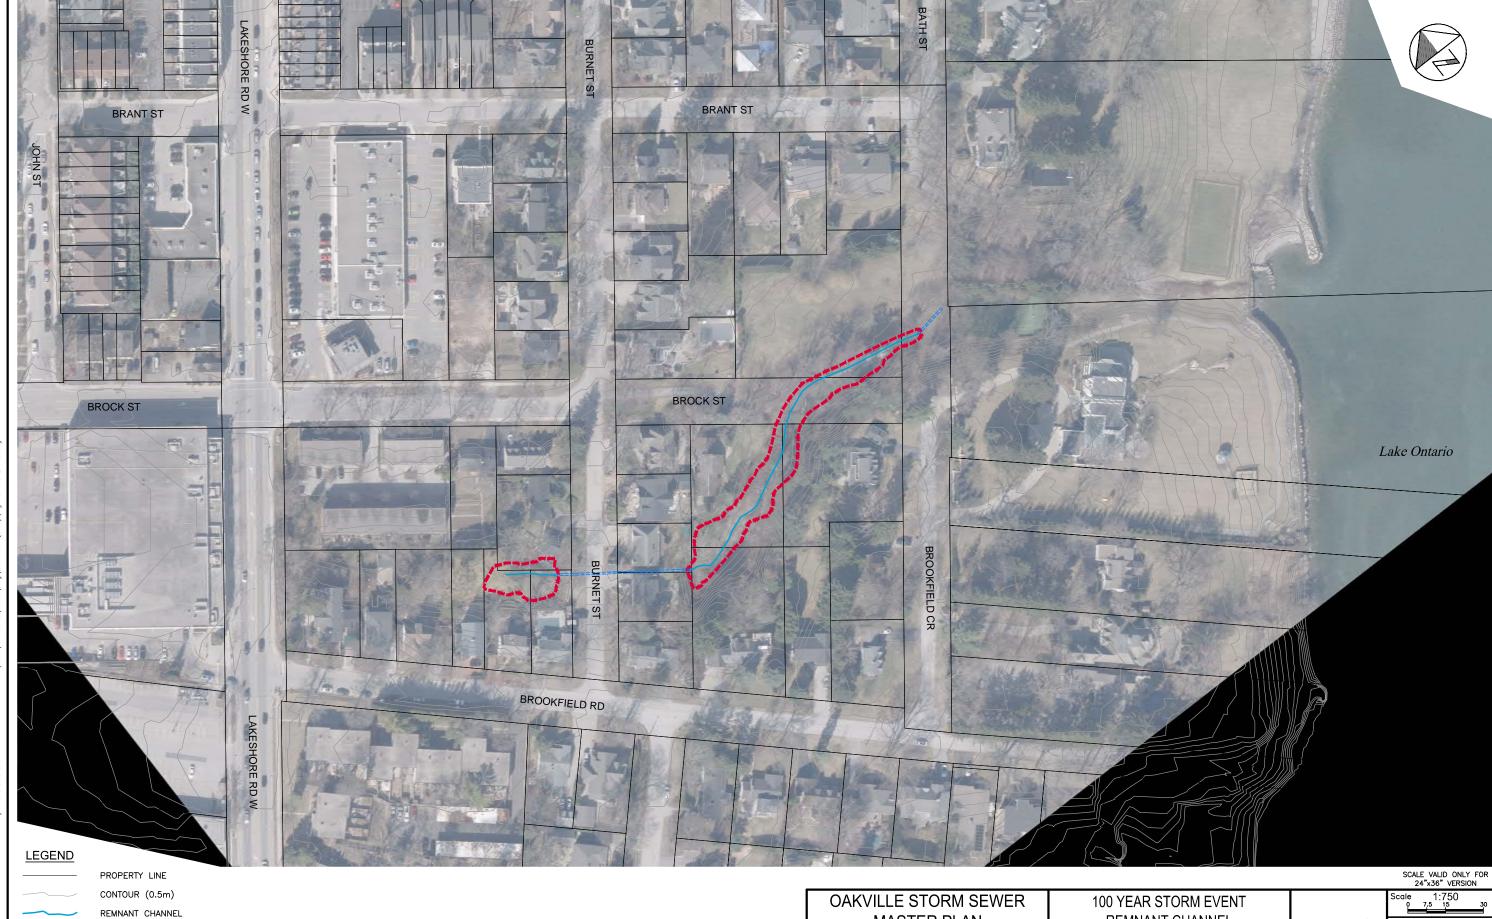
UNDERGROUND CONVEYANCE REMNANT CHANNEL FLOW LIMIT

MASTER PLAN PHASE II TOWN OF OAKVILLE REMNANT CHANNEL FLOW LIMITS (EXISTING CONDITIONS)
