Hydrologic Modelling and Subcatchment Parameterization

PROJECT NAME: FOURTEEN HILE CREEK / McCRANEY CREEK WATERSHED PLANNING STUDY

WATERSHED MODELLING SCHEMATIC

Subject: May 12/13, 2000 Storm Events- General Flooding and Damages

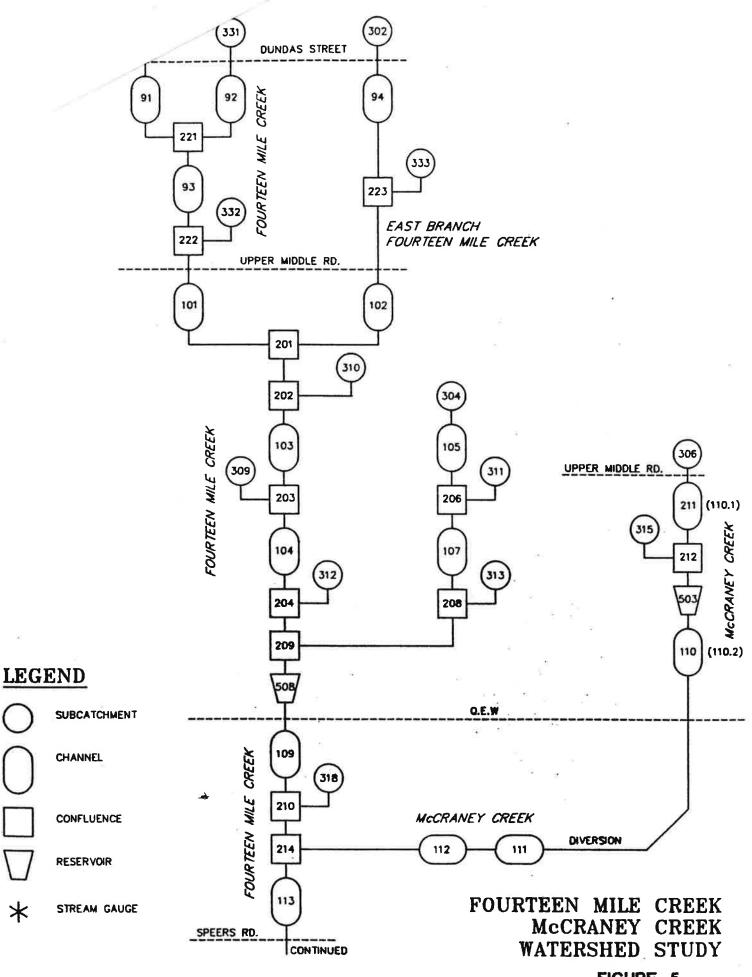
FIGURE: 5

FOURTEEN MILE CREEK
McCRANEY CREEK
WATERSHED STUDY

WATERSHED MODELLING SCHEMATIC

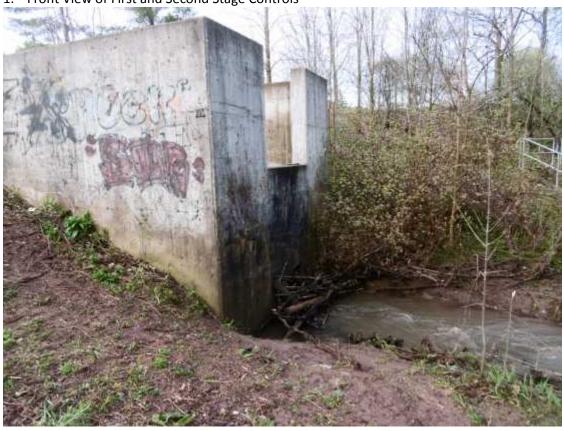
Abbeywood Drive Structure

1. Front View of First and Second Stage Controls

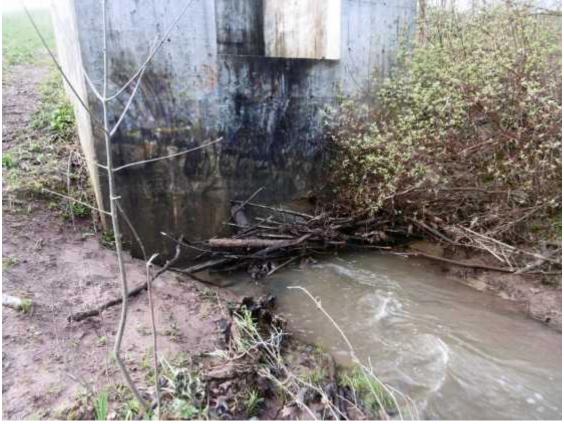
2. Front View of First & Second Stage Controls

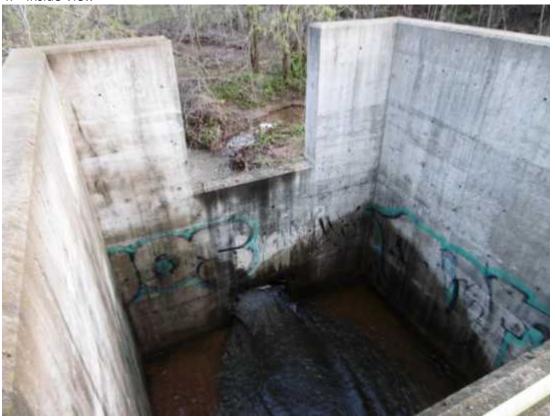
Inside View

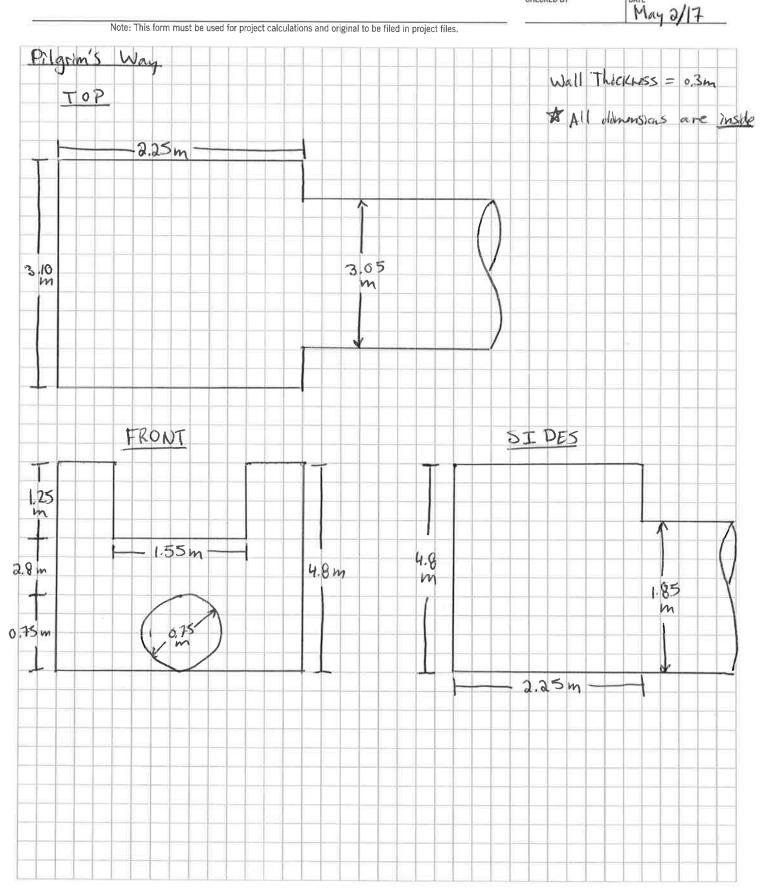
CLIENT Town of Oakville	foster wheeler		
PROJECT 14 Mile / McCraney	TP11163	PAGE	
SUBJECT In-line Structures - Field Measurements	PREPARED BY	FILE NO.	
Session of the street of the transportation	CHECKED BY	DATE

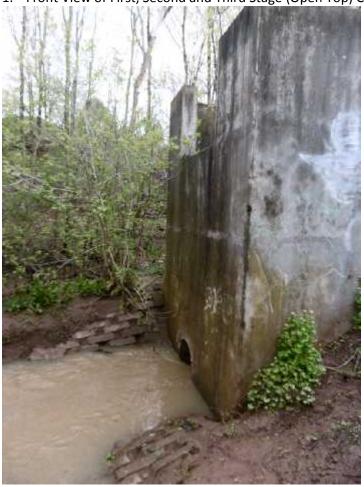
Pilgrims Way Structure

1. Front View of First, Second and Third Stage (Open Top) Controls

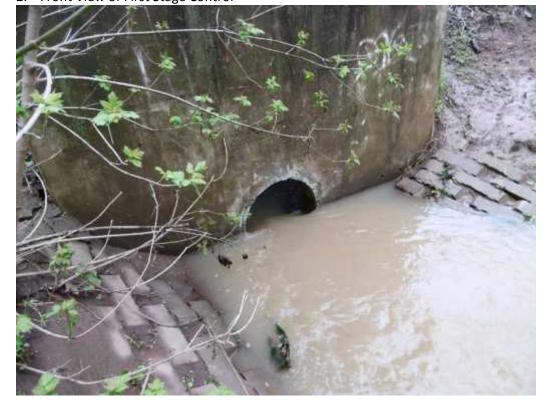
2. Front View of First Stage Control

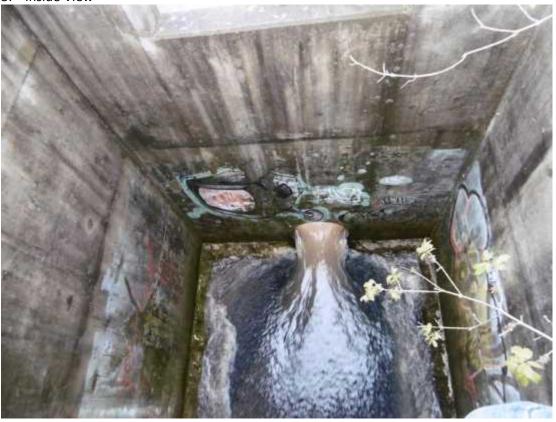
3. Inside View

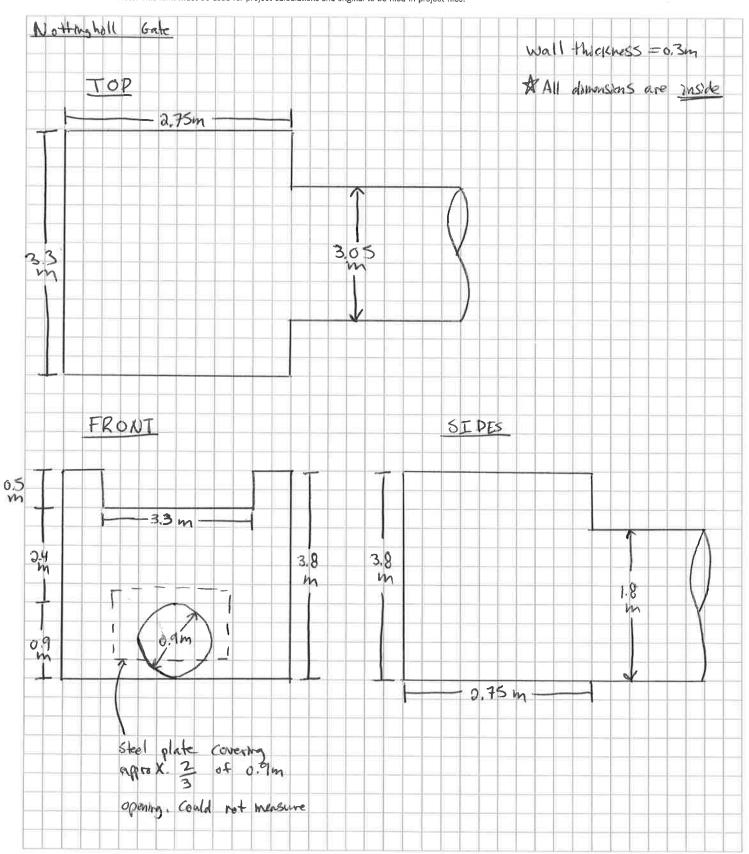
CLIENT Town of Oakulle	10 Page 1 - 1 - 1 - 1 - 1 - 1 - 1 - 1 - 1 - 1	foster wheeler		
PROJECT 14 Mile / McCraney	TPINGS/ PAGE 3			
SUBJECT In-line Structures - Field Measurements	PREPARED BY FILE NO.			
	CHECKED BY DATE

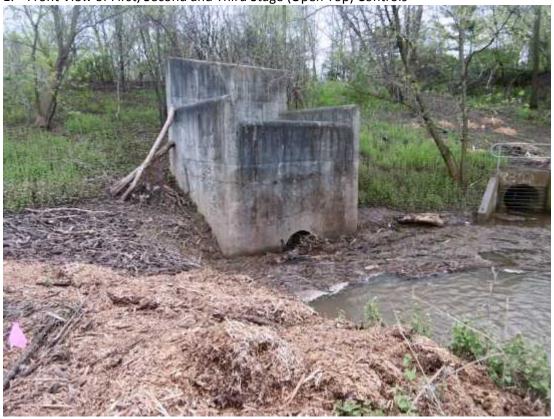
Nottinghill Gate Structure

1. Front View of First, Second and Third Stage (Open Top) Controls

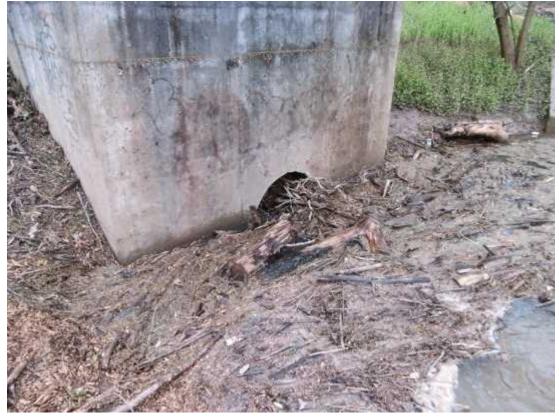
2. Front View of First Stage Control

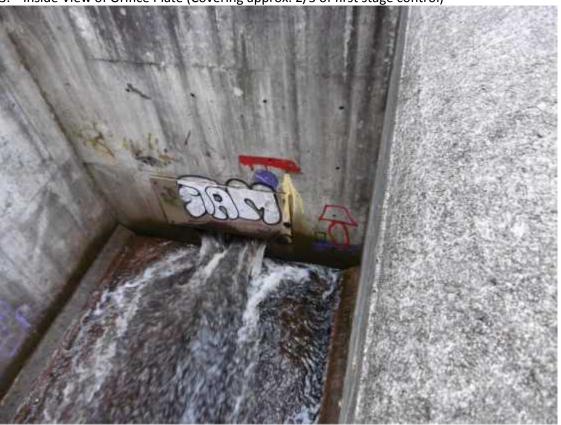
3. Inside View of Orifice Plate (Covering approx. 2/3 of first stage control)

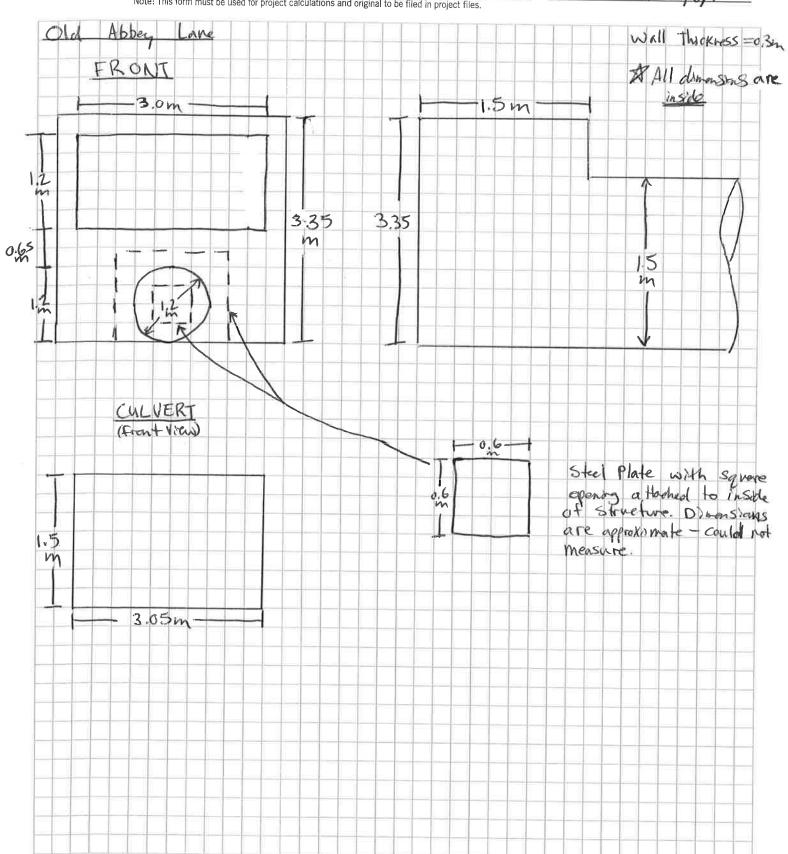
Old Abbey Lane Structure

CLIENT Town of Oakville PROJECT NO. PROJECT 14 Mile / Mc Craney FILE NO. TPING3 SUBJECT In-Line Structures - Field Measure monts # 120 DATE May 2/17 M B CHECKED BY

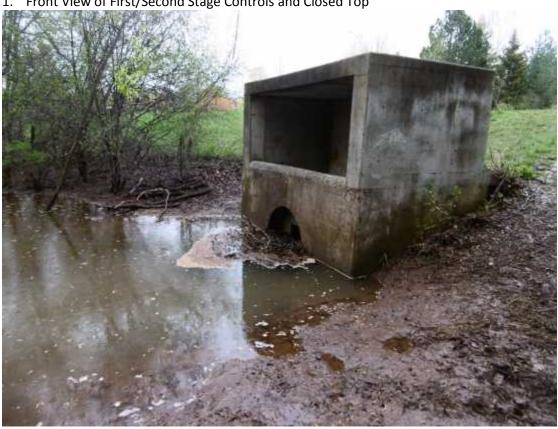
Front View of First/Second Stage Controls and Closed Top

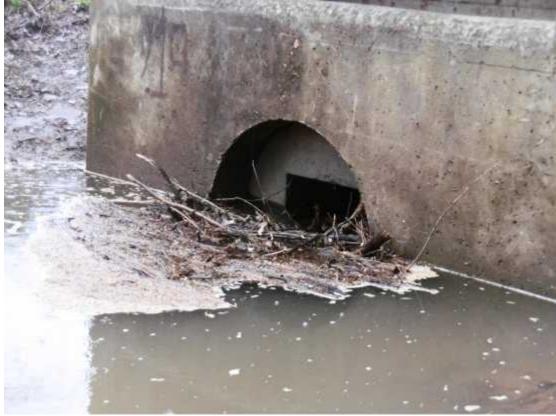
Front View of First Stage Control with Square Orifice Plate Attached (approx. dimensions of 0.6 m x 0.6 m)

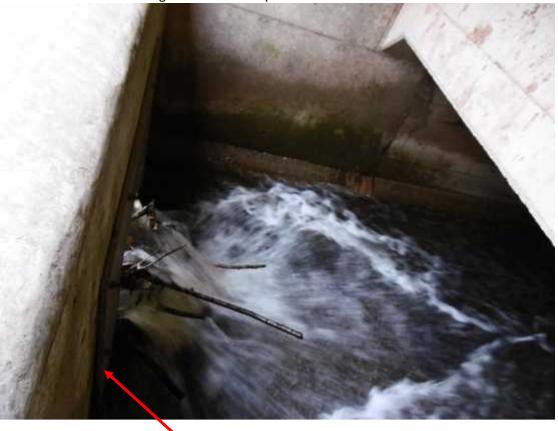
3. Inside View of First Stage Control with Square Orifice Plate Attached

Orifice Plate

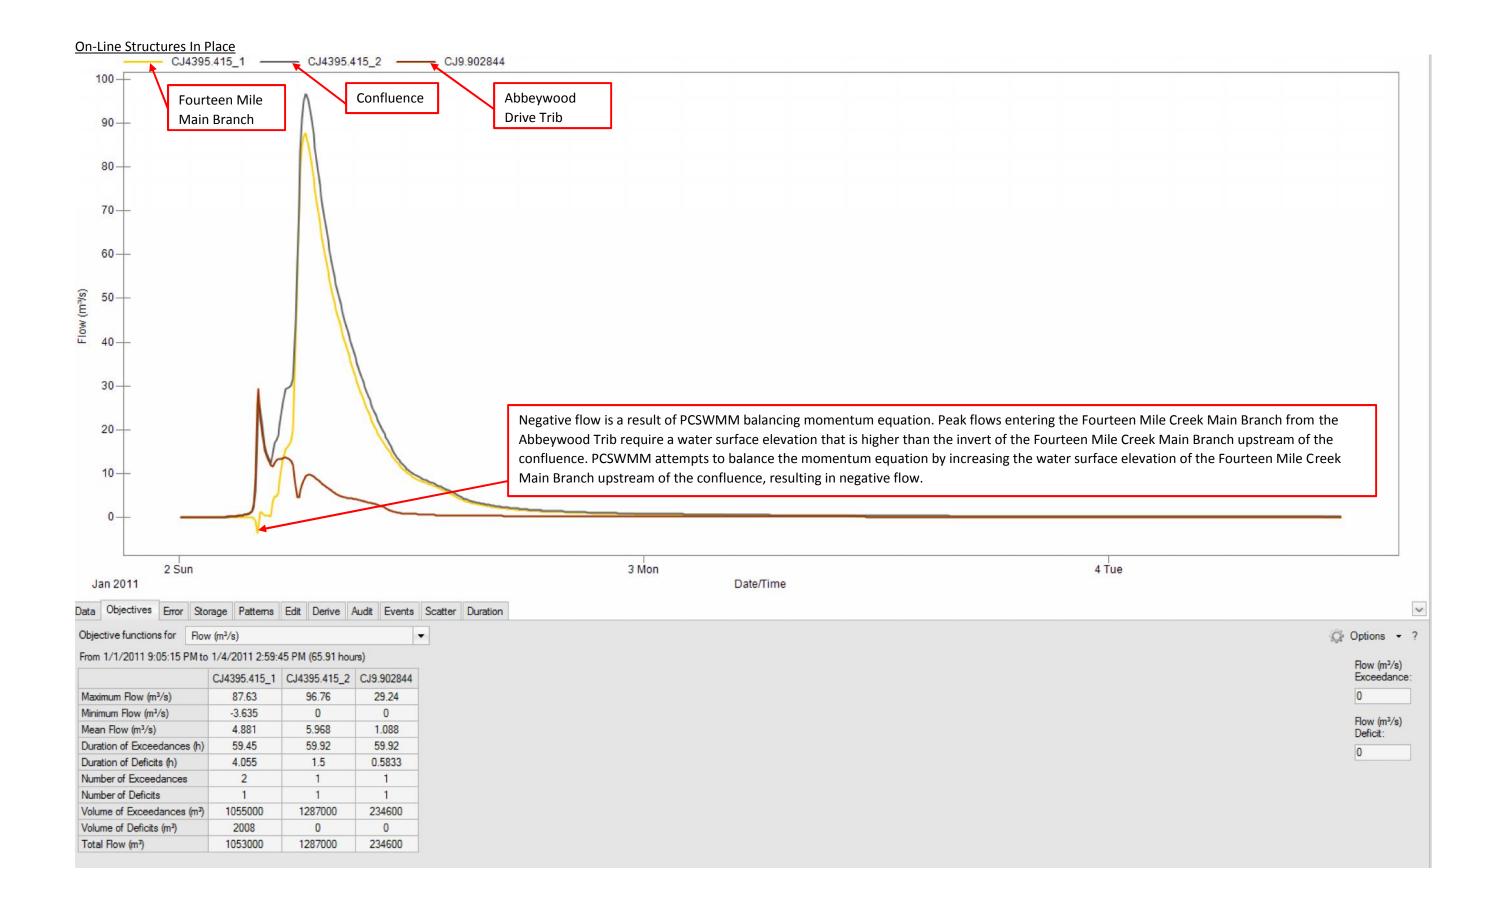
Confluence of Abbeywood Drive Tributary & Fourteen Mile Creek Main Branch – 100 Year **On-Line Structure Culverts Only** CJ4395.415_1 CJ4395.415_2 -CJ9.902844 Abbeywood Confluence Fourteen Mile 90-Drive Trib Main Branch 80-70-60-Flow (m³/s) 30-Negative flow is a result of PCSWMM balancing momentum equation. Peak flows entering the Fourteen Mile Creek Main Branch from the 20-Abbeywood Trib require a water surface elevation that is higher than the invert of the Fourteen Mile Creek Main Branch upstream of the confluence. PCSWMM attempts to balance the momentum equation by increasing the water surface elevation of the Fourteen Mile Creek 10-Main Branch upstream of the confluence, resulting in negative flow. 3 Mon 4 Tue 2 Sun Jan 2011 Date/Time Data Objectives Error Storage Patterns Edit Derive Audit Events Scatter Duration Objective functions for Flow (m³/s) Options - ? From 1/1/2011 9:05:15 PM to 1/4/2011 2:59:45 PM (65.91 hours) Flow (m³/s) Exceedance: CJ4395.415_1 CJ4395.415_2 CJ9.902844 94.42 0 Maximum Flow (m³/s) 87.67 33.27 Minimum Flow (m³/s) -3.888 0 0 Flow (m³/s) Mean Flow (m3/s) 4.882 5.968 1.087 Deficit: 59.36 59.92 59.92 Duration of Exceedances (h) 0 Duration of Deficits (h) 4.137 1.5 0.5833 Number of Exceedances 2 1 1 Number of Deficits 234500 Volume of Exceedances (m³) 1056000 1287000 Volume of Deficits (m³) 2603 0 0 1053000 1287000 Total Flow (m³) 234500
