Project File Report
McCraney Creek Bridge Replacement
Municipal Class Environmental
Assessment

Appendix C: Fluvial
Geomorphology Review and
Preliminary Channel Design (2018)

Fluvial Geomorphology Review and Preliminary Channel Design Fourteen Mile Creek & McCraney Creek Lakeshore Road West Improvements Class Environmental Assessment Town of Oakville

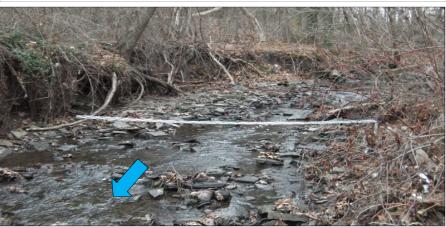
Existing Conditions Active Channel - Section 1 upstream

Hydraulic Geometry

Flow regime conditions for the proposed channel design are based on field survey of existing active flow or bankfull conditions. Field survey was done at two representative locations, upstream and downstream of the existing crossing, to determine a target bankfull flow.

Channel bed and bank geometry and bankfull flow geomorphic indicators were measured at each cross-section for use in geomorphic modeling. Channel bed substrates were measured through random-step Wolman pebble counts and recorded using the Wentworth sediment distribution scale. Cross-section locations were selected on evidence of active channel processes and defined bankfull shape and stage. Points of significant organic debris blockage that create localized backwater conditions were avoided. Observable tailwater flow indicators such as matted or flattened vegetation edges and root structures were located along banks and within encroaching vegetation for demarcation of cross-section limits.

Geomorphic open channel flow models were created for each cross-section location. Each model required input of channel bed substrate data, cross-section dimensions, gradient, and bank geometry. Modeling tests were done for each cross-section to determine hydraulic geometry, erosion thresholds, and bankfull flow. The detailed modeling results for existing bankfull conditions are appended. The proposed design bankfull flow rate was determined to be 3.65m³ s⁻¹. Based on the urbanized watershed context and lack of known upstream stormwater management facilities it is expected that bankfull or channel forming flows occur potentially several times a year and that peak events have flashy timing. Erosion threshold indicators from proposed design sections are not extreme, with velocity ranging from 1.1-1.4m s⁻¹ and shear stress ranging from 30-80N m⁻²/. Indicators are moderately high enough however that sympathetic design treatments are warranted, given the specific consideration that shading will impact vegetative reinforcement.

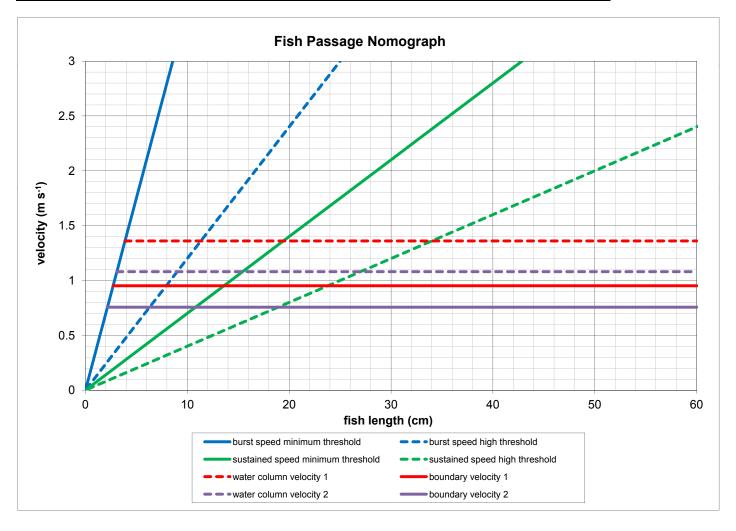
FSH-PASS v.2.2 Fish Passage Channel Velocity Analysis Model

Project: McCraney Creek Preliminary Channel Design
Lakeshore Road Crossing

S _b D _s burst speed swimming distance (m)						
	1	2				
water column	90.2	105.6				
boundary	112.6	123.4

Fish Length Data					
		sustained speed high threshold	sustained speed	burst speed high threshold	burst speed
1	fish length L _f (cm) at V	34.0	19.4	11.3	3.9
	fish length L_f (cm) at V_b	23.8	13.6	7.9	2.7
2	fish length L _f (cm) at V	27.0	15.4	9.0	3.1
	fish length L _f (cm) at V _b	18.9	10.8	6.3	2.2
