PHASE TWO ENVIRONMENTAL SITE ASSESSMENT

PROPOSED RESIDENTIAL DEVELOPMENT

LAKESHORE AVENUE WEST AND WEST STREET

Reference No. 1610-E074

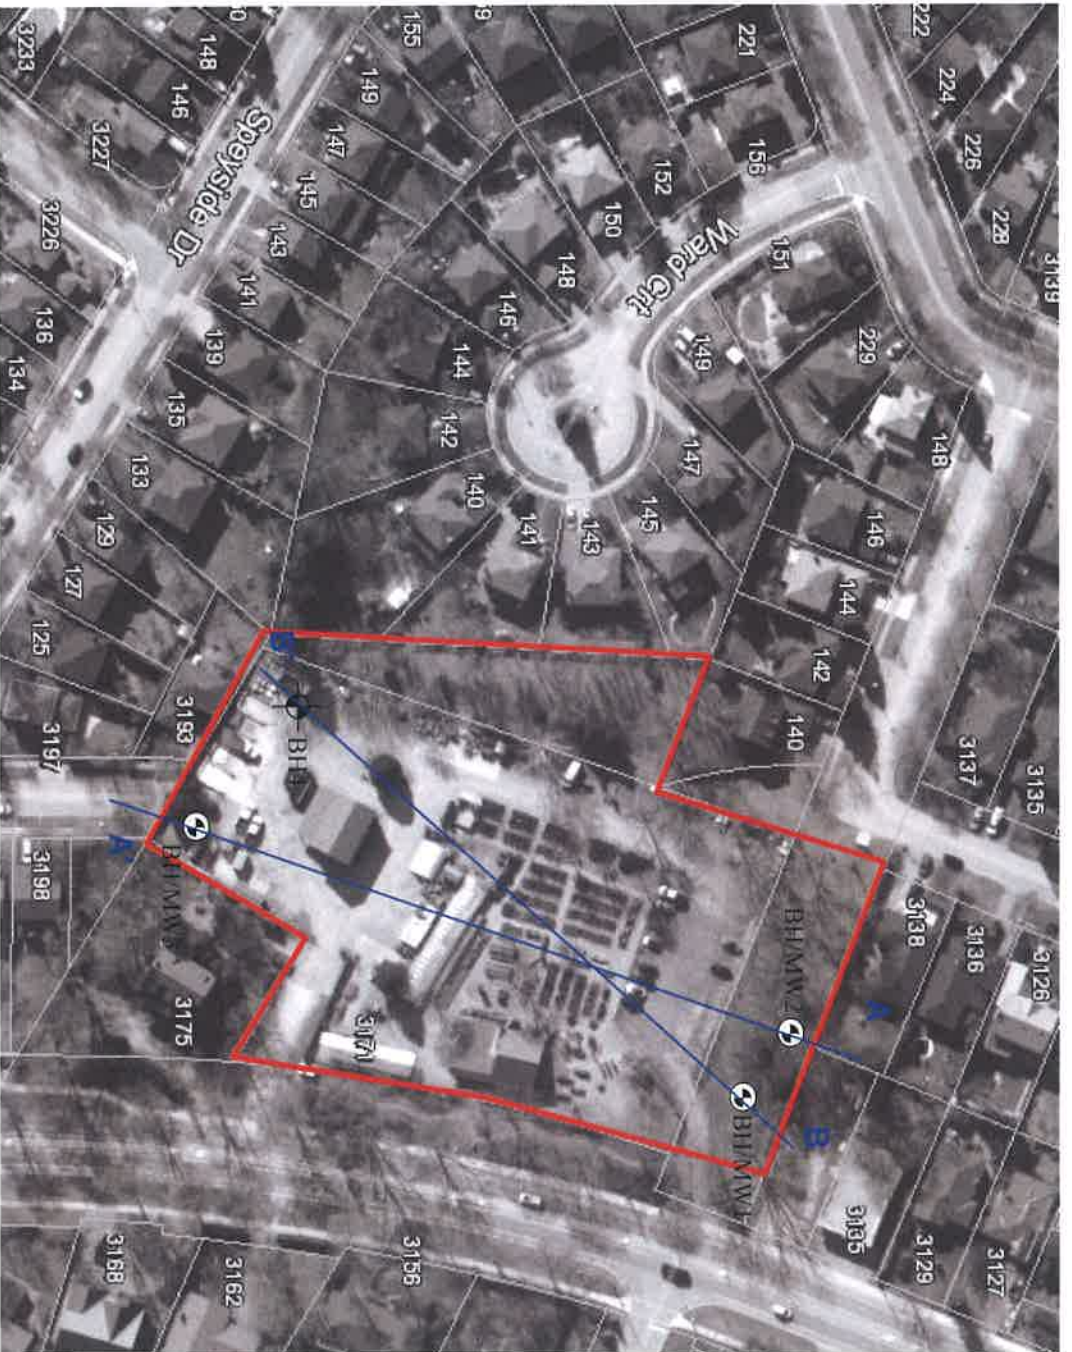
Title Borehole Monitoring Well and Test Pit Location Plan
Project Proposed Residential Development 3171 Lakeshore Road West Town of Oakville
Reference No. 1610-E074
Date July 14, 2017
Scale See drawing
Drawing No. 2

The field investigation for this Phase Two ESA consisted of conducting four (4) boreholes (designated as BH1 to BH4) at depths ranging from 4.7 mbgs to 6.1 mbgs and four (4) hand-dug test pits up to depths of 0.5 mbgs. The subsoil conditions at the borehole and test pit locations indicate a layer of topsoil, sandy silt to silty sand fill at the ground surface followed by native strata of silty clay and silt at various depths and locations. Weathered shale/shale bedrock was encountered on the subject site at depths ranging from 2.7 mbgs to 4.6 mbgs.
