PHASE ONE ENVIRONMENTAL SITE ASSESSMENT 349 DAVIS ROAD OAKVILLE, ONTARIO

1.0 EXECUTIVE SUMMARY

PROJECT No.: SM 220059-E

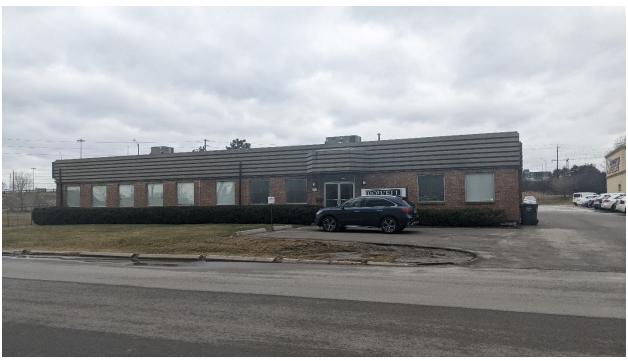
Photo of the front of the Site building, taken from the south side of Davis Road, facing northwest.

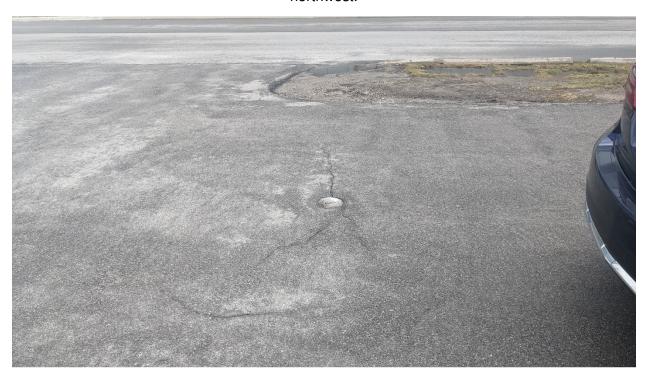
Photo of flush mount monitoring well located just south from the southeast corner of the Site building, facing southeast.

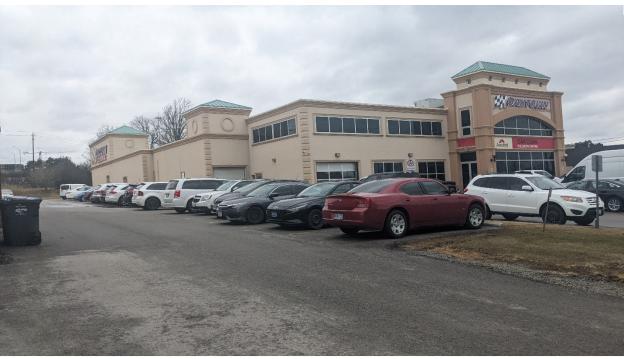
Photo of adjacent auto collision repair facility to the east of the Site, taken from the southeast corner of the Site, facing north-northwest.

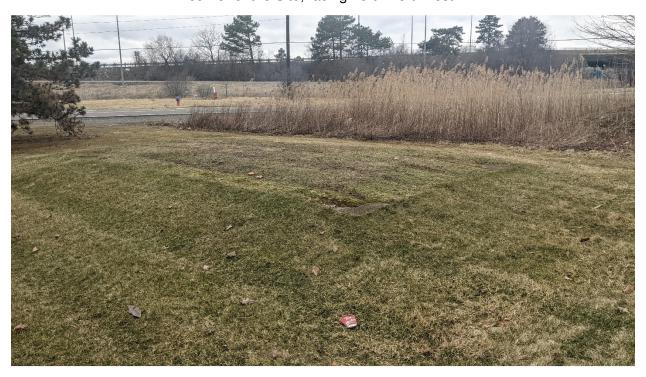
Photo of grassed over concrete pad at the north end of the Site, facing west.

In addition to the above, a concrete pad was observed on the northern portion of the Phase One Property. Information gathered during the completion of this report suggests the concrete pad is associated with a former storage shed, although this was not confirmed or refuted to be the case. As such, it is recommended that a Ground Penetrating Radar [GPR] and an Electro-Magnetic Survey [EMS] be conducted in the immediate vicinity of the concrete pad to assess the area for potential unknown buried features.

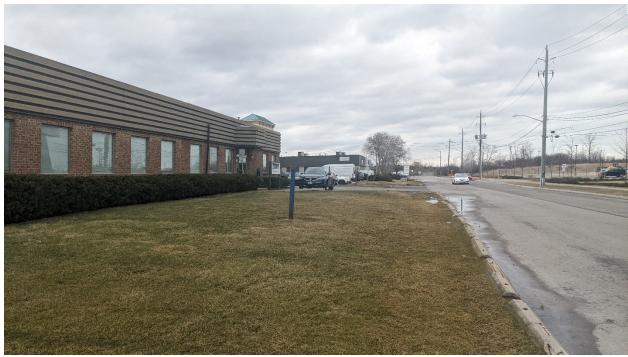
Photo from the southwest corner of the Site, facing northeast, with a stick up monitoring well in the foreground.
