MATTAMY PHASE 3 ADDENDUM TO THE JOSHUA'S CREEK TRIBUTARIES EIR/FSS
DRAWING 11
TREE ASSESSMENT ALONG TRAIL/SWALE
MAY 2020

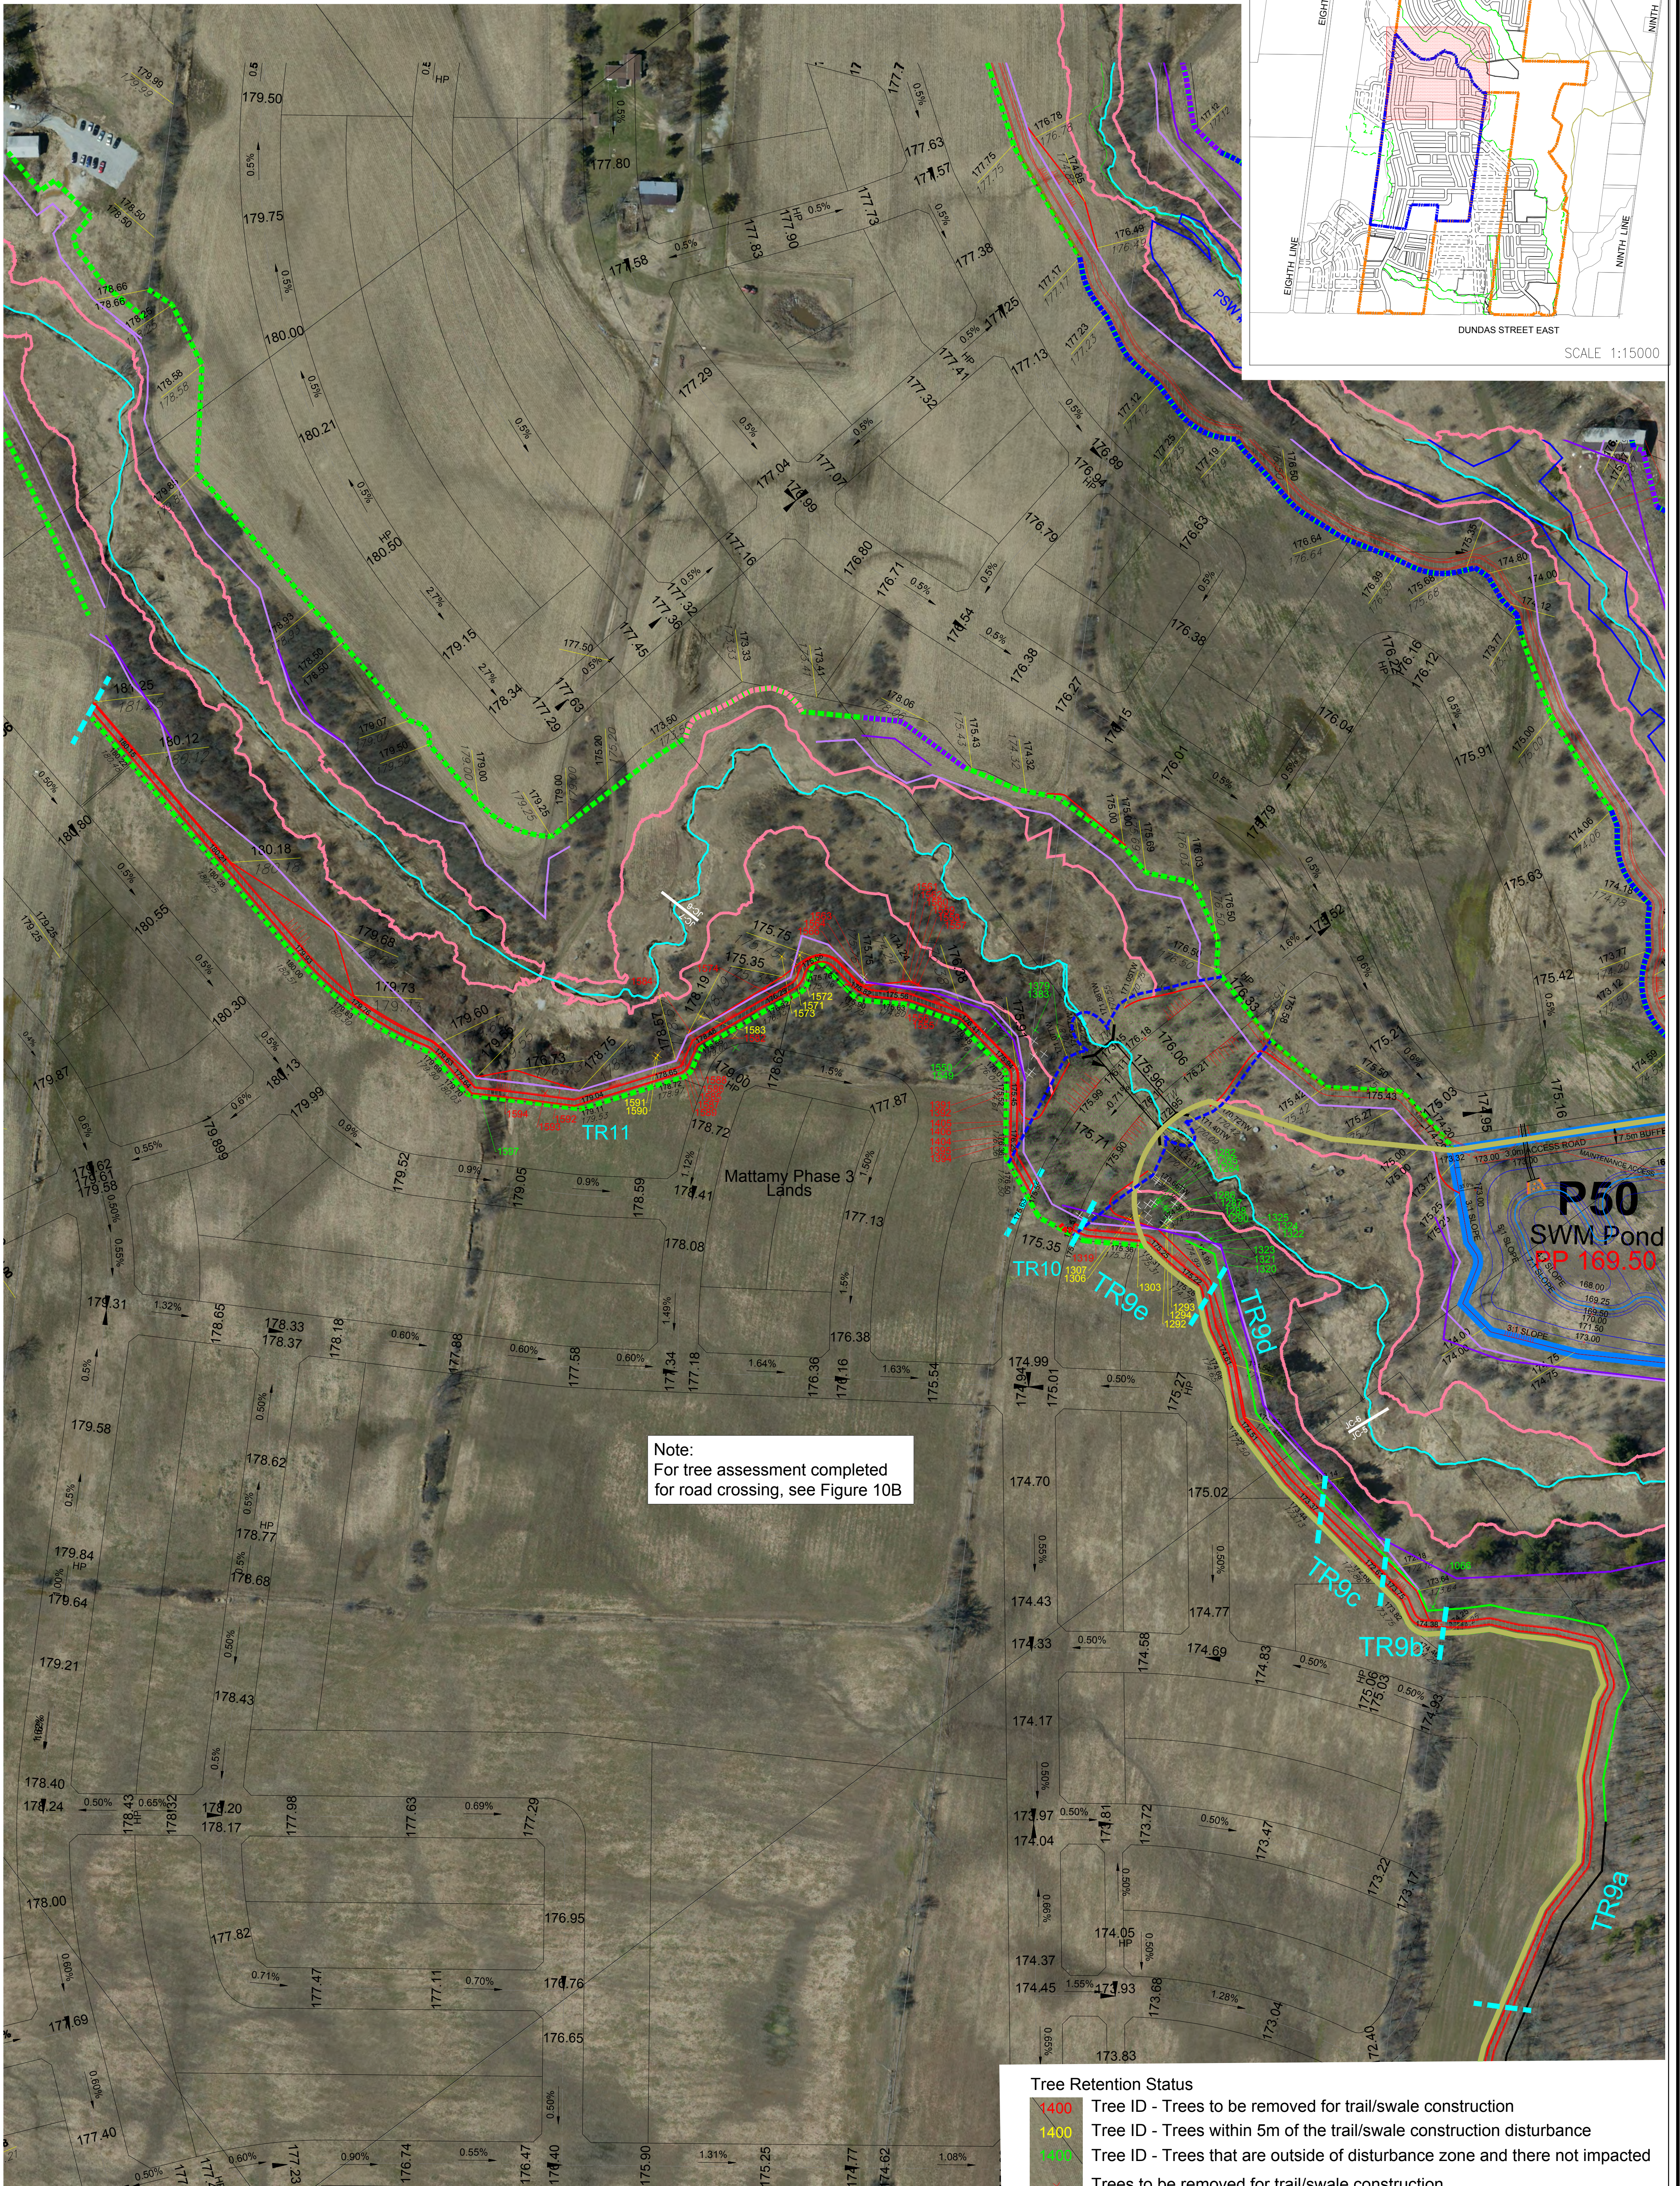
Note:
For tree assessment completed
for road crossing, see Figure 10B

Tree Retention Status	
1400	Tree ID - Trees to be removed for trail/swale construction
1400	Tree ID - Trees within 5m of the trail/swale construction disturbance
1400	Tree ID - Trees that are outside of disturbance zone and there not impacted
X	Trees to be removed for trail/swale construction
X	Trees within 5m of the trail/swale construction disturbance
X	Trees that are outside of disturbance zone and there not impacted
X	Dead Trees
