5.0 Natural Environment

6.0 Water Resources

Environmental Implementation Report / Functional Servicing Study for 14 Mile Creek West and the Lazy Pat Farm Property

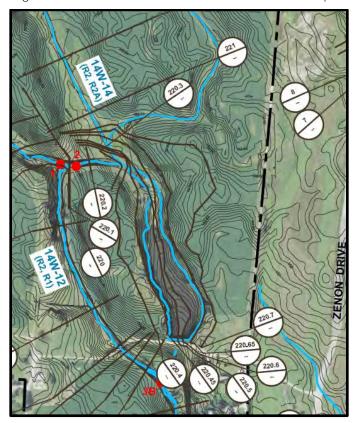
Figure 6.7 - Hec-RAS cross-section location for Riparian Storage existing condition model

The cross sections in existing condition Hec-RAS model were revised. Reach 14W-12A and the flood storage about the permanent pool in the human-made pond were combined with Reach 14W-14, representing only single reach due to confluence located on the downstream side. Figure 6.7 shown the Hec-RAS model cross section locations for human-made pond and Reach 14W-12 that combined with Reach 14W-14. Cross section 220.7 to 220.4 were added in the model.

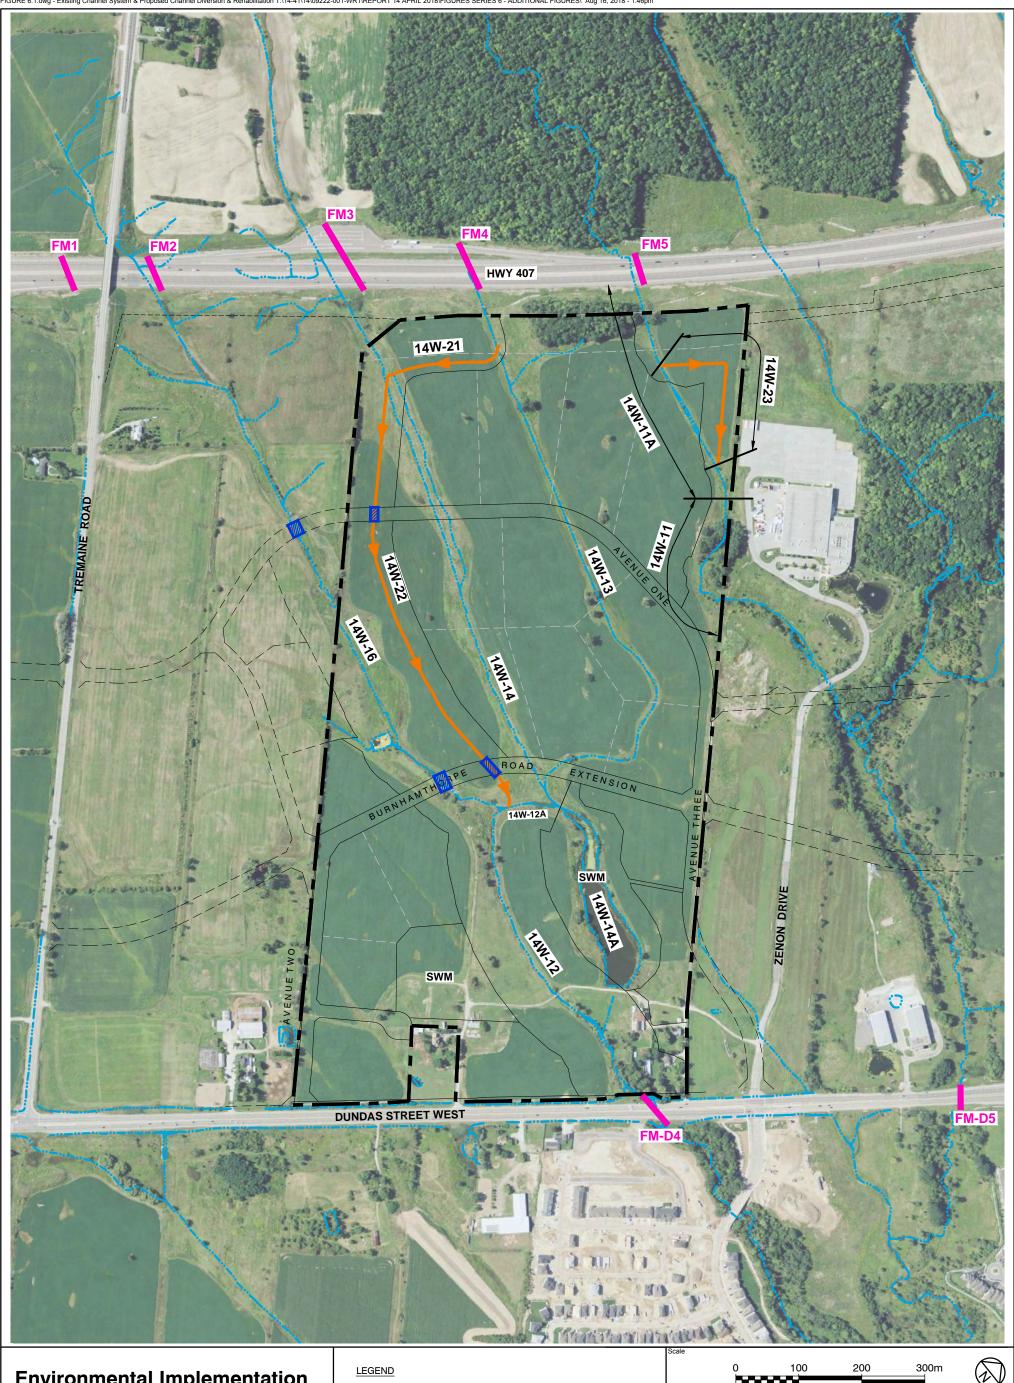
Existing Channel System, And Proposed Channel Diversion and Rehabilitation

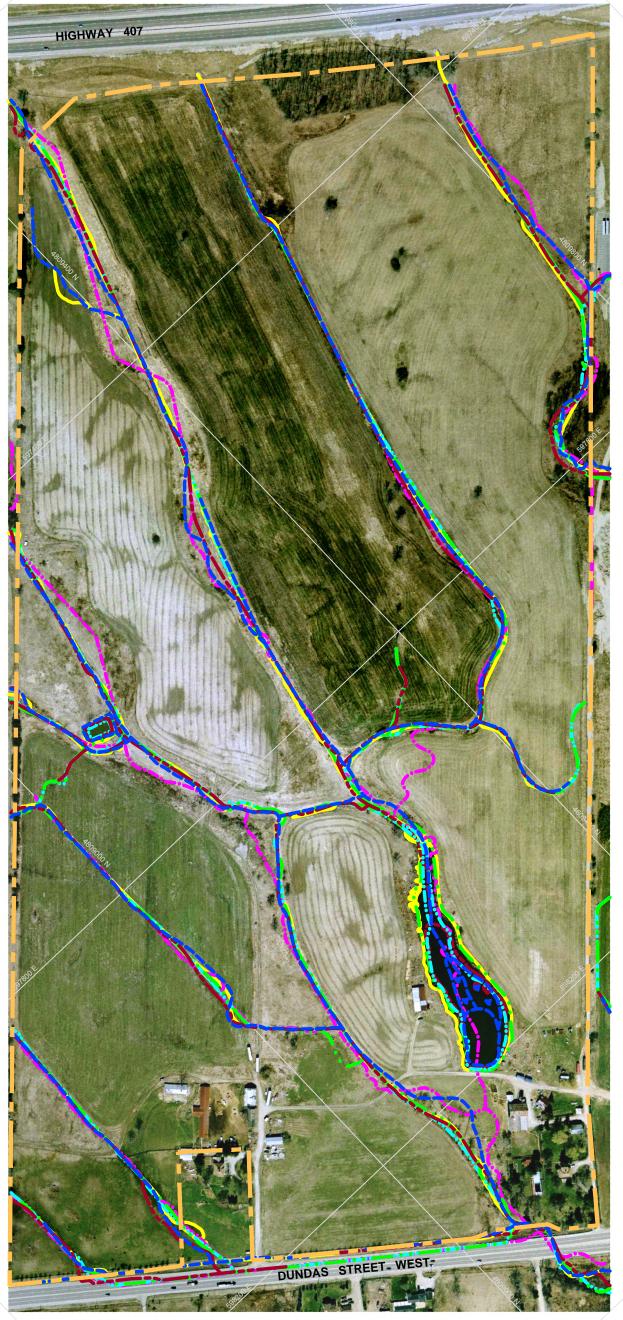
Historical Channel Planform

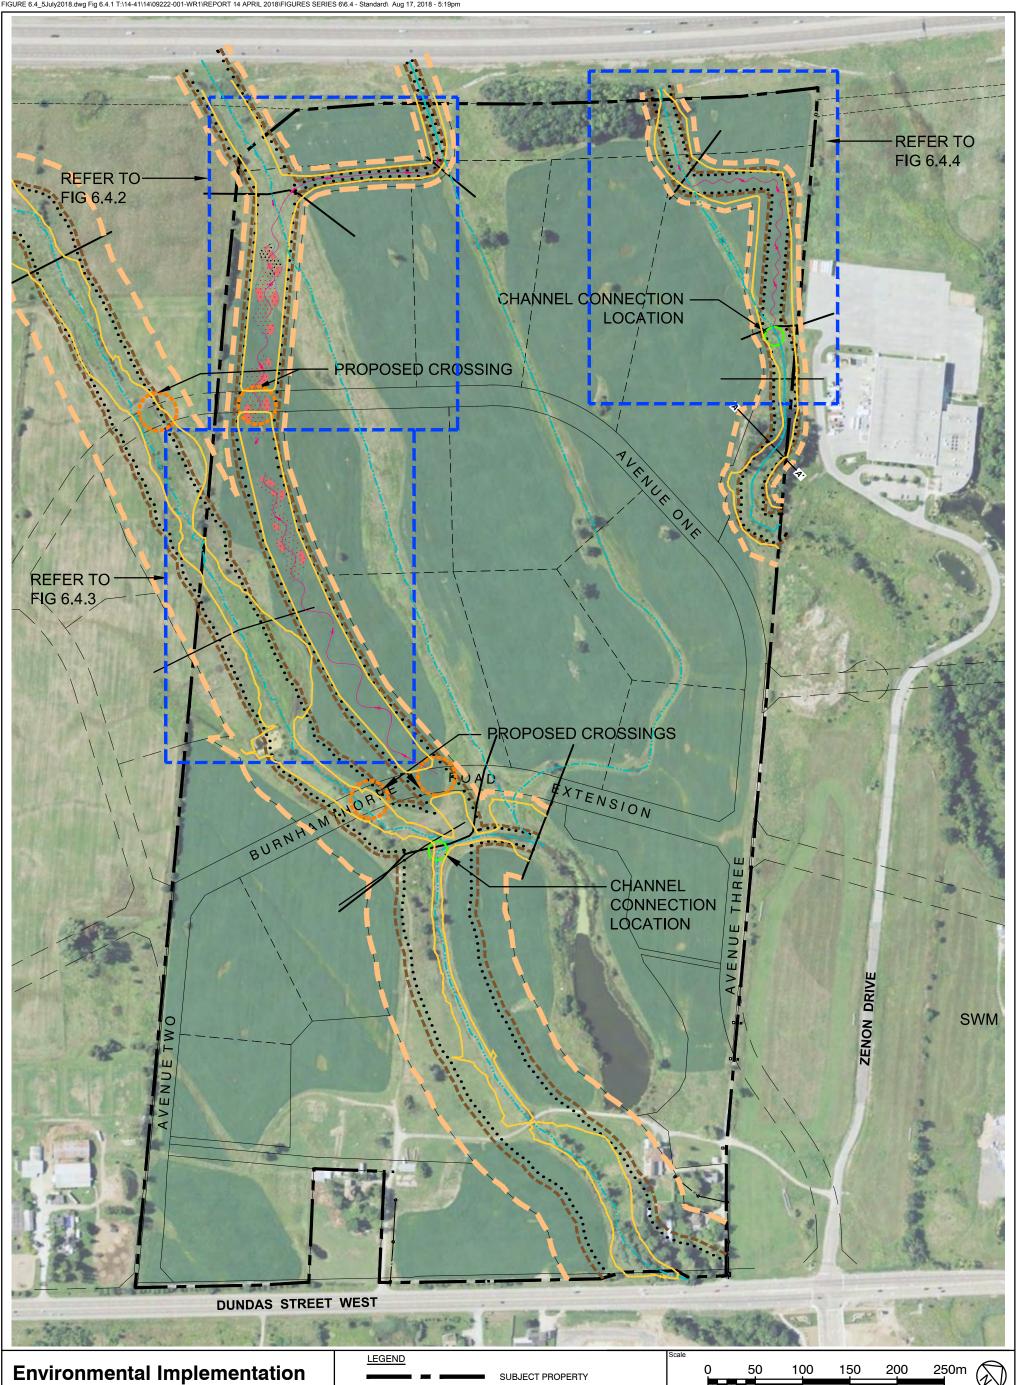
14 Mile Creek Natural Channel Design Alignment And Planform -Key Plan (Ultimate Phase)

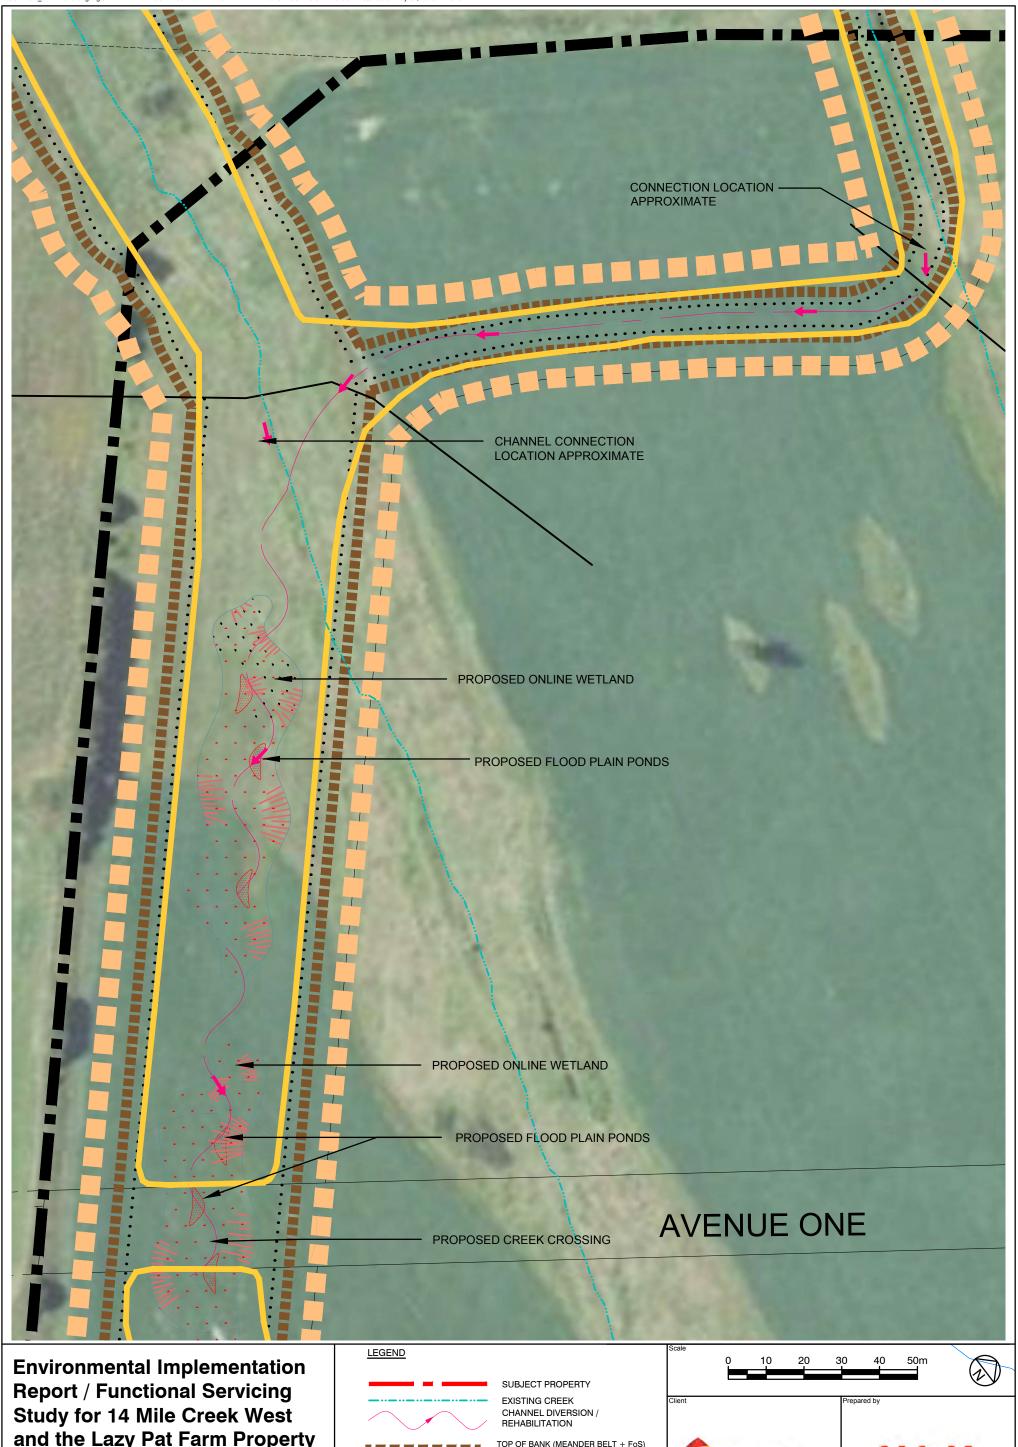
Diversion Channels 14W-21 And 14W-22 Alignment And Planform

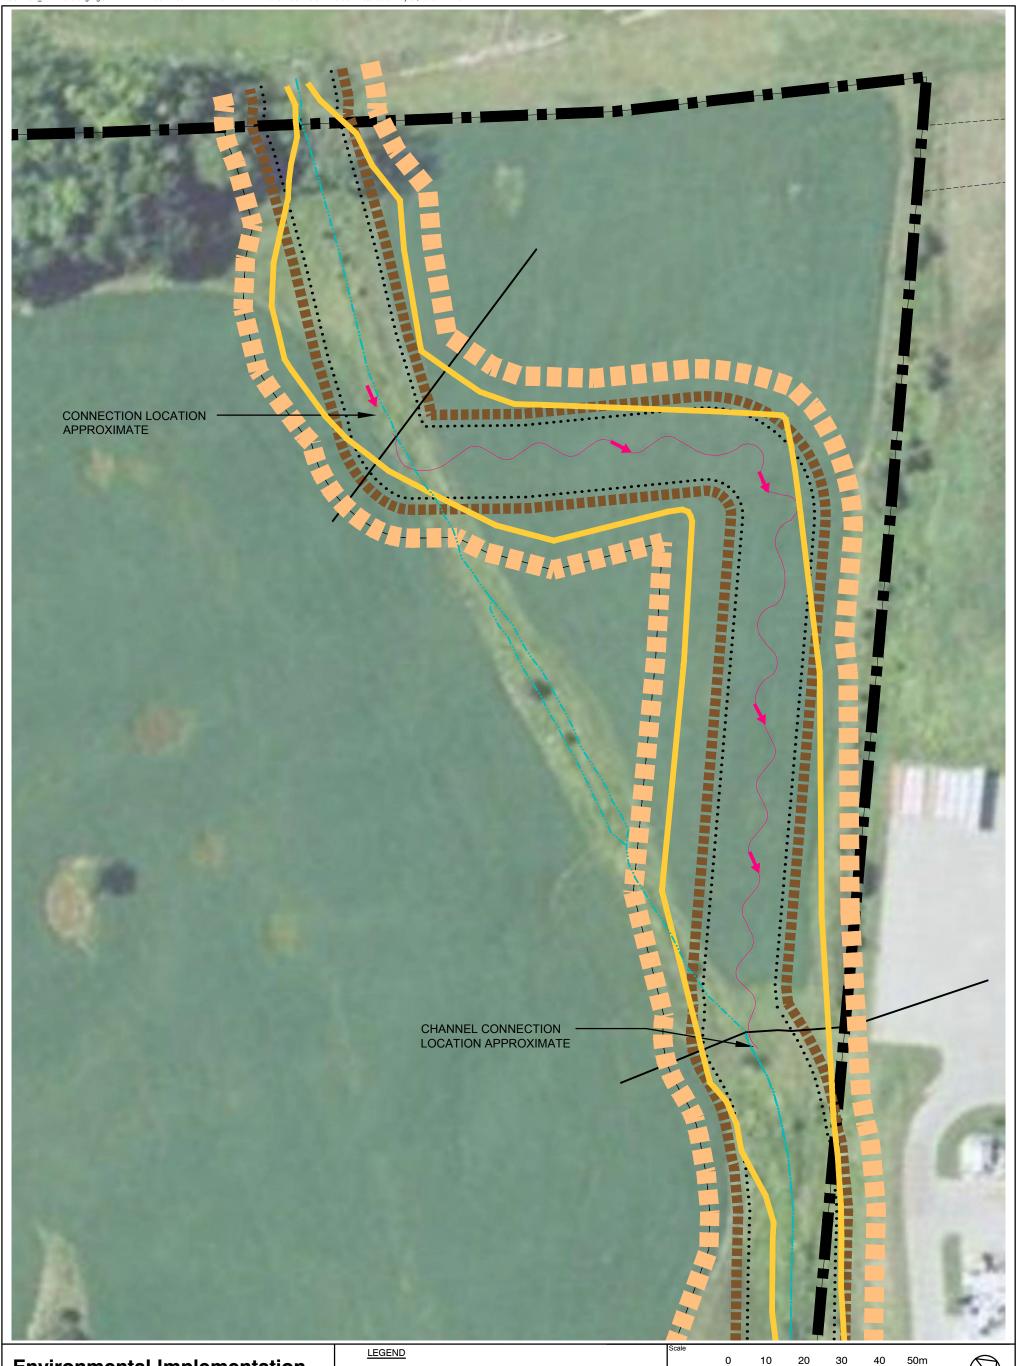
Diversion Channels 14W-23 and 14W-11 Alignment And Planform

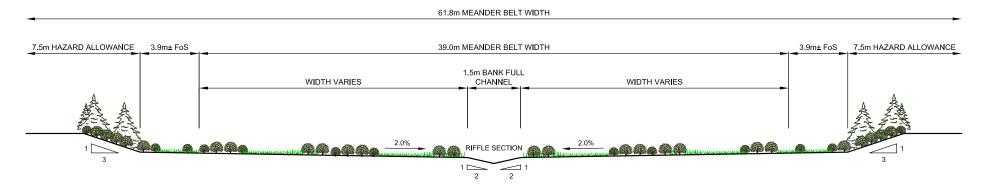
CHANNEL CORRIDOR - CHANNEL OUTSIDE BEND N.T.S.

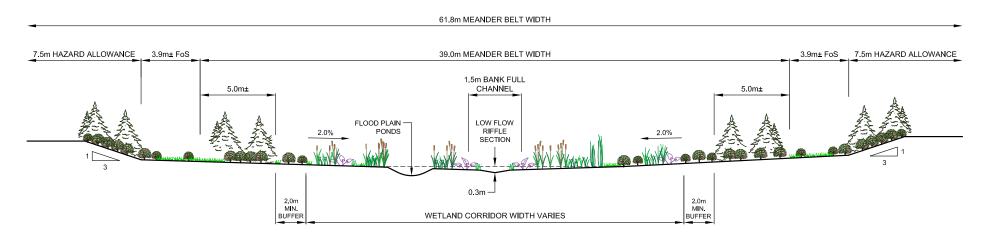
CHANNEL CORRIDOR - CHANNEL RIFFLE SECTION BEND N.T.S.

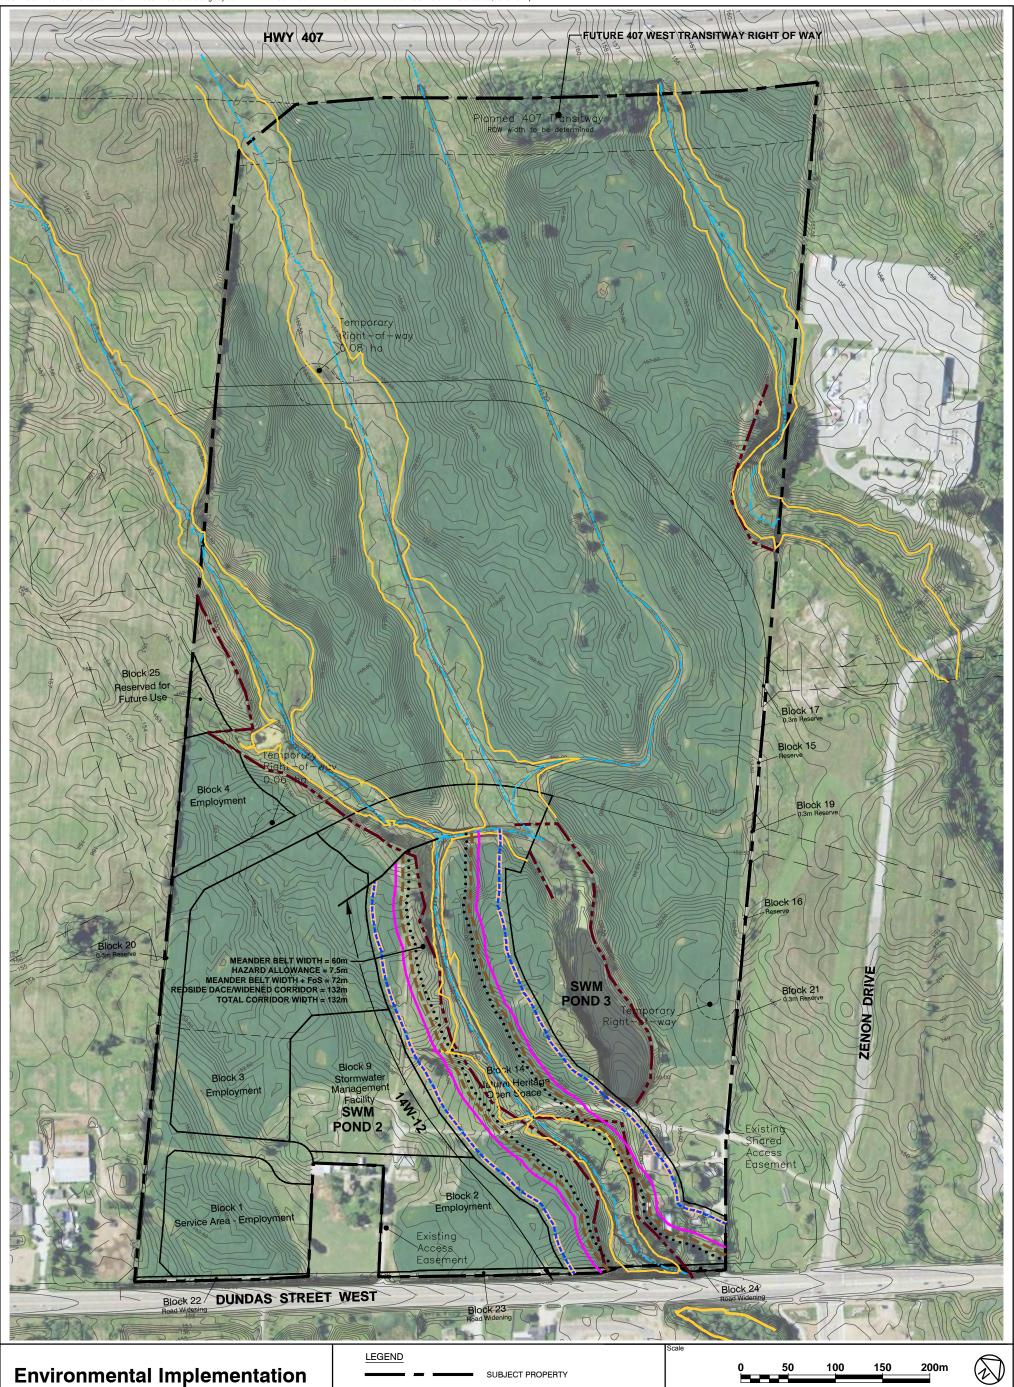
Corridor Delineation

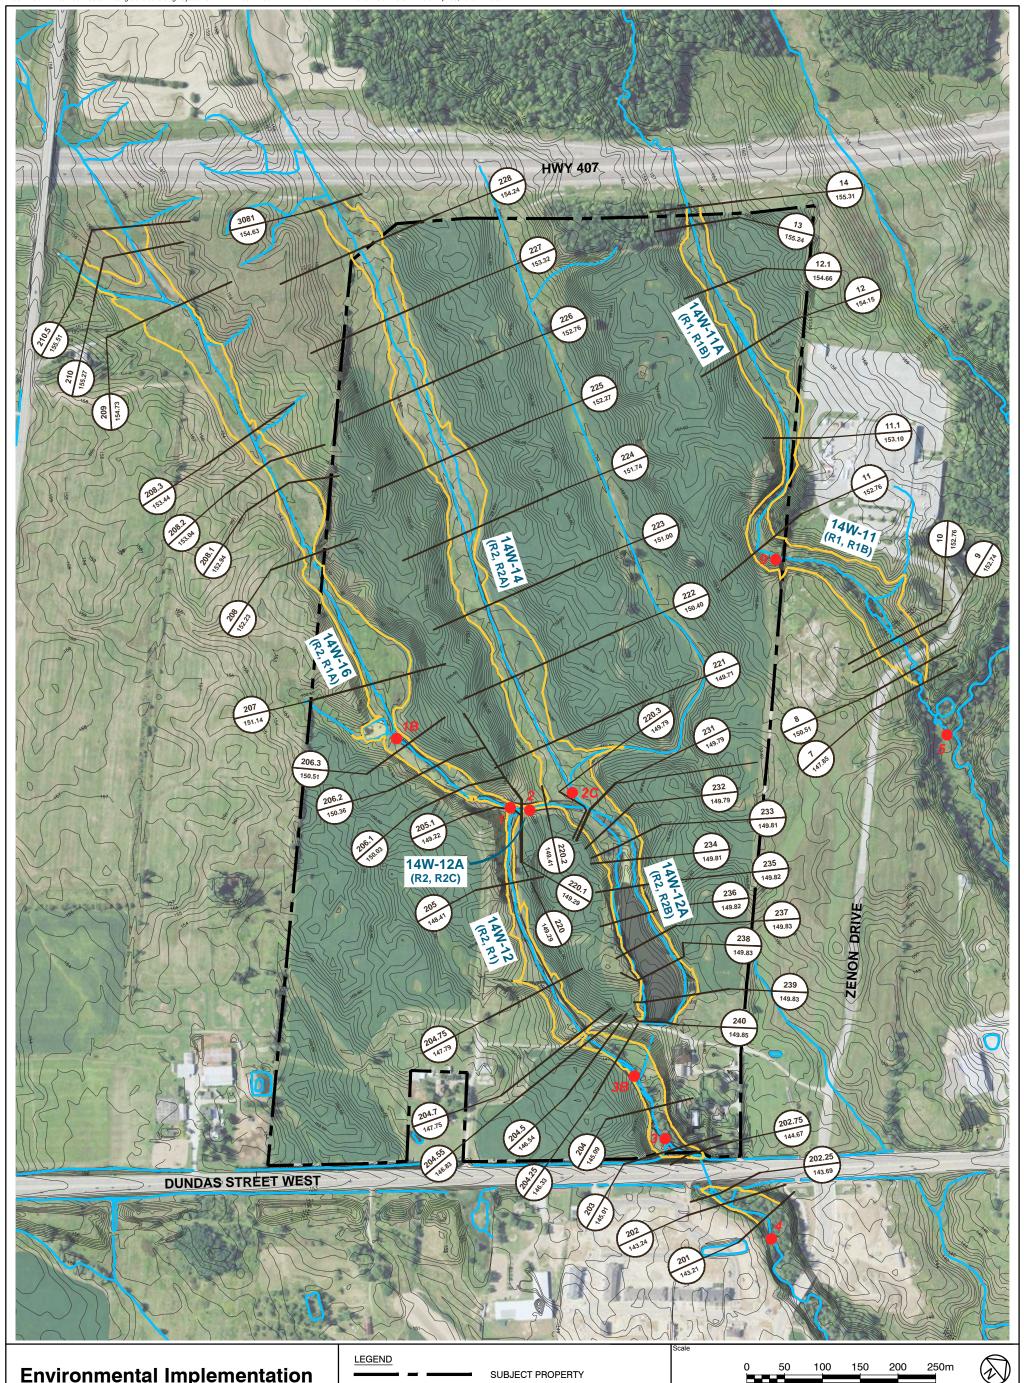
Hec-Ras Cross-Sections
Existing Conditions

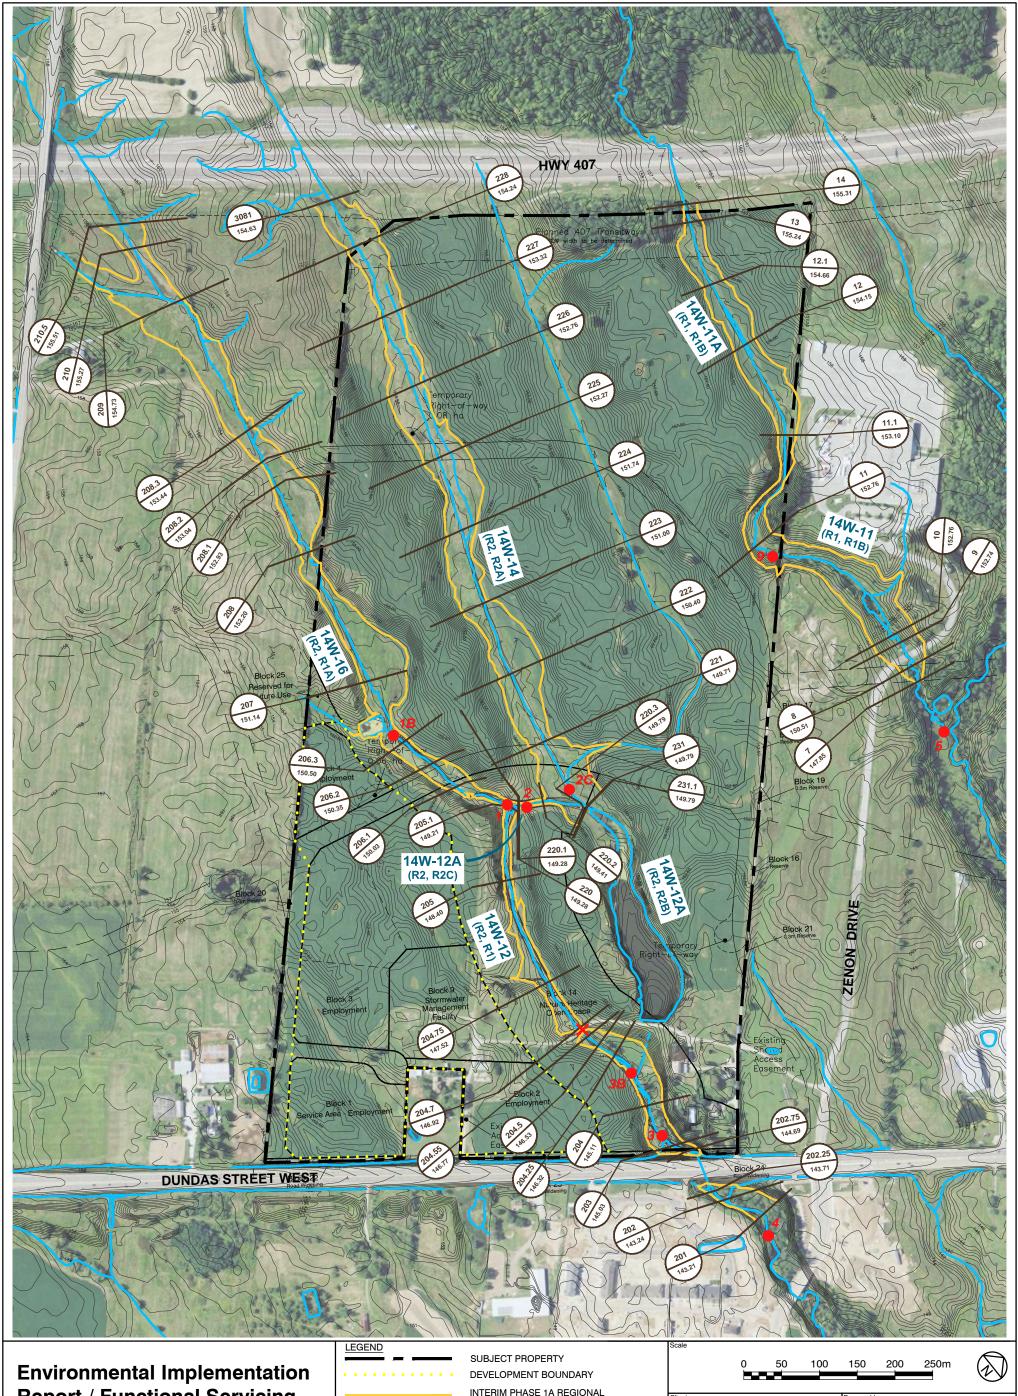
Hec-Ras Cross-Sections
Interim Phase 1A Conditions

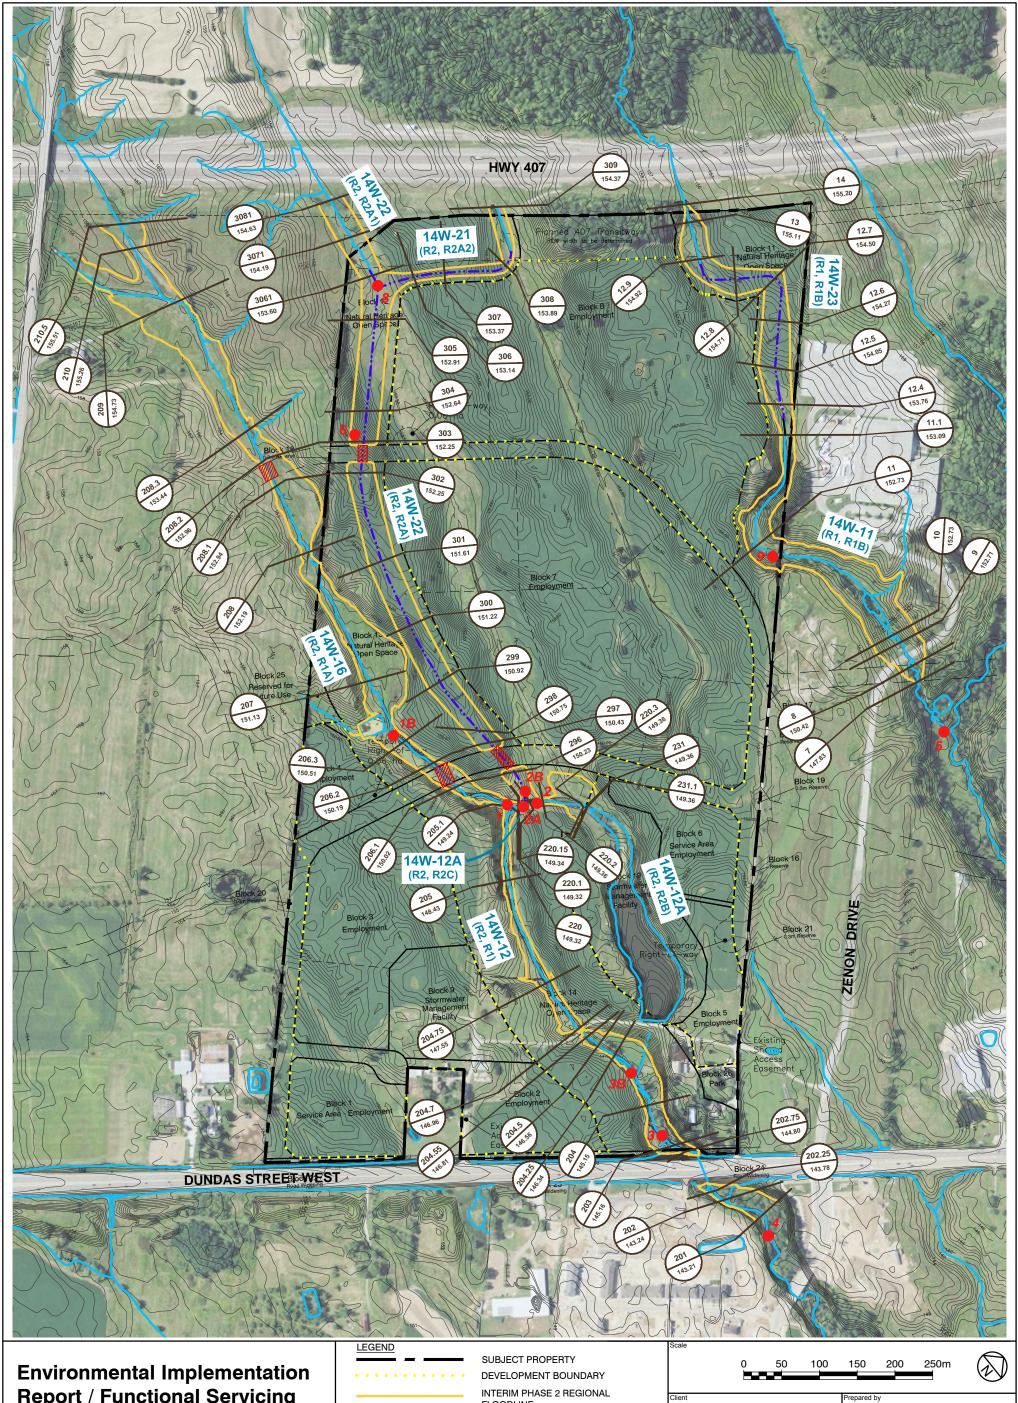
Hec-Ras Cross-Sections Interim Phase 2 Conditions

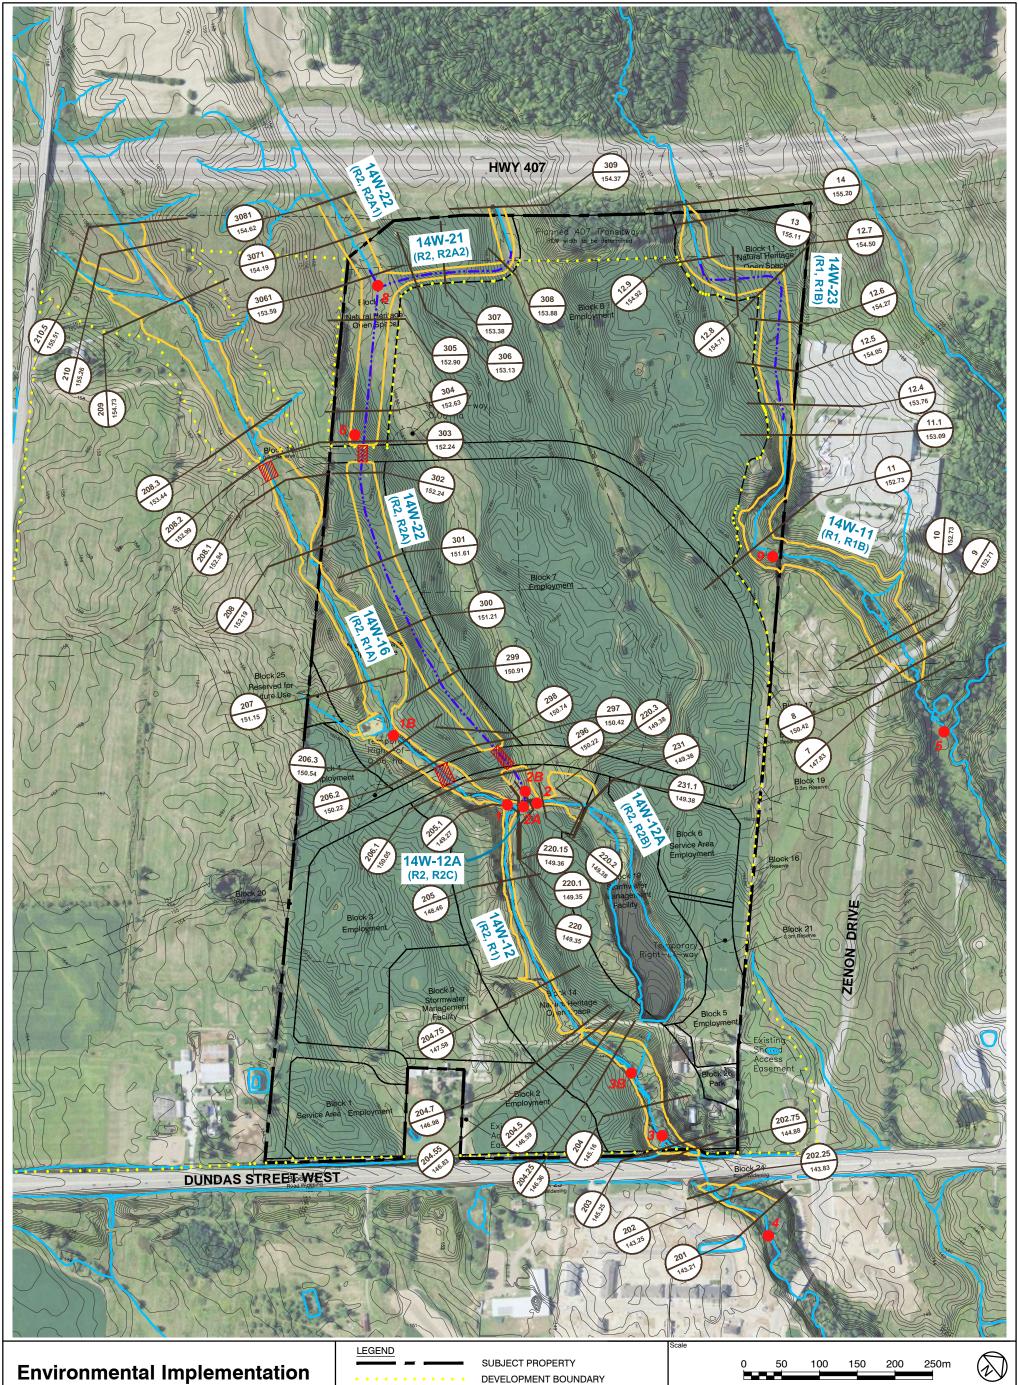
Hec-Ras Cross-Sections
Ultimate Conditions

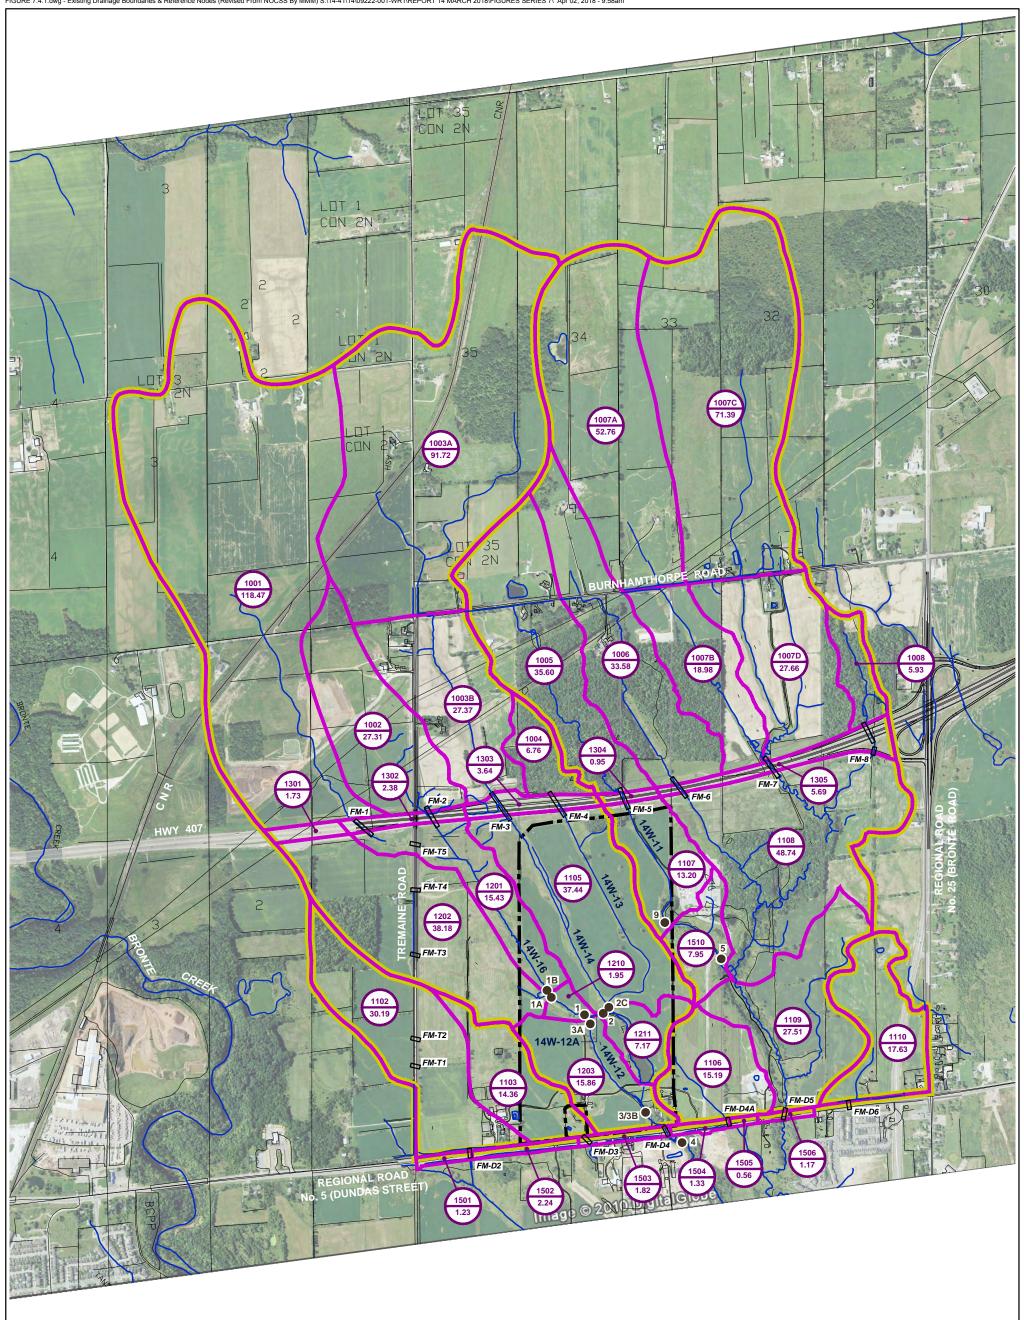
Existing Drainage Boundaries and Reference Nodes (Revised from NOCSS by MMM)

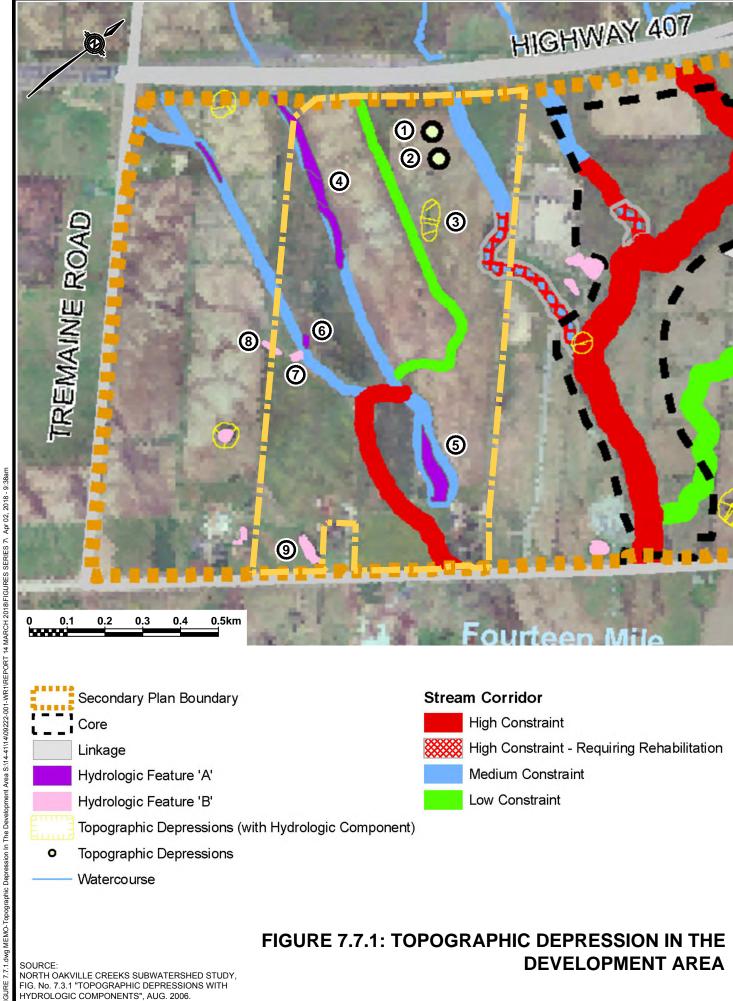
NORTH OAKVILLE CREEKS SUBWATERSHED STUDY, FIG. No. 7.3.1 "TOPOGRAPHIC DEPRESSIONS WITH HYDROLOGIC COMPONENTS", AUG. 2006.
