# **Geotechnical Slope Stability Hazard and Risk Assessment - Desktop Study & Site Inspection Report**

**East Morrison Creek Erosion Mitigation Study  
Town of Oakville, Ontario**

**Client:** Matrix Solutions Inc.

**Date:** April 11, 2025

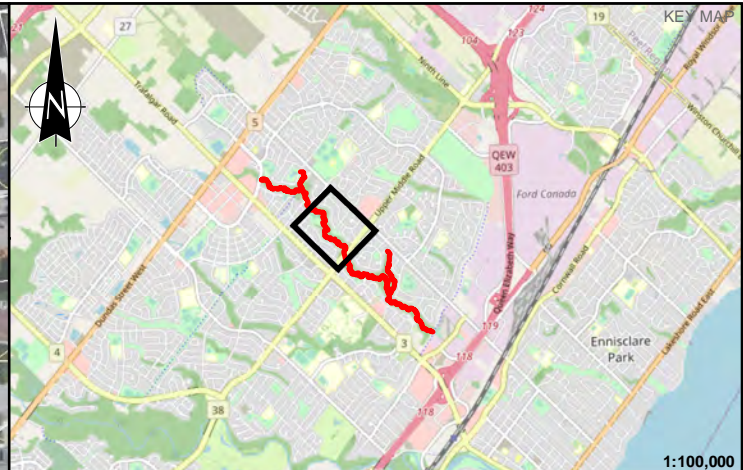
- LEGEND**
- EROSION SITE (NOTED BY OTHERS)
  - WATERCOURSE
  - TOPOGRAPHIC CONTOUR, metres
  - SITE
- SLOPE STABILITY RATING (OMNR TECHNICAL GUIDE RIVER & STREAM SYSTEMS: EROSION HAZARD LIMIT TABLE 4.2)**
- LOW HAZARD (0 - 24)
  - SLIGHT HAZARD (25 - 35)
  - MODERATE HAZARD (>35)

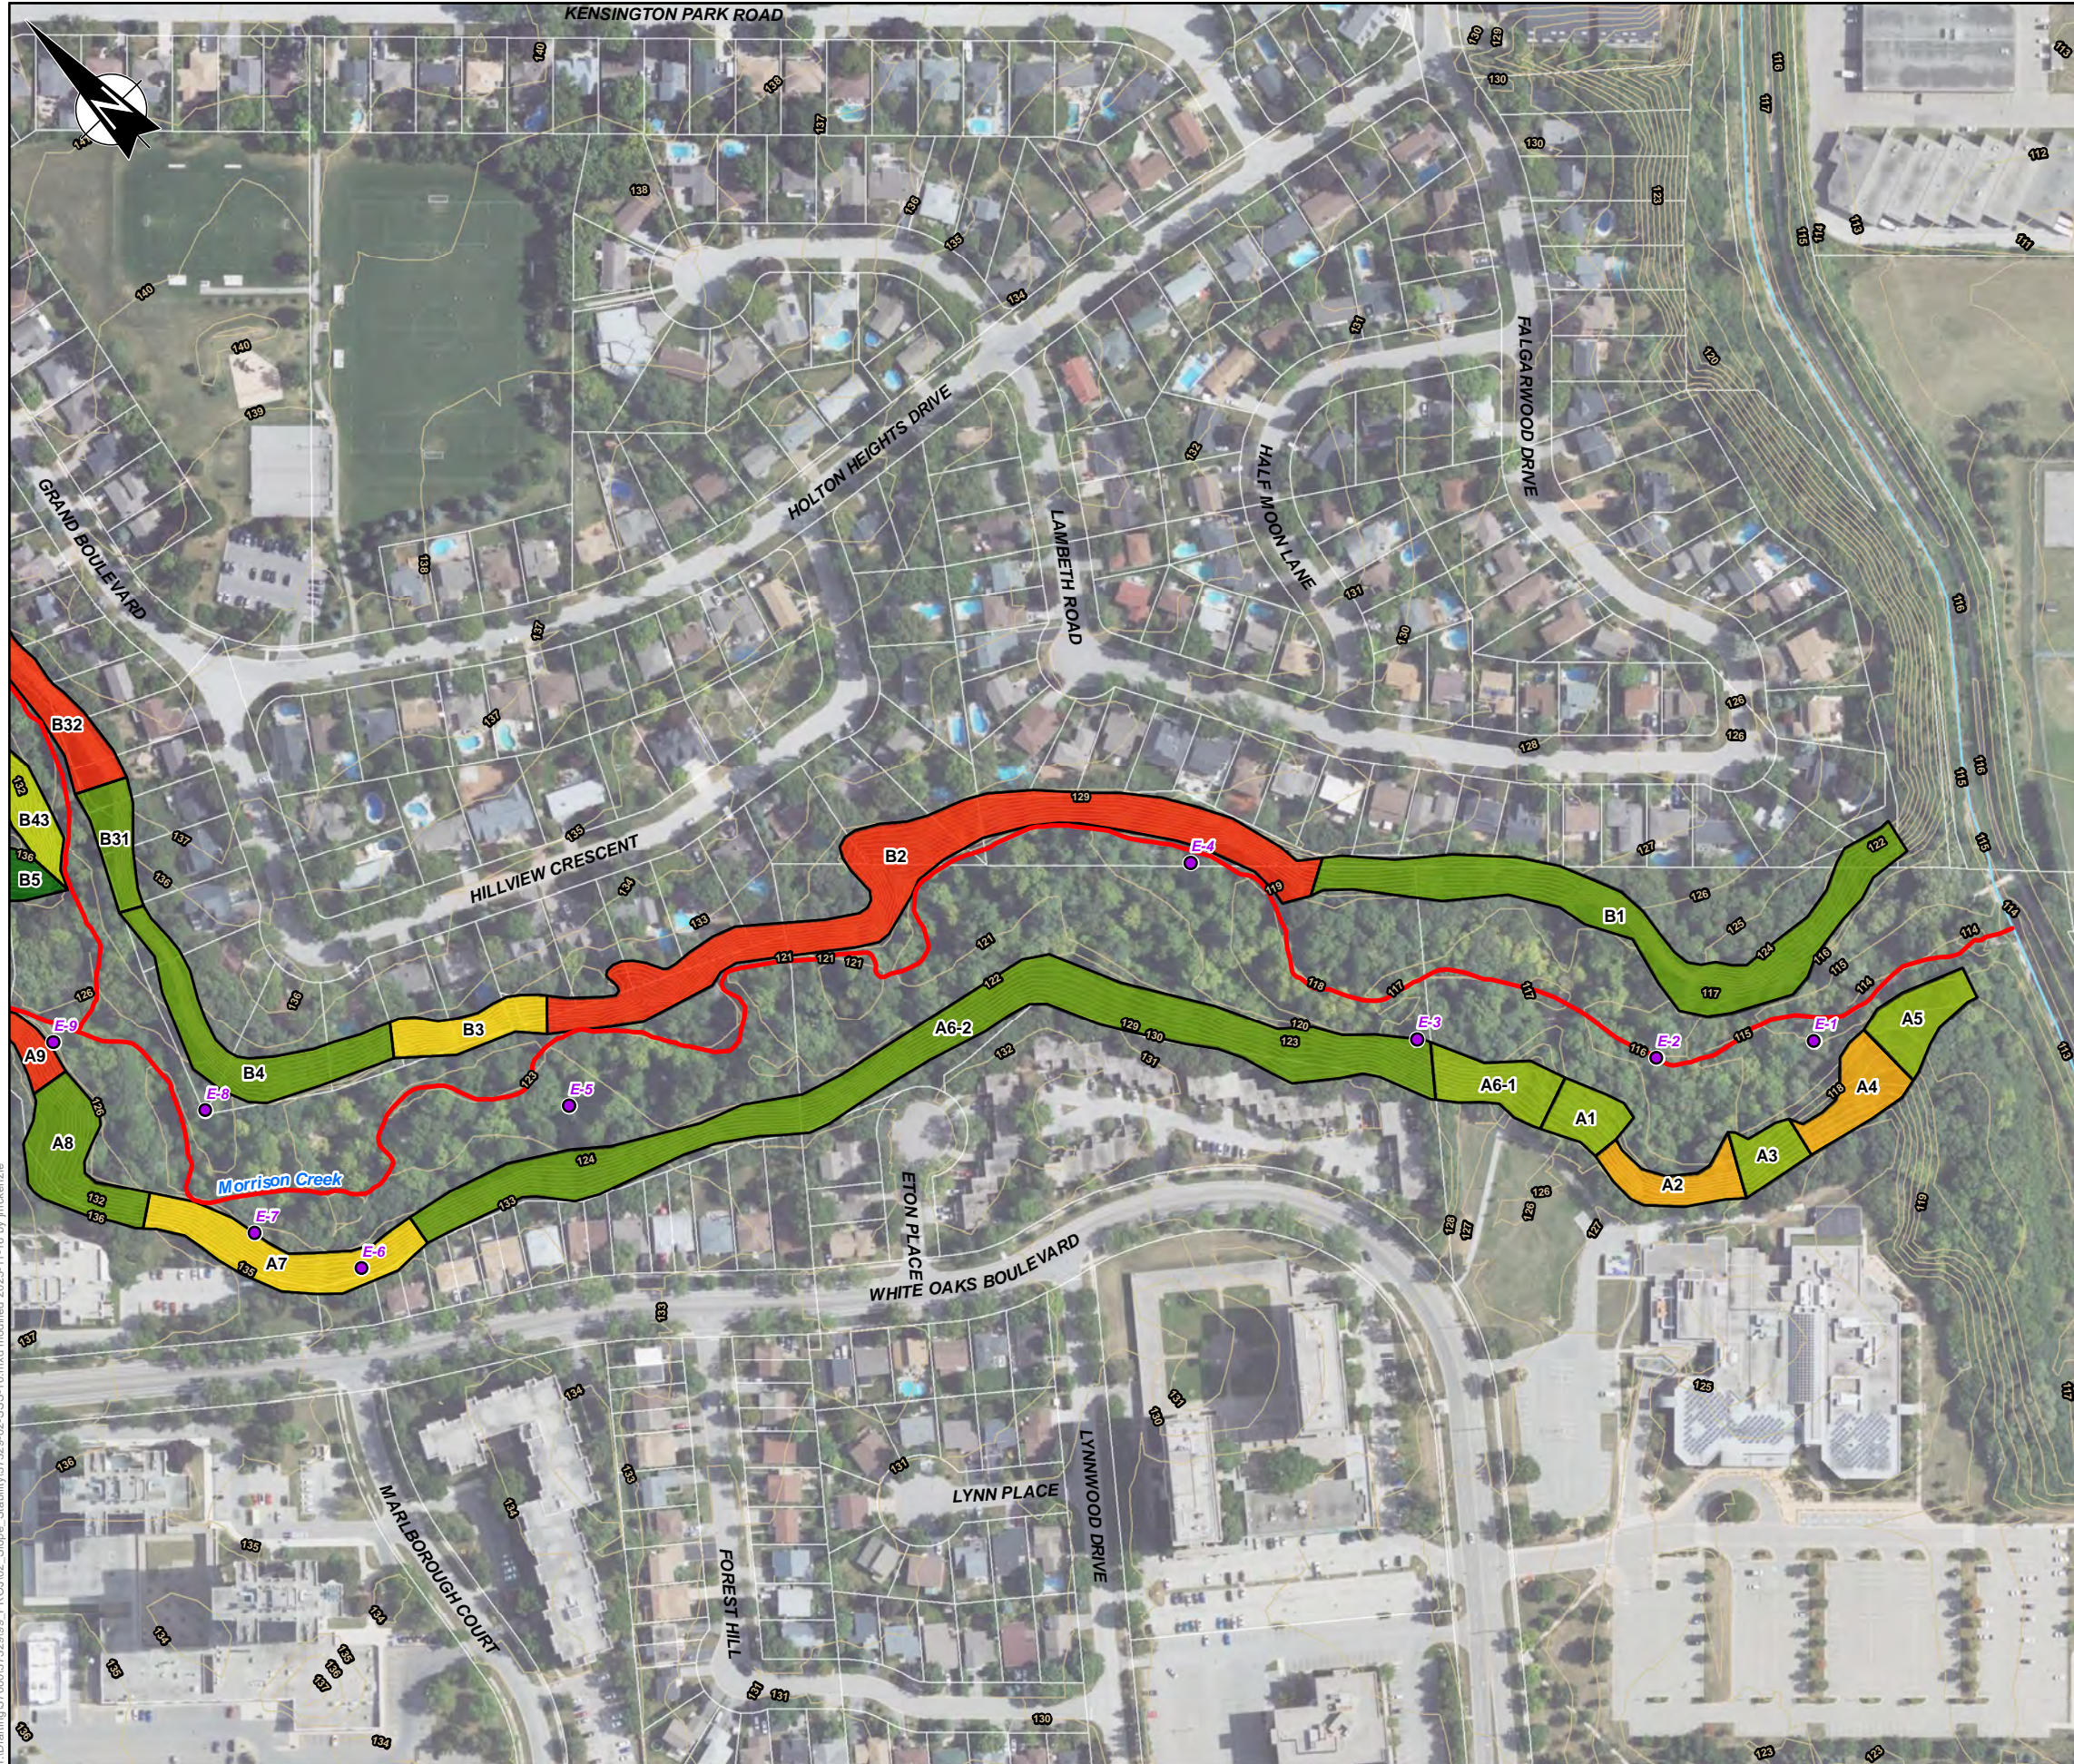
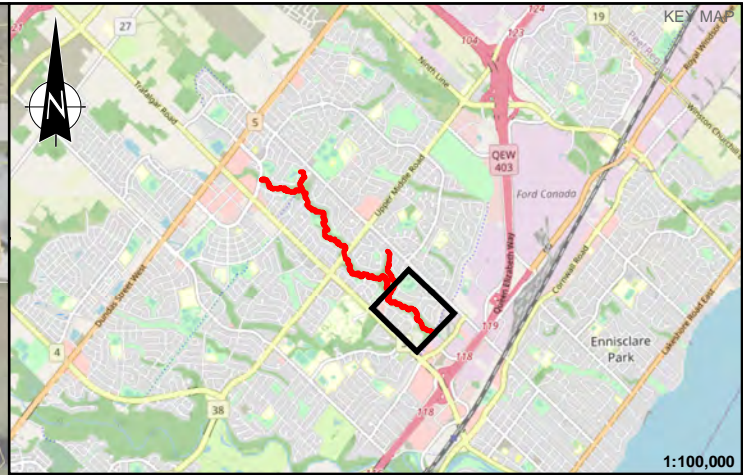
PROJECT No.	37329
ENGINEER	GS
DRAWN	JEM
APPROVED	KF
DATE	2023-11-16
FIGURE No.	10

A third set of maps was created which combines the slope instability hazard and potential consequences to visualize the total slope instability risk in the Study Area. The zones are colour coded on a gradient scale where green is lowest risk, and red is highest risk in Figures 10 to 13 of Appendix B.
